EFFECT OF SURFACE FINISH AND HARD COATINGS ON SCUFFING OF STEEL DISCS

Thesis submitted in candidature
for the degree of
Doctor of Philosophy at Cardiff University

Institute of Theoretical, Applied and Computational Mechanics
Cardiff School of Engineering
Cardiff University

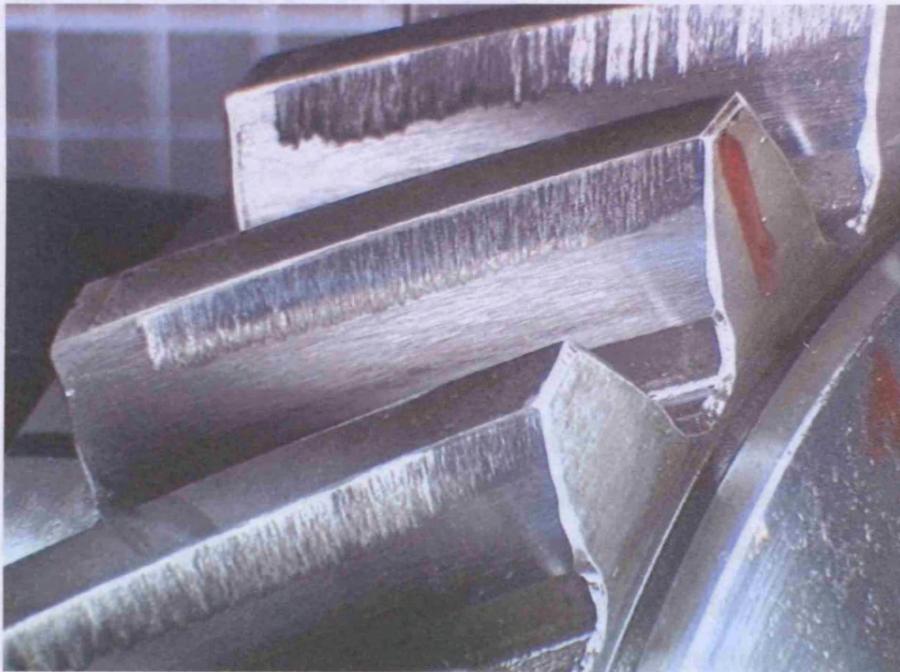
Figure 1.1. Gear teeth which have suffered severe scuffing failure.
(Design Unit, Newcastle University)

An excellent review of scuffing which covered developments up to the mid 1970s was produced by Dyson (1975). Dyson explains that scuffing often appears in machinery which has been asked to carry heavier loads, transmit more power or operate at higher speed than before. Historically, at first the demand for increased duty led to forms of failure such as breakage of gear teeth because of the low strength materials in use at the time. This difficulty was overcome by using cast iron or steel in the place of wood. As loads and speeds were increased other limitations were encountered such as pitting of gear teeth. This form of failure was largely eliminated by through-hardening or case-hardening of the teeth and the use of cleaner steels with fewer inclusions. Finally scuffing became the failure mode, limiting the duty of gears and other mechanisms such as cams. The clear signs of scuffing failure are an increase in noise and vibration followed by a rapid increase in temperature of the surfaces involved. Smoke and sparks may be seen, in which case the surfaces usually become completely disrupted and unserviceable. The typical appearance of the surfaces of gear teeth which have been destroyed by scuffing is shown in Figure 1.1.

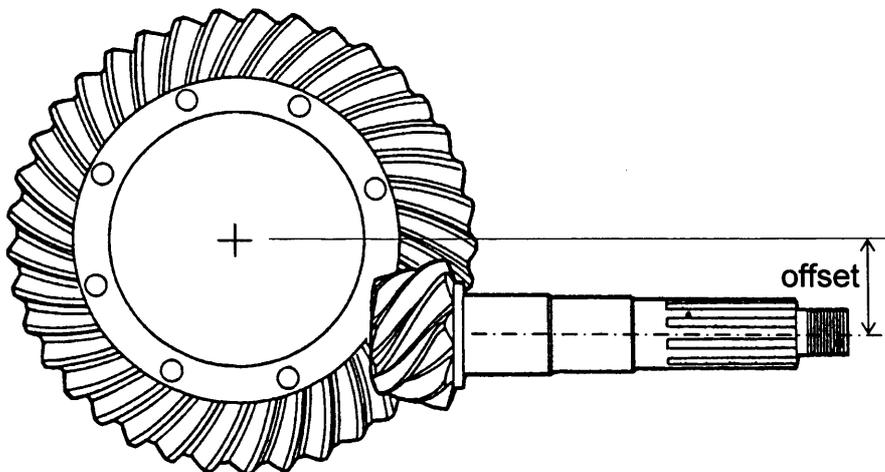
Figure 1.2. Hypoid gears
[British Gear Association]

An important example of the way in which new design requirements can increase the likelihood of scuffing is the case of the hypoid rear axle gearing. This type of offset right-angle drive (Figure 1.2.) was introduced in the place of conventional bevel gears in order to lower the propeller shaft in passenger cars. The increased amount of sliding (compared to that in conventional bevel gears) present in hypoids led to scuffing problems, however, which were eventually cured by the introduction of special EP axle oils. A lower position of the propeller shaft can be achieved by using a worm drive, but in this case even the special EP oils cannot give protection when both gears are of steel, so one of the gears (the wheel) is made from a softer material (bronze) in order to avoid scuffing.

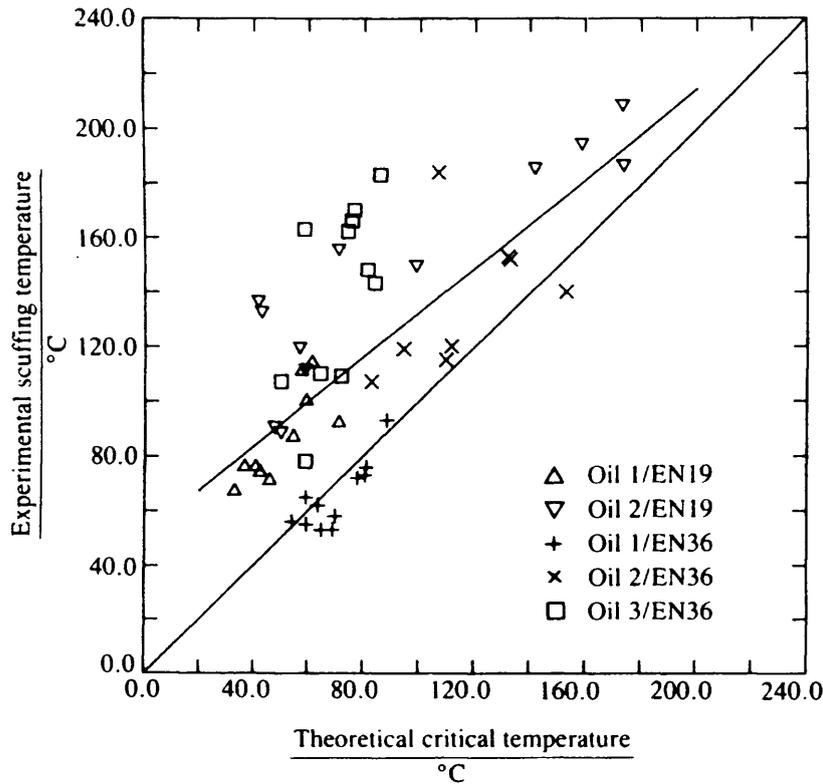
Figure 1.3. Experimental bulk temperature at scuffing versus calculated critical temperature. Lower line shows theory and upper line is least-squares mean line through experimental points. [Dyson, Evans, Karami, Paliwal and Snidle (1990)]

concluded that chemical factors, which were ignored in the theory, would be beneficial and probably explain the better than expected performance in the case of the additive oils. The results obtained in the latter paper are summarised in Figure 1.3.

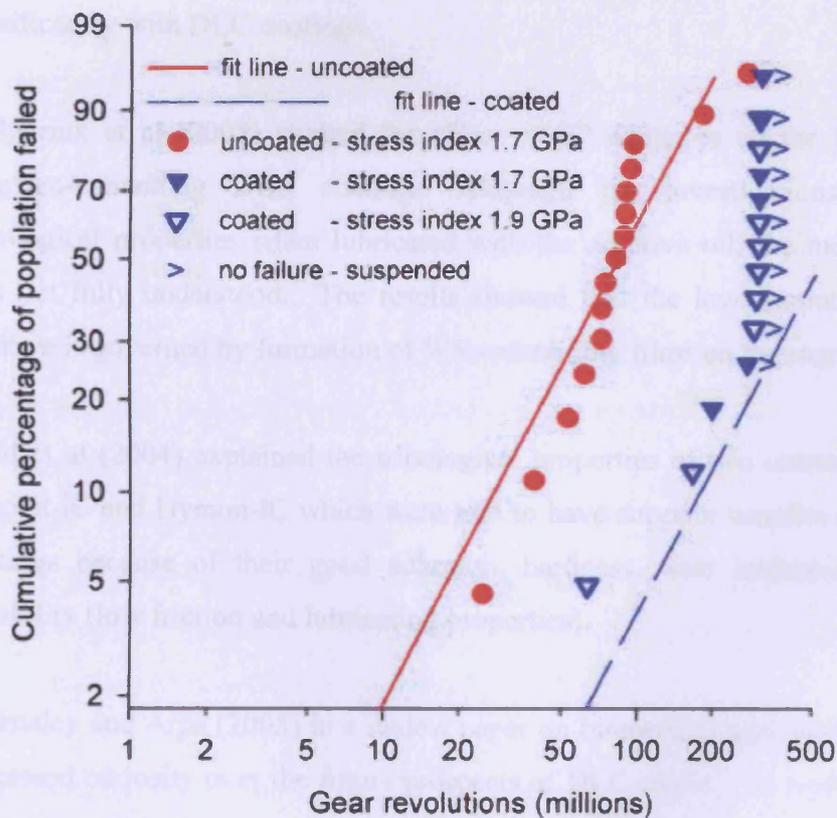
Figure 1.4. Weibull plot of the fatigue test results with best fit lines as was estimated using the maximum likelihood method [Krantz, 2004]

In an important paper Krantz et al (2004) reported the results of work in which spur gears both with and without a metal-containing DLC coating were run in surface fatigue tests. The surface fatigue lives of the gears were evaluated by accelerated tests. For the uncoated gears all of the 15 tests resulted in fatigue failure before completing 275 million revolutions. For coated gears 11 of the 14 tests were suspended with no surface fatigue (pitting) failure after 275 million revolutions. The improved durability as a result of coating gave an approximately sixfold increase in life and was a statistically significant result. The results of this series of tests are summarised in Figure 1.4 which shows the Weibull plot of the results for the coated and uncoated gears.

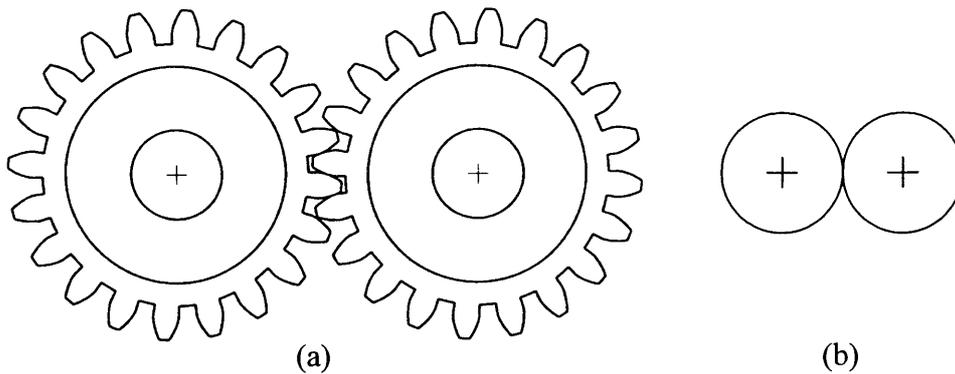
Figure 2.2. Illustration of a pair of equal gears (a) and corresponding pair of equal rollers (b) which give the same relative contact geometry between the gear teeth when contact occurs at the pitch point as shown.

typical working pressure angle of 20° then from the above equation with $r_{b1} = r_{b2} = r_b$ and a value of $R = 19$ mm, (which is equivalent to the radius of relative curvature at the line contact between two rollers of 76 mm diameter as used in the Cardiff rig – see later), the equivalent pair of gears would have a base diameter r_b of about 200 mm. This approximate equivalence of gears and discs is illustrated schematically in Figure 2.2.

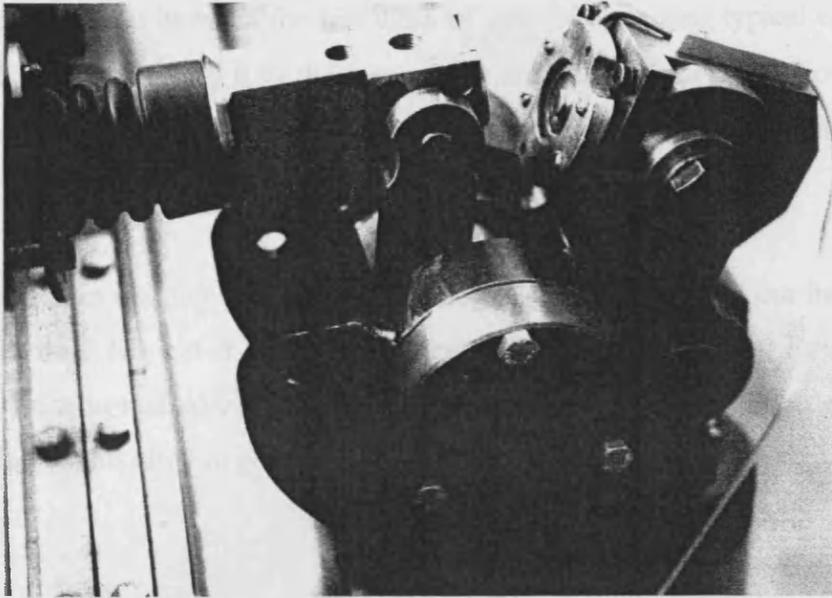
Figure 2.8. Photograph of the loading mechanism showing load pushrod and load cell. (The load cell is the disc-shaped unit which has a cable protruding from its top edge)

The discs are loaded together by means of a hydraulic ram which acts via a bell-crank and push rod mechanism as shown in Figure 2.8. The pressure applied to the ram was controlled via a variable voltage applied to an electro-hydraulic pressure relief valve. The slower speed disc is mounted in a swinging yoke as shown and the end of the push rod in contact with this yoke is made through a crossed knife edge so that the load is applied accurately in line with the discs both in the vertical and horizontal directions. This arrangement also limits any twisting of the yoke which would tend to misalign the discs. An electrical resistance load cell mounted in line with the push rod provides a direct measurement of the load. The load cell (seen in Figure 2.8) was calibrated using a special in-situ dead weight loading arrangement. When scuffing was detected during an experiment it was necessary to reduce the load as rapidly as possible so as to leave some of the “run-in” surface of the discs for profile measurements and to prevent a rapid increase in temperature to a dangerous level due to the high friction that occurs under scuffing conditions. This was achieved by providing a manually operated quick-release valve in the hydraulic supply to the ram.

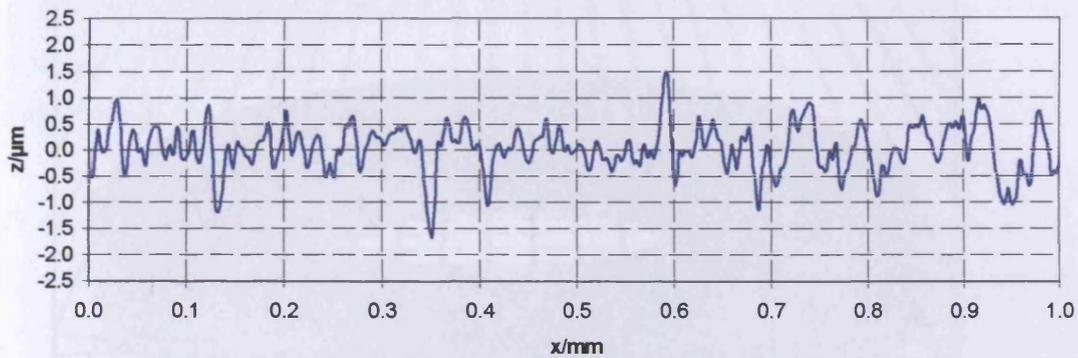
Figure 2.14. Typical circumferential profile taken from test discs. In this particular case, the type of surface finish corresponds to a ground disc, Unrun condition.

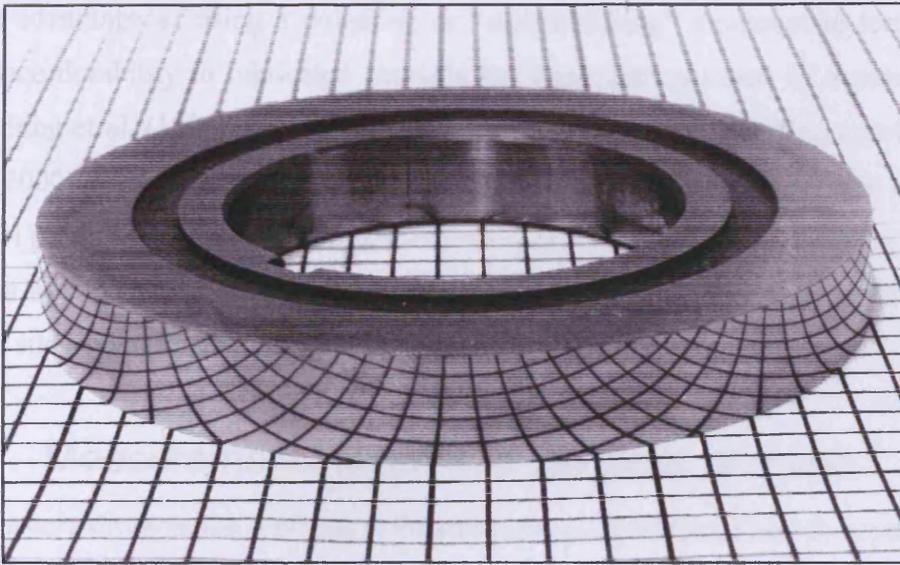
Figure 2.15. Superfinished disc showing highly-reflective surface

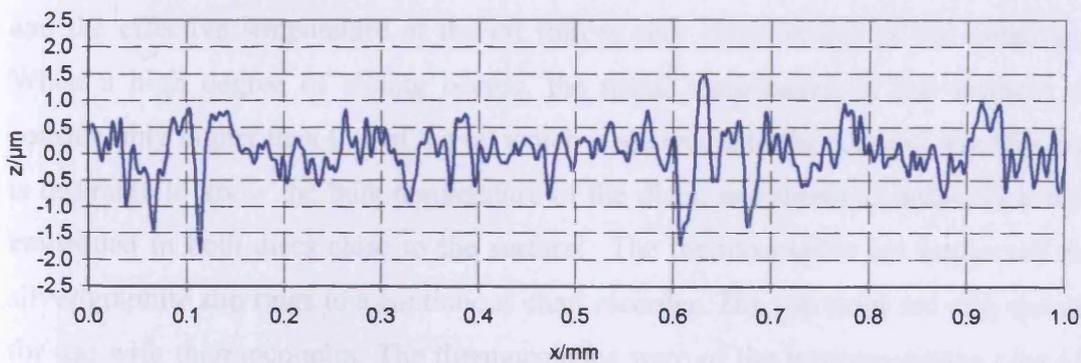
Figure 2.16.(a) Typical circumferential profile taken from test discs. In this particular case, the type of surface finish corresponds to a ground disc, Unrun condition.

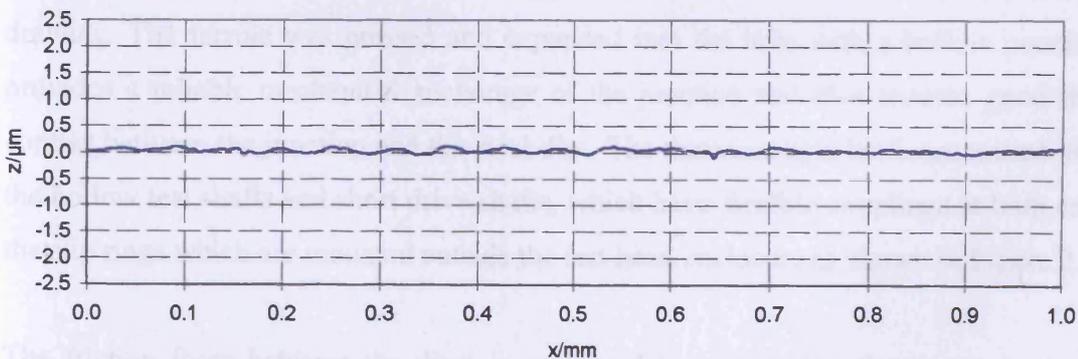
Figure 2.16.(b) Typical circumferential profile taken from test discs. In this particular case, the type of surface finish corresponds to a superfinished disc, Unrun condition.

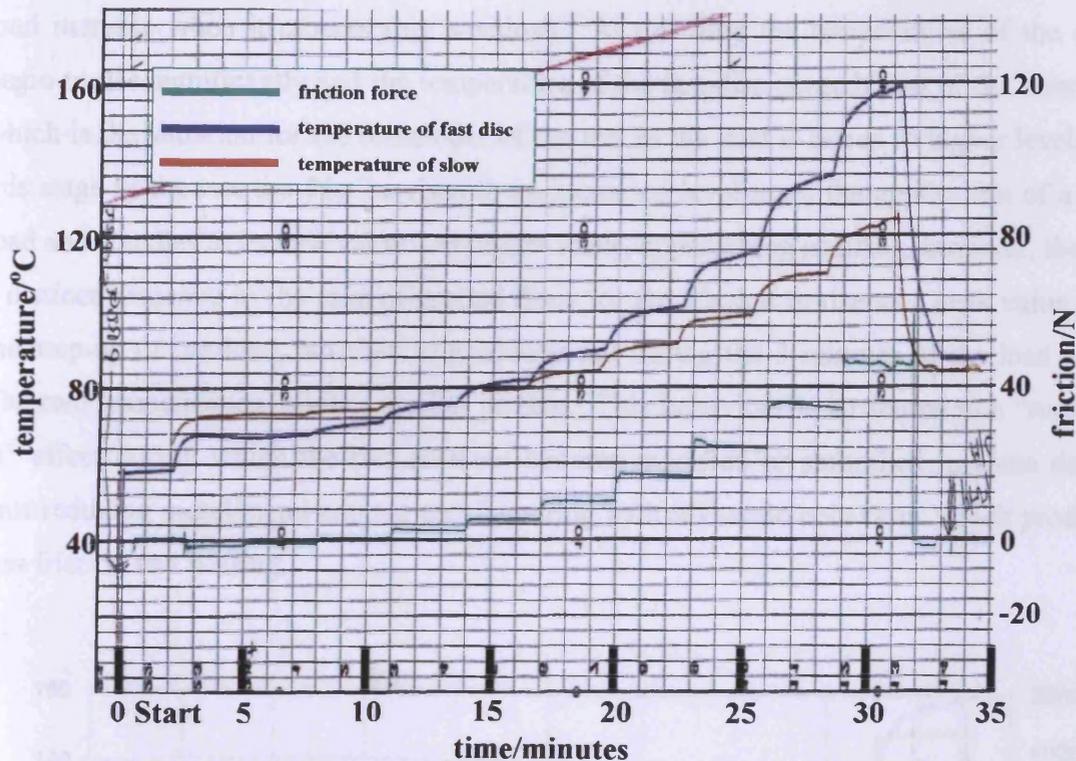
Fig 2.17. A typical test trace from the chart recorder record of scuffing test AD02, sliding speed of 12m/s slow disc: ground; fast disc: super finished

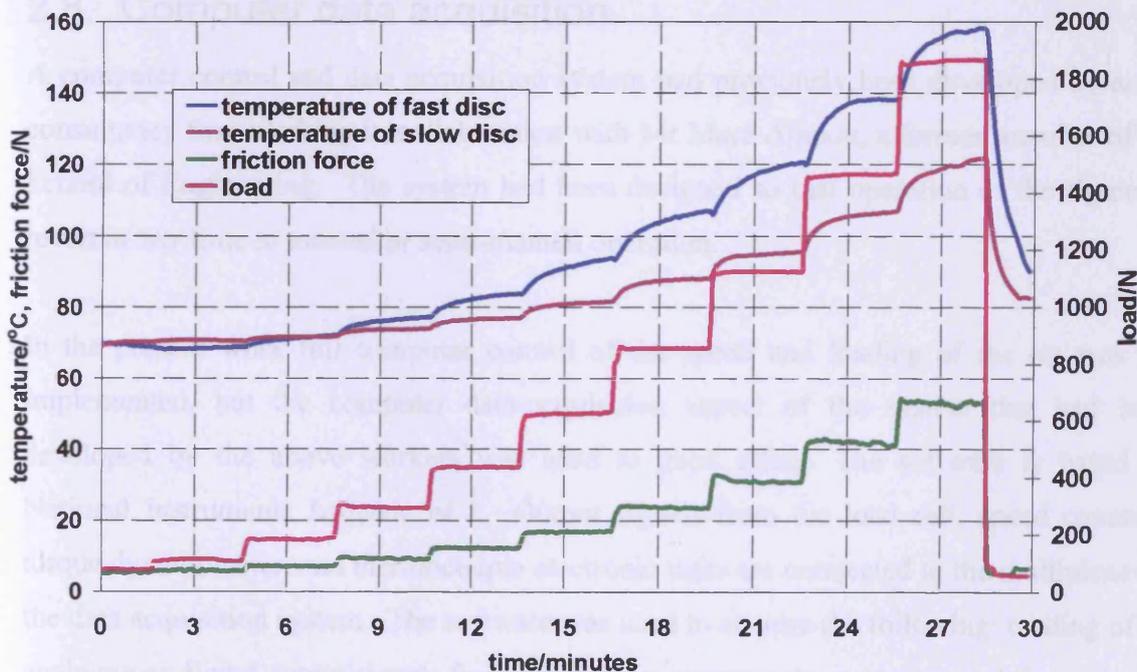
Figure 2.18. Typical test trace from the data acquisition software of scuffing test AD02, sliding speed of 12m/s slow disc: ground; fast disc: super finished

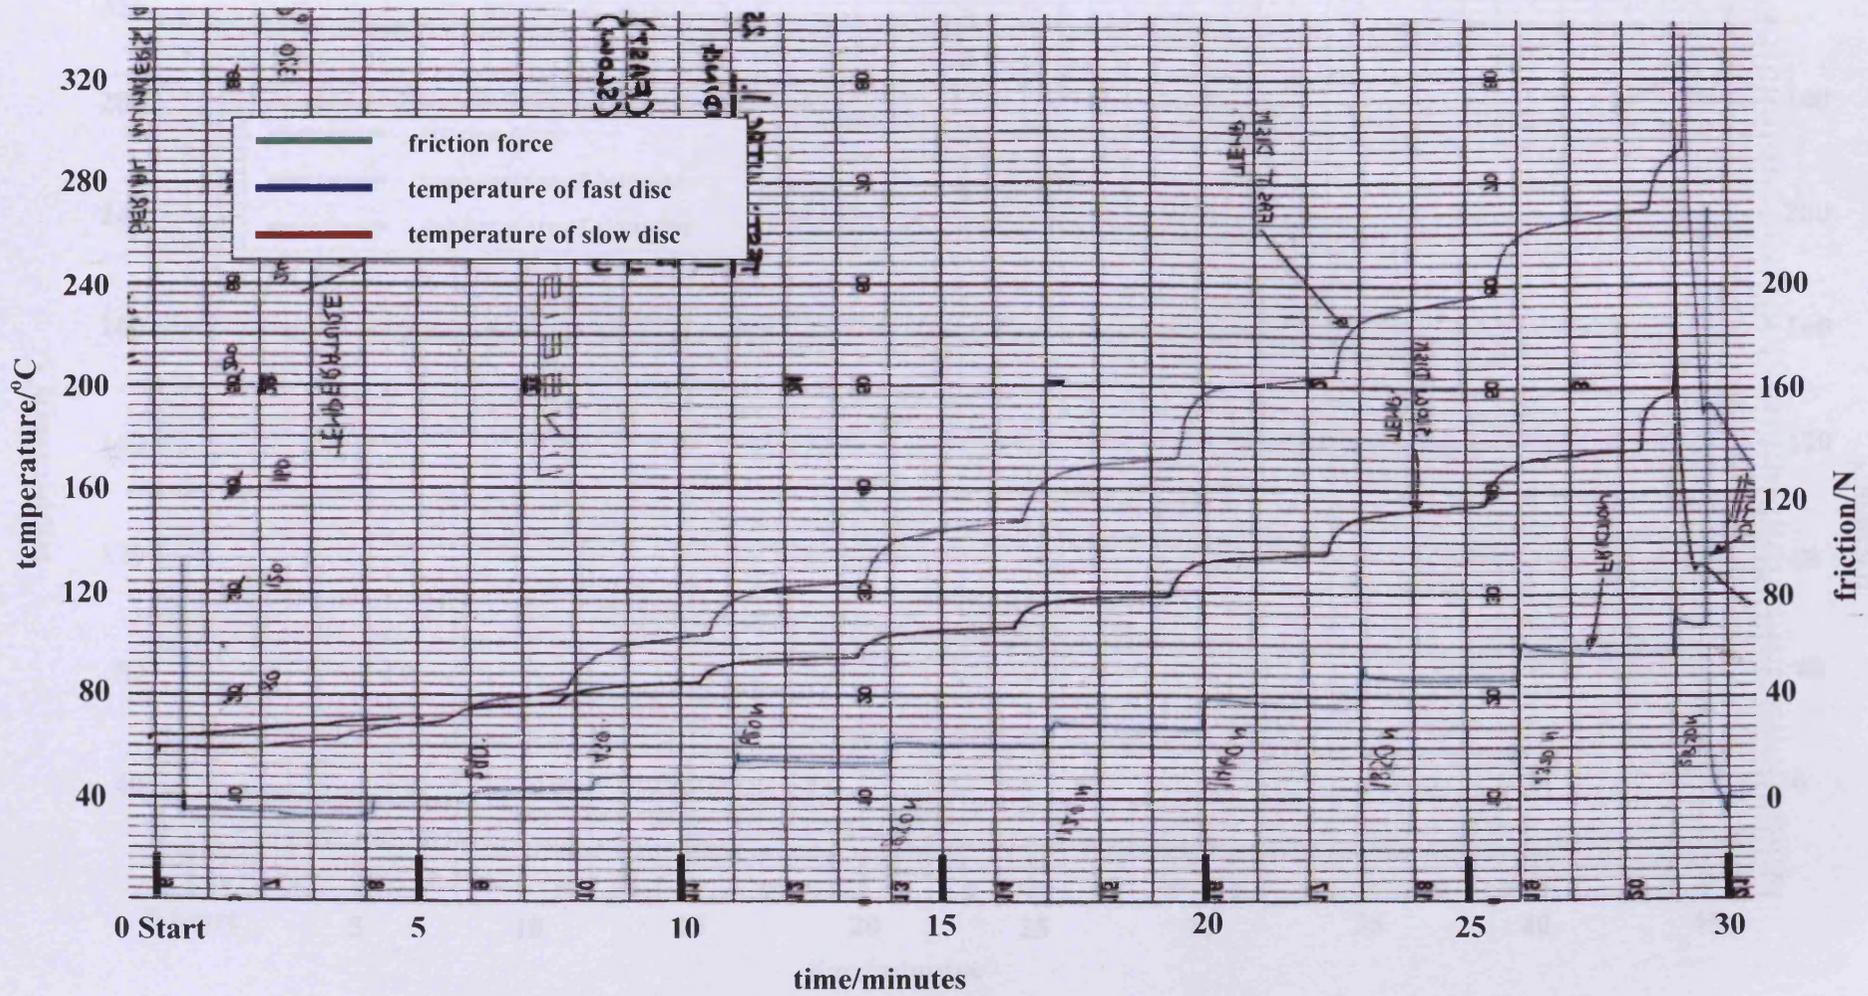
Figure 3.1. Chart recorder record of scuffing test UTRC01, , graph shows applied load and bulk temperatures of two discs

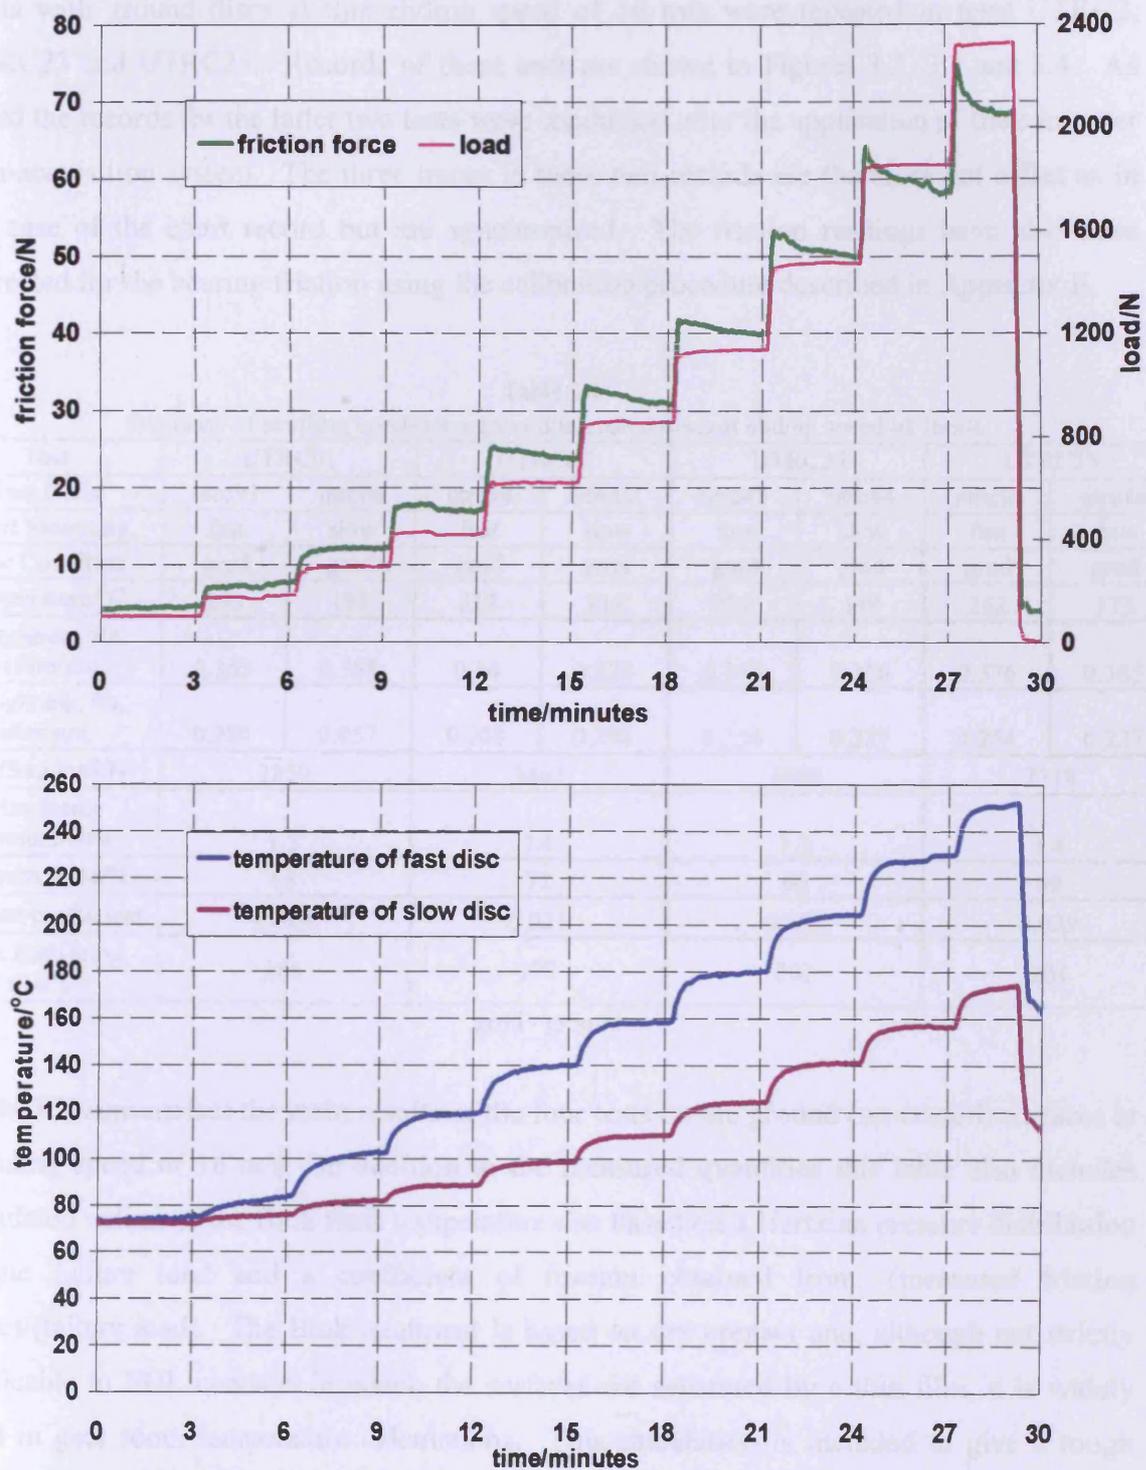
Figure 3.4. Record of scuffing test UTRC25, upper graph shows applied load and friction force; lower graph shows bulk temperatures of the two discs

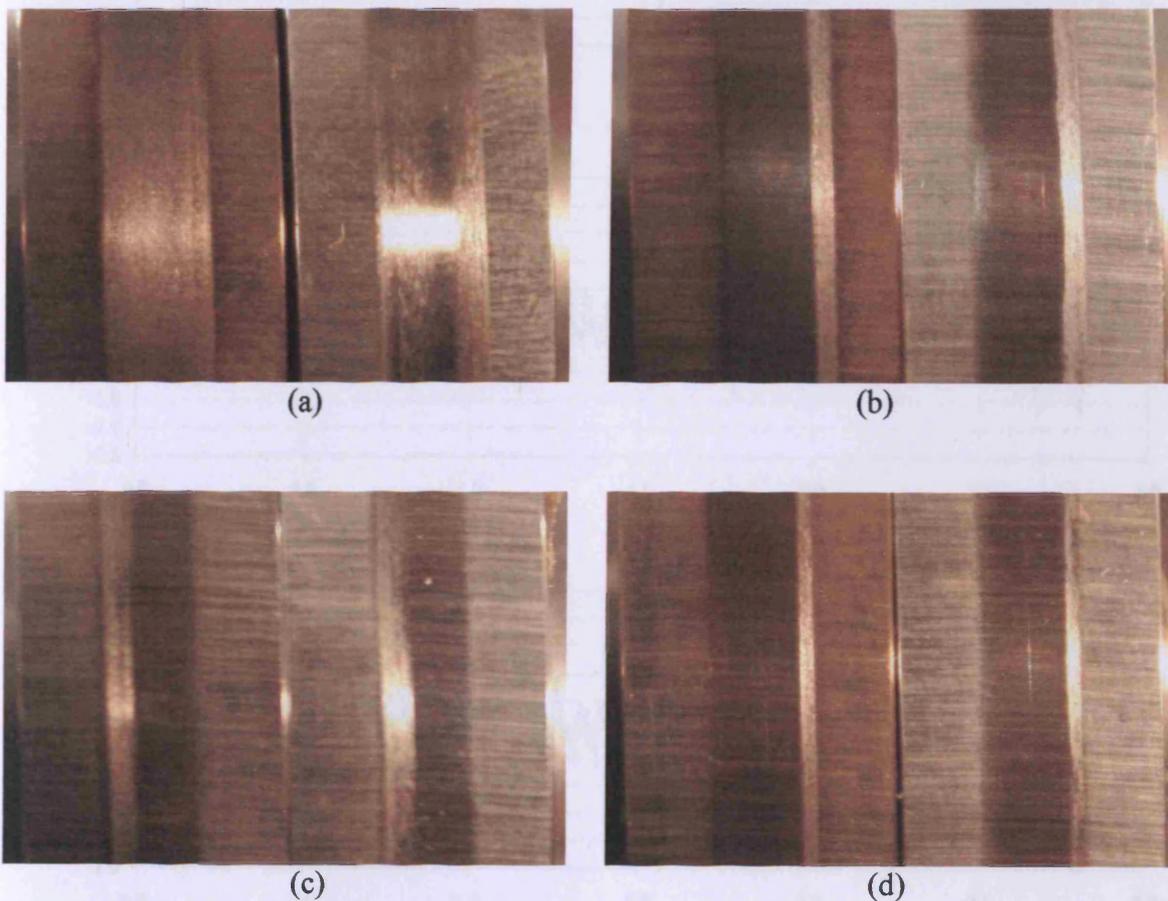
Figure 3.5. Photographs of discs following testing at 16m/s

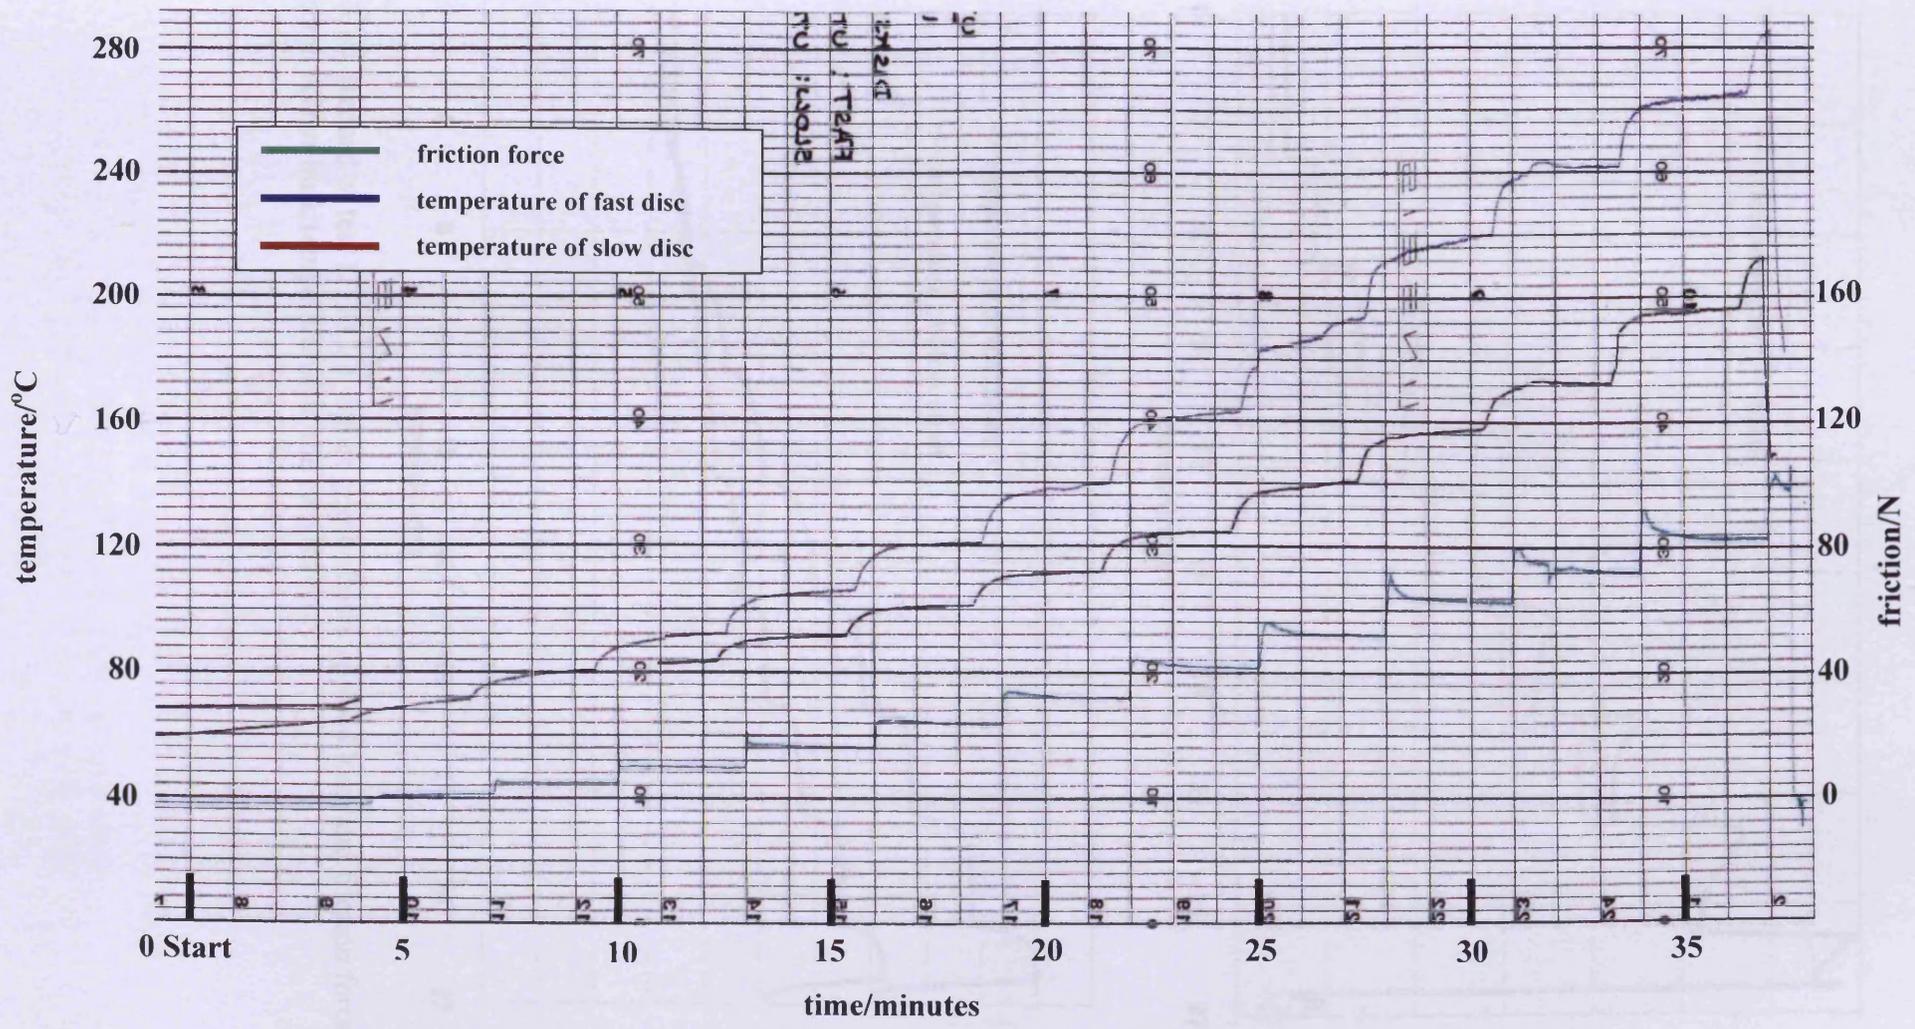
Figure 3.9. Record of scuffing test UTRC07, graph shows friction force and bulk temperatures of the two discs

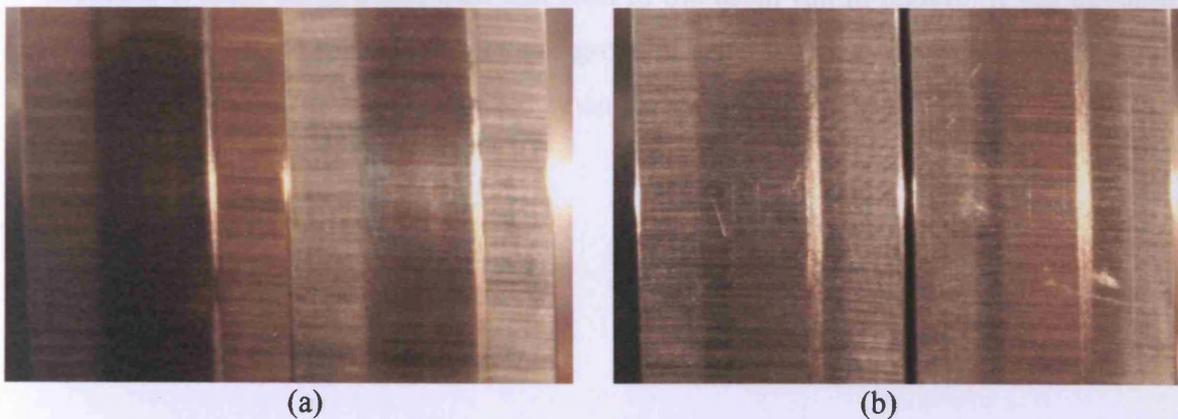
Figure 3.11. Photographs of discs following testing at 12m/s
 (a) UTRC07; left: ground disc on fast shaft; right: ground disc on slow shaft
 (b) UTRC28; left: ground disc on fast shaft; right: ground disc on slow shaft

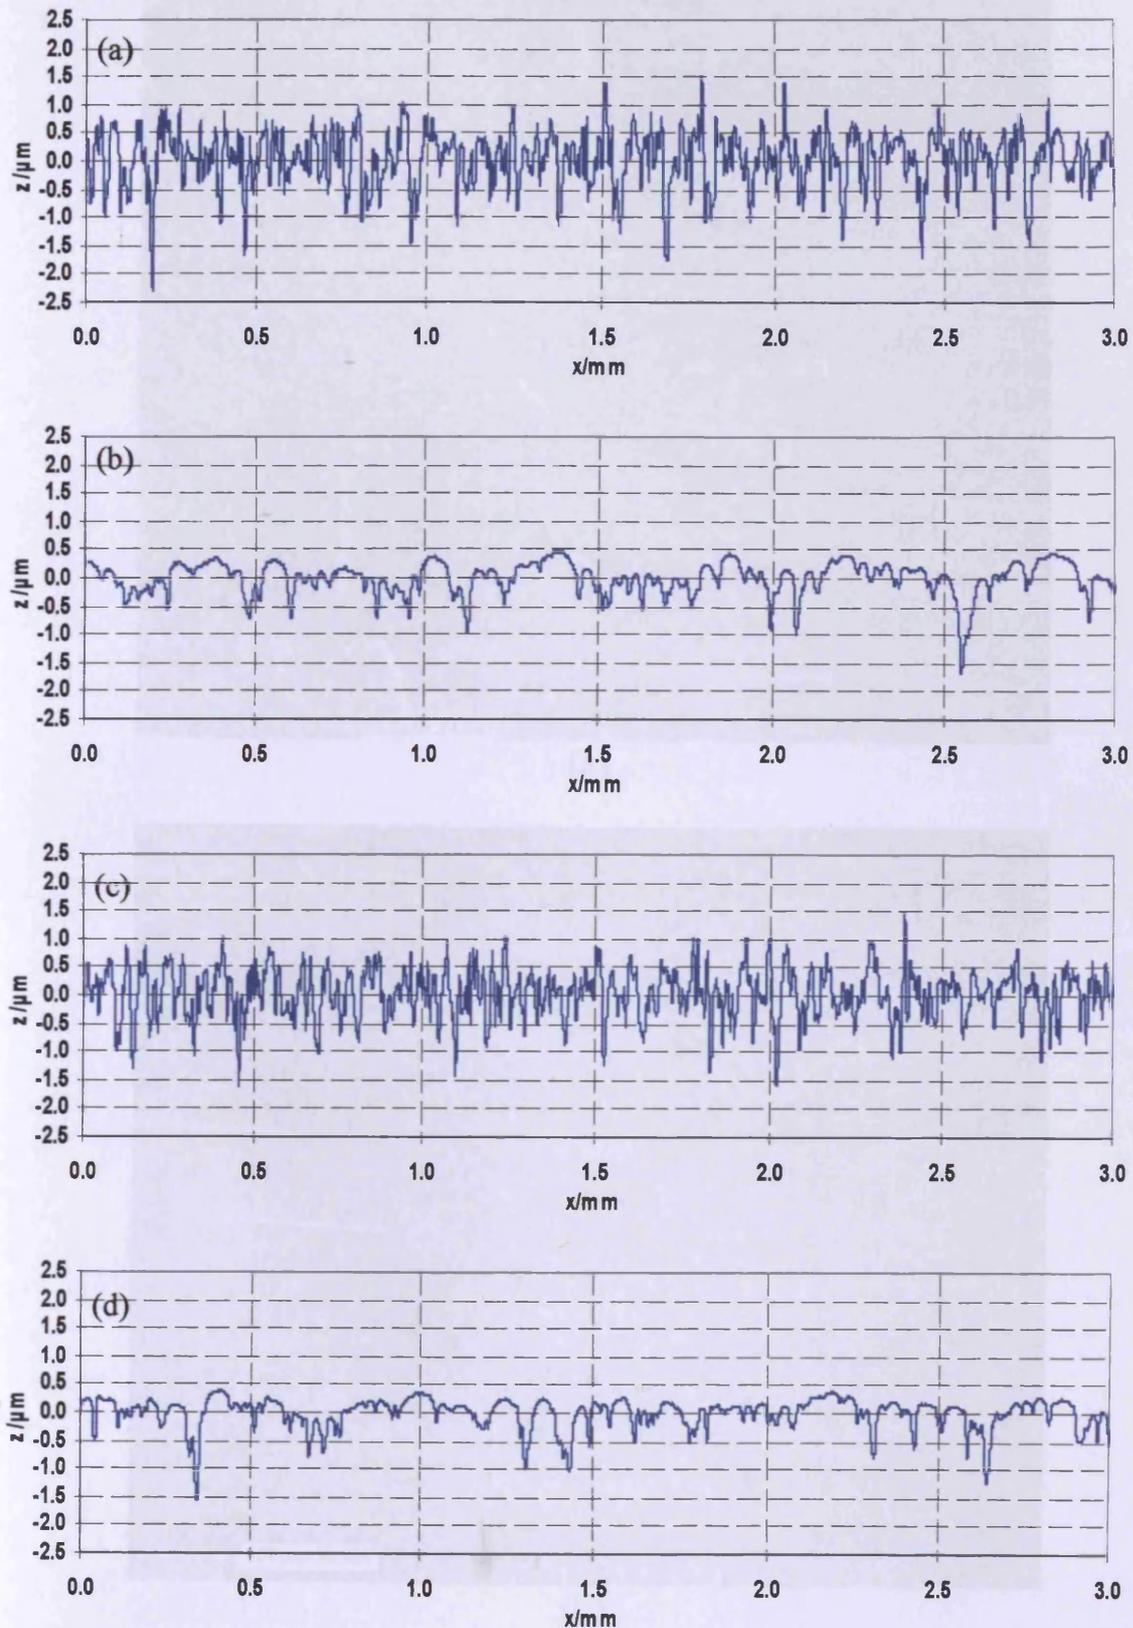
Figure 3.12. Surface profiles taken in the circumferential direction from discs used in test UTRC07
Profiles from fast disc (a) before test; $R_a = 0.373 \mu\text{m}$ (b) after test; $R_a = 0.214 \mu\text{m}$
Profiles from slow disc (c) before test; $R_a = 0.358 \mu\text{m}$ (d) after test; $R_a = 0.206 \mu\text{m}$

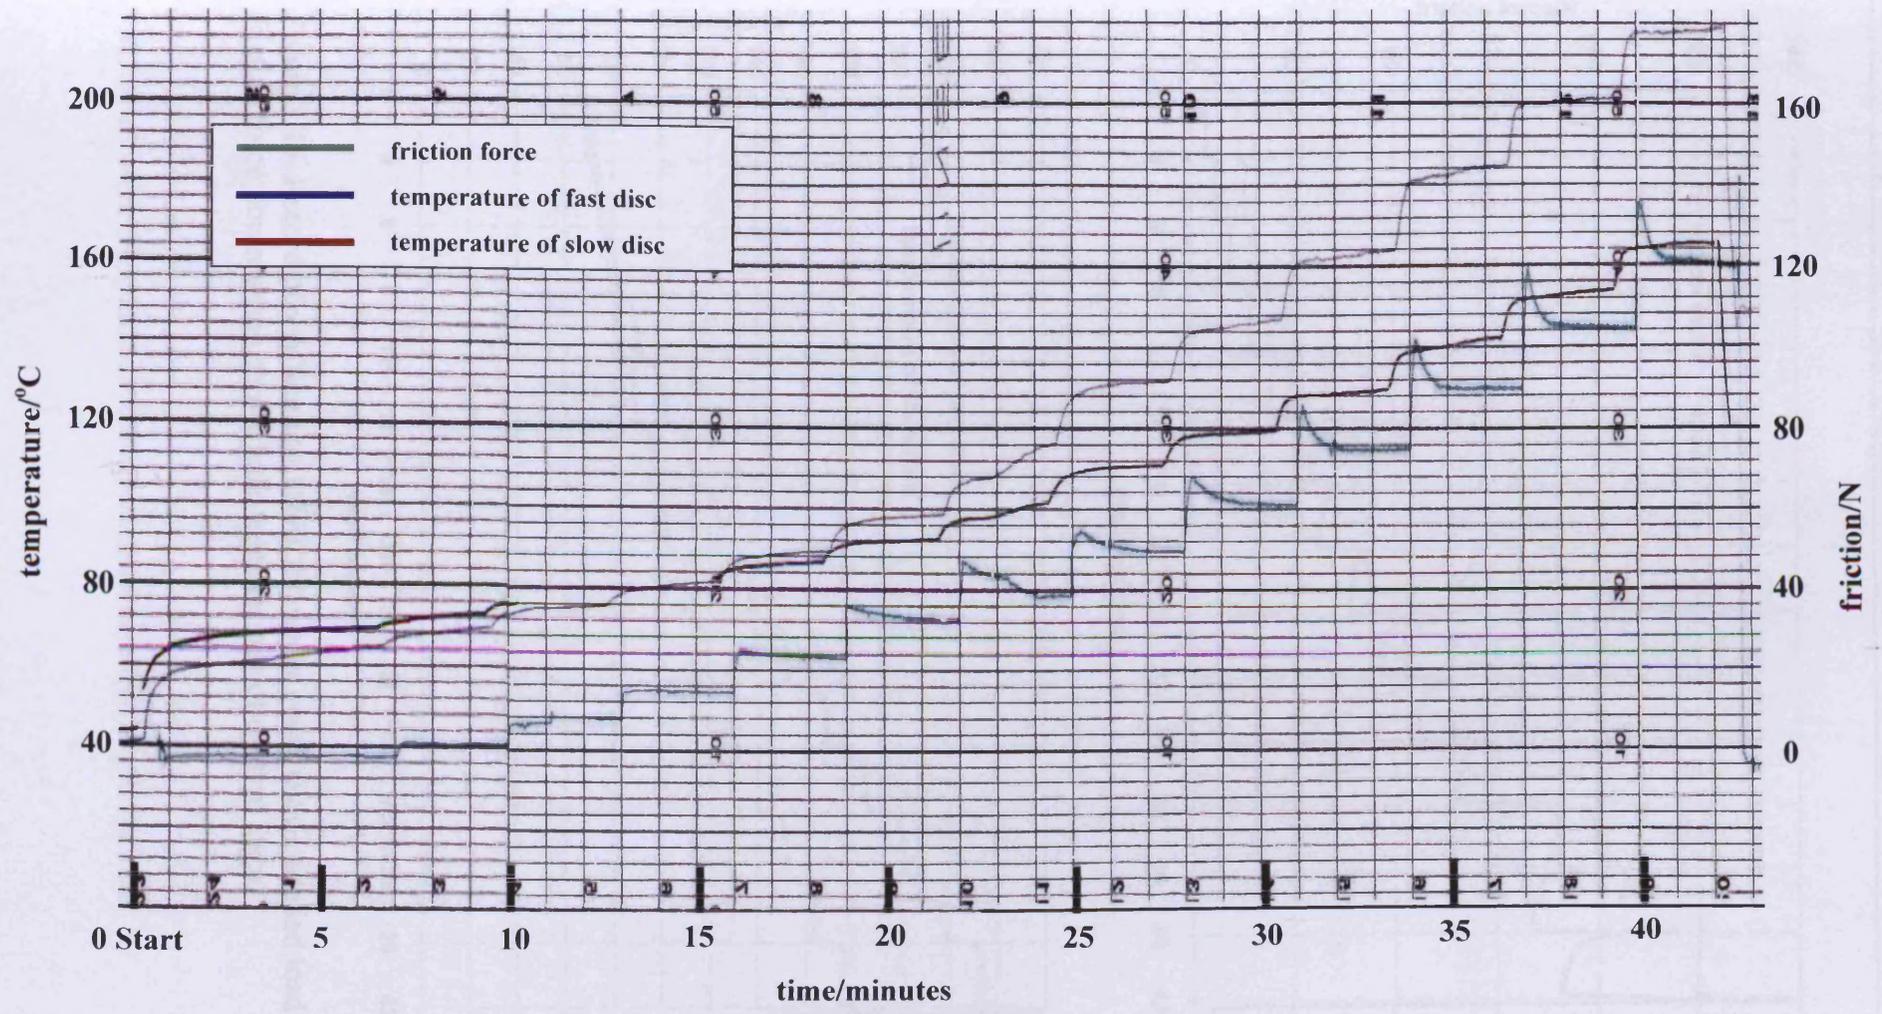
Figure 3.15. Chart recorder record of test UTRC05, graph shows friction force and bulk temperatures of two discs.

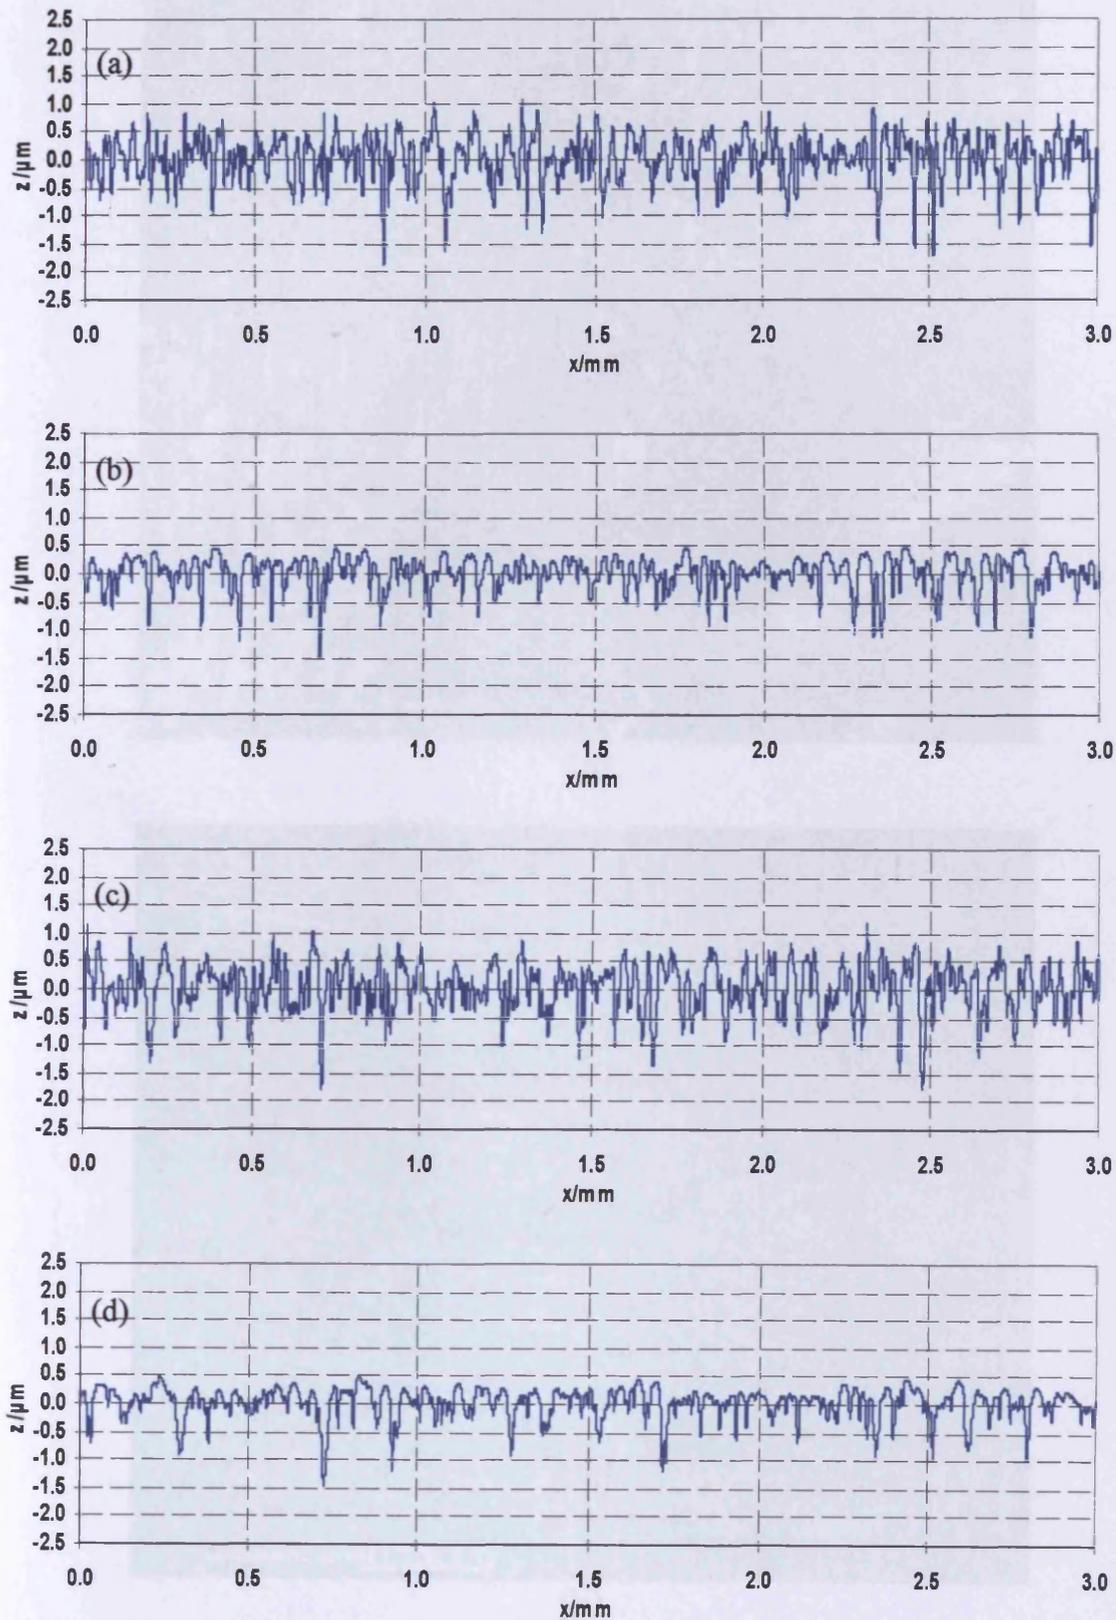
Figure 3.18. Surface profiles taken in the circumferential direction from discs used in test UTRC05
Profiles from fast disc (a) before test; $R_a = 0.323 \mu\text{m}$ (b) after test; $R_a = 0.221 \mu\text{m}$
Profiles from slow disc (c) before test; $R_a = 0.354 \mu\text{m}$ (d) after test; $R_a = 0.214 \mu\text{m}$
