EFFECT OF SURFACE FINISH AND HARD COATINGS ON SCUFFING OF STEEL DISCS

Thesis submitted in candidature
for the degree of
Doctor of Philosophy at Cardiff University

Institute of Theoretical, Applied and Computational Mechanics
Cardiff School of Engineering
Cardiff University

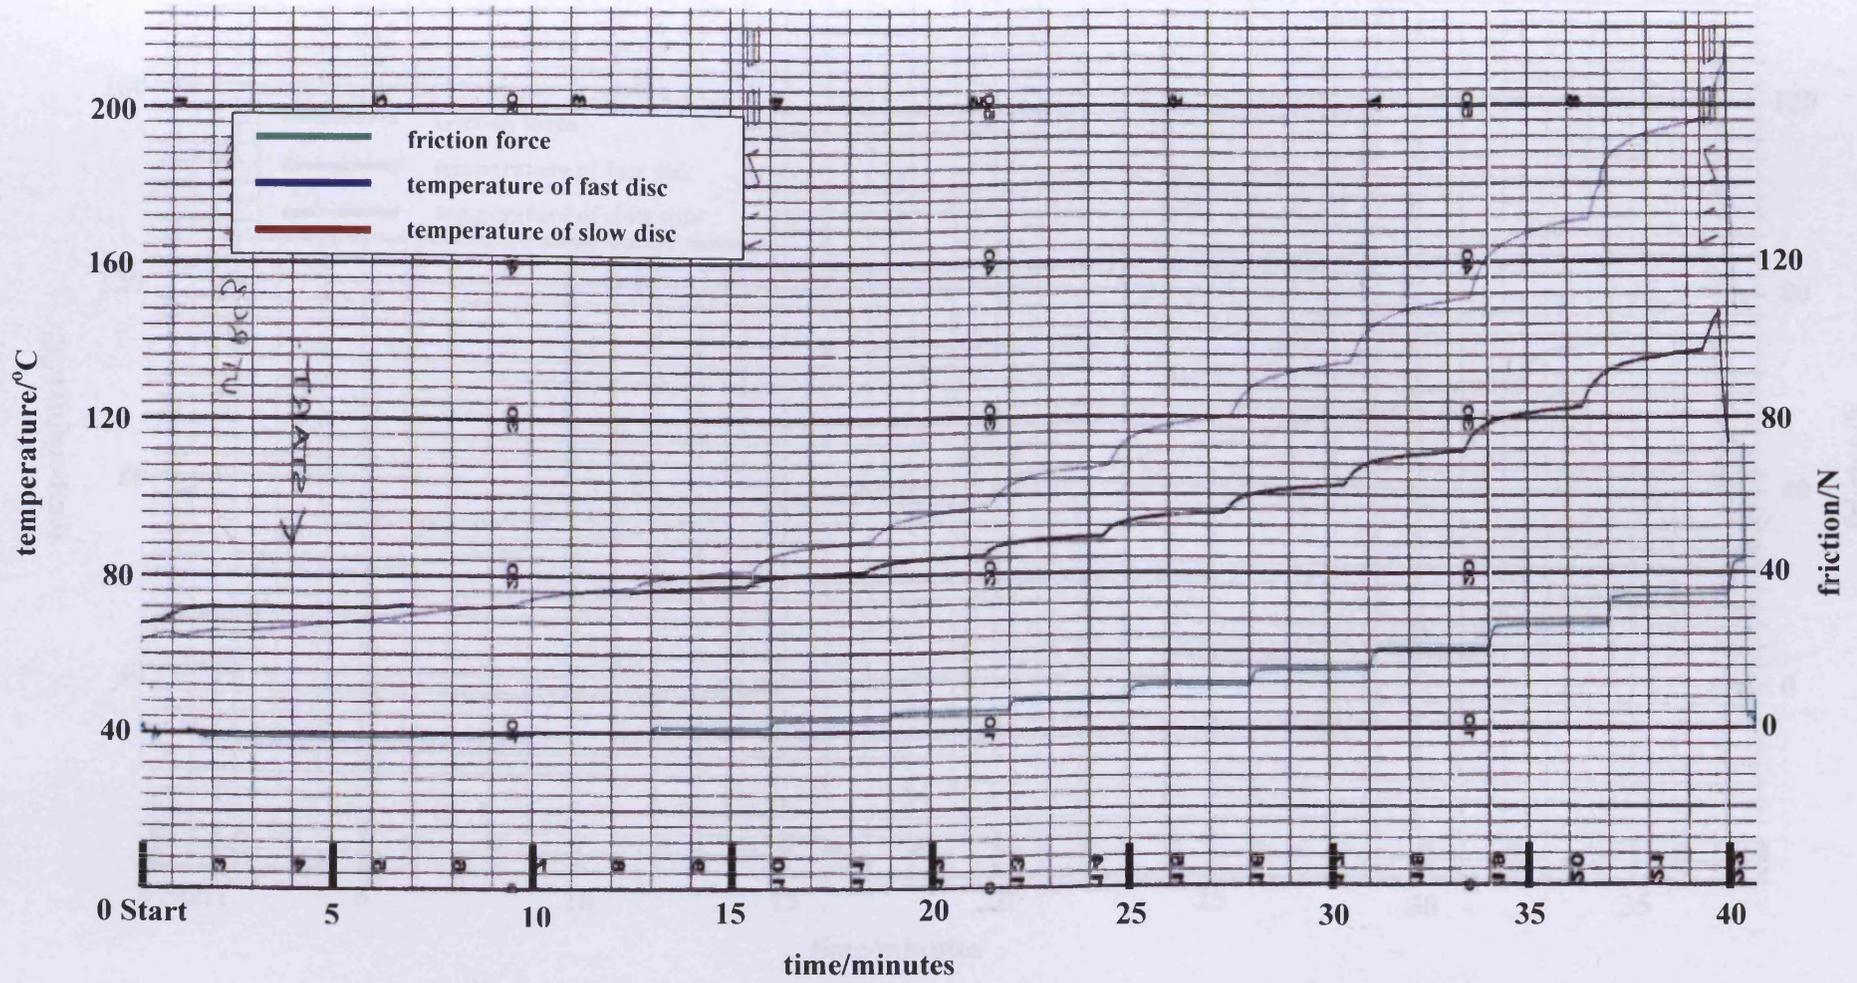
Figure 3.21. Chart recorder record of test UTRC03, graph shows friction force and bulk temperatures of two discs

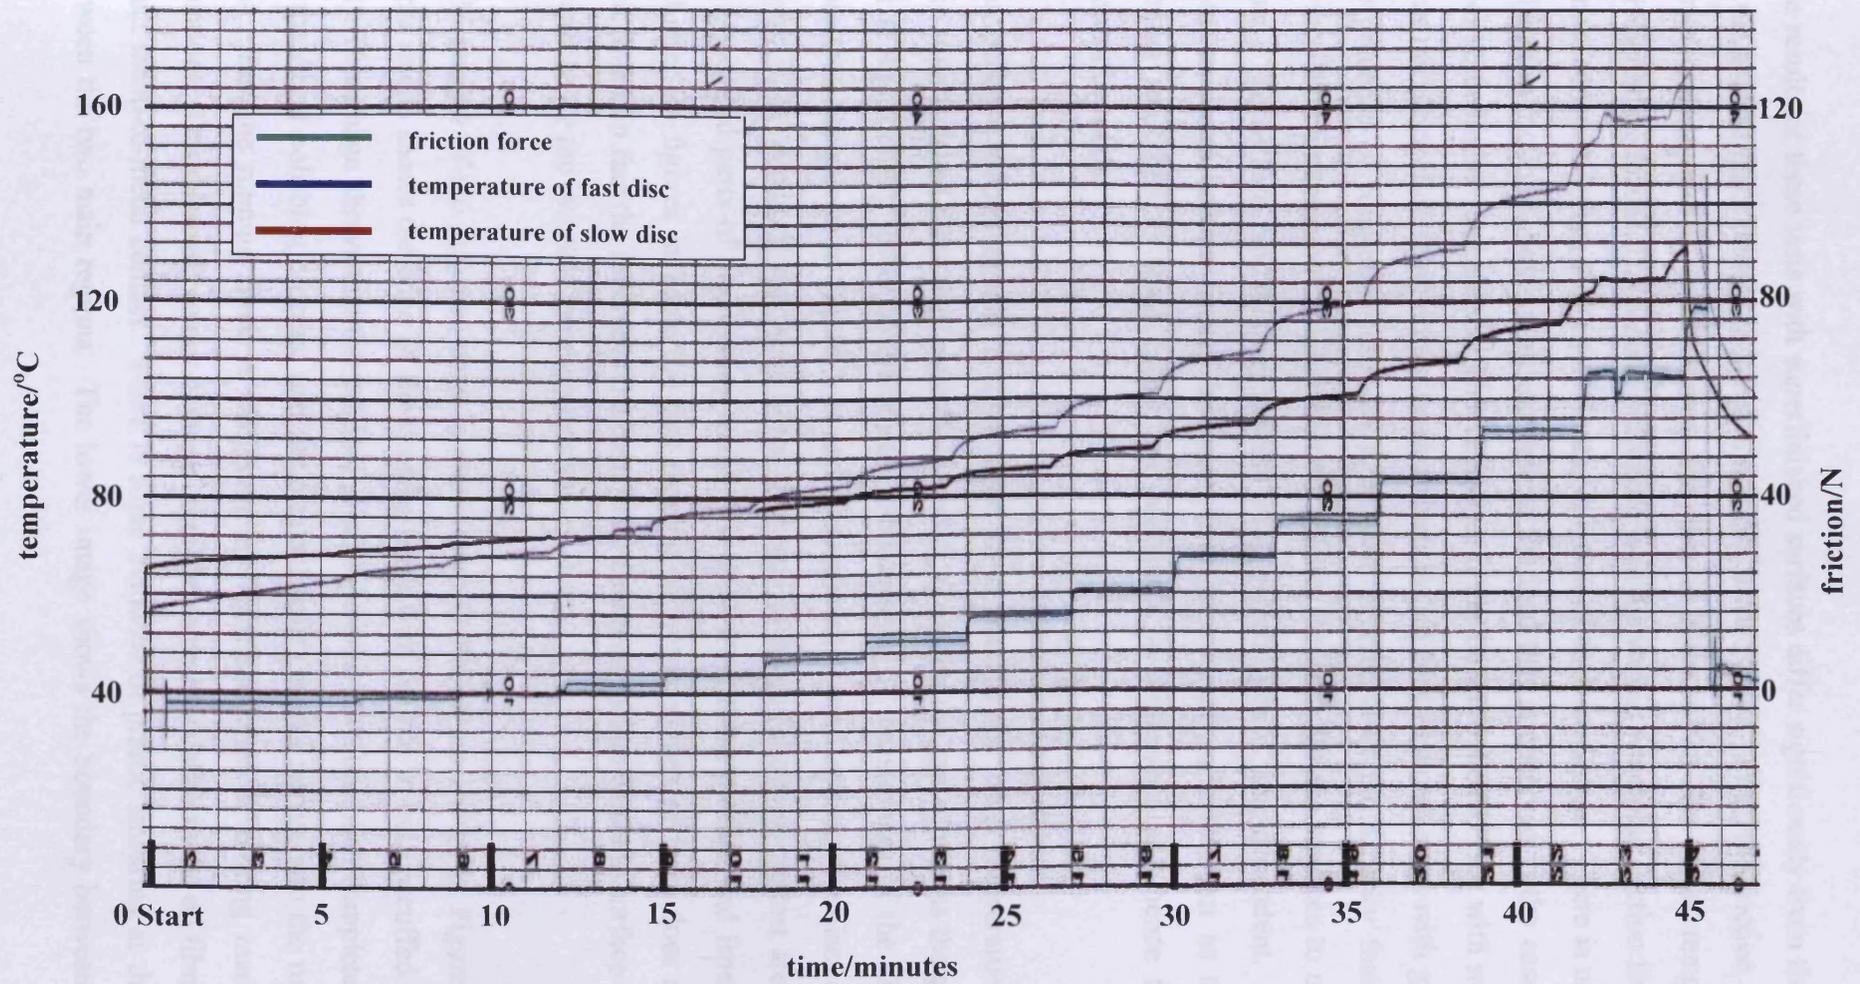
Figure 3.23. Chart recorder record of test UTRC06, graph shows friction force and bulk temperatures of two discs

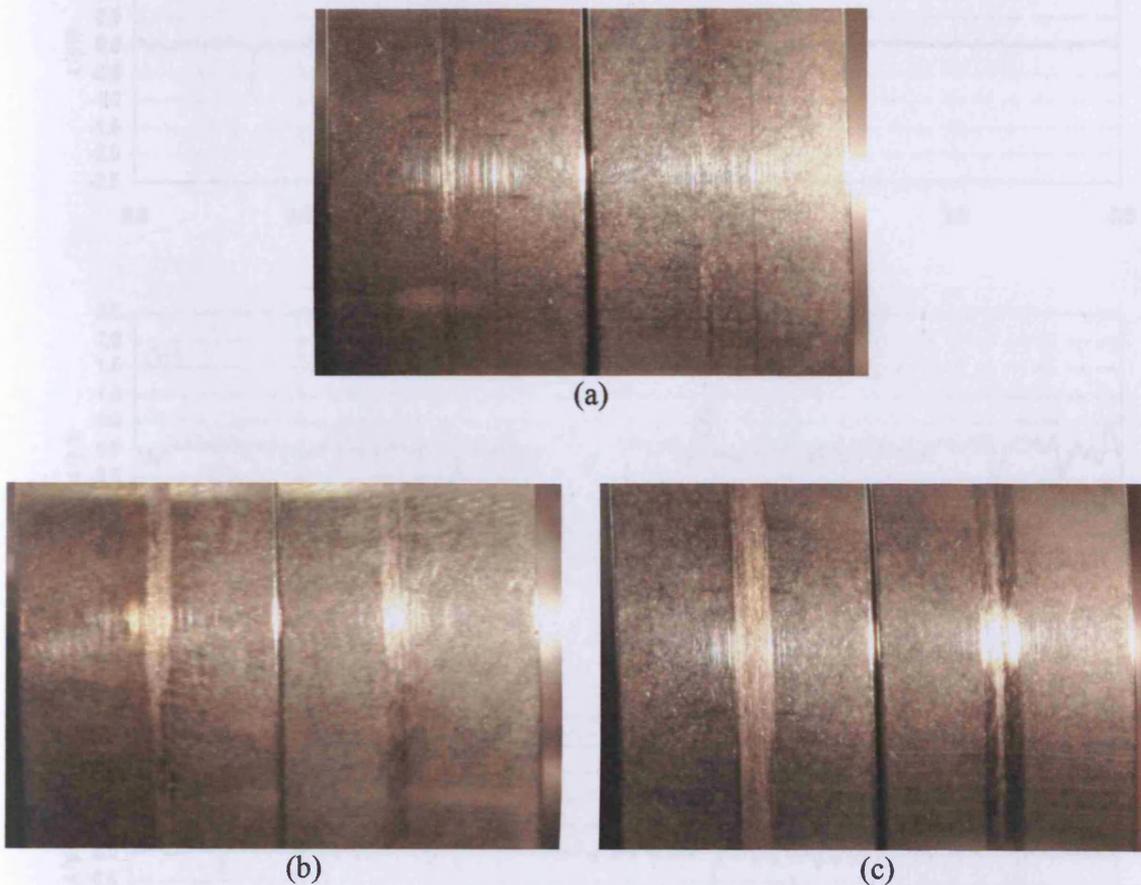
Figure 3.24. Photographs of discs following testing at 7m/s and 16m/s

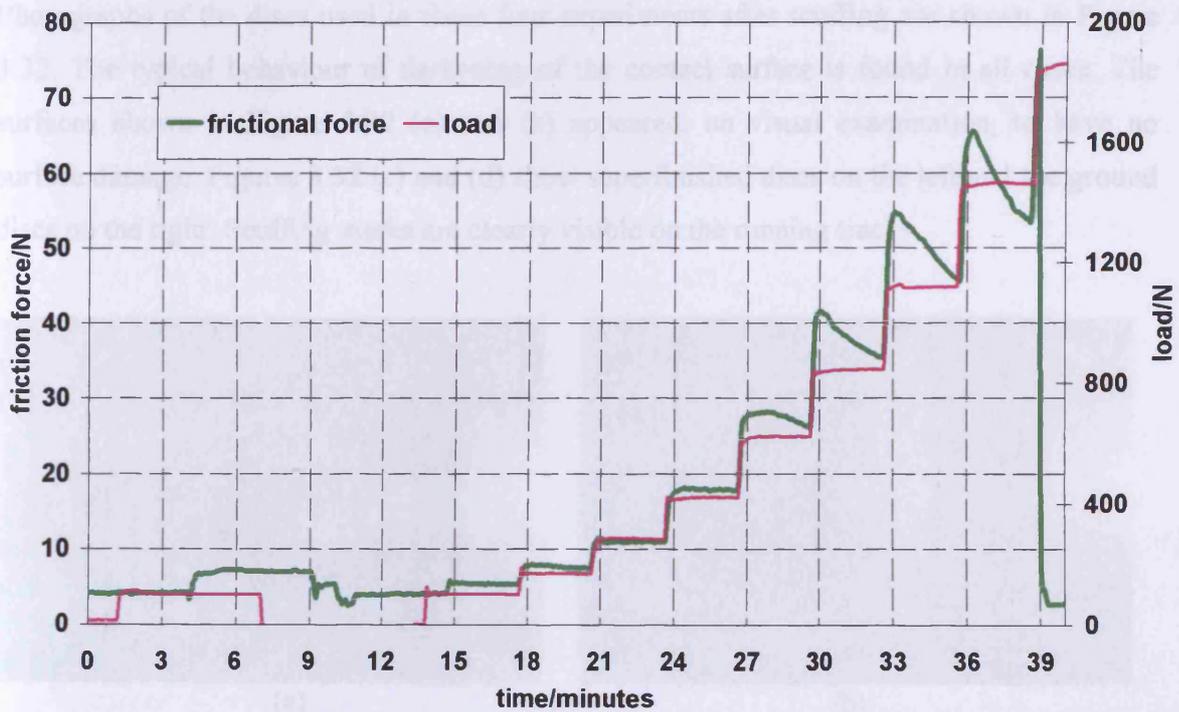
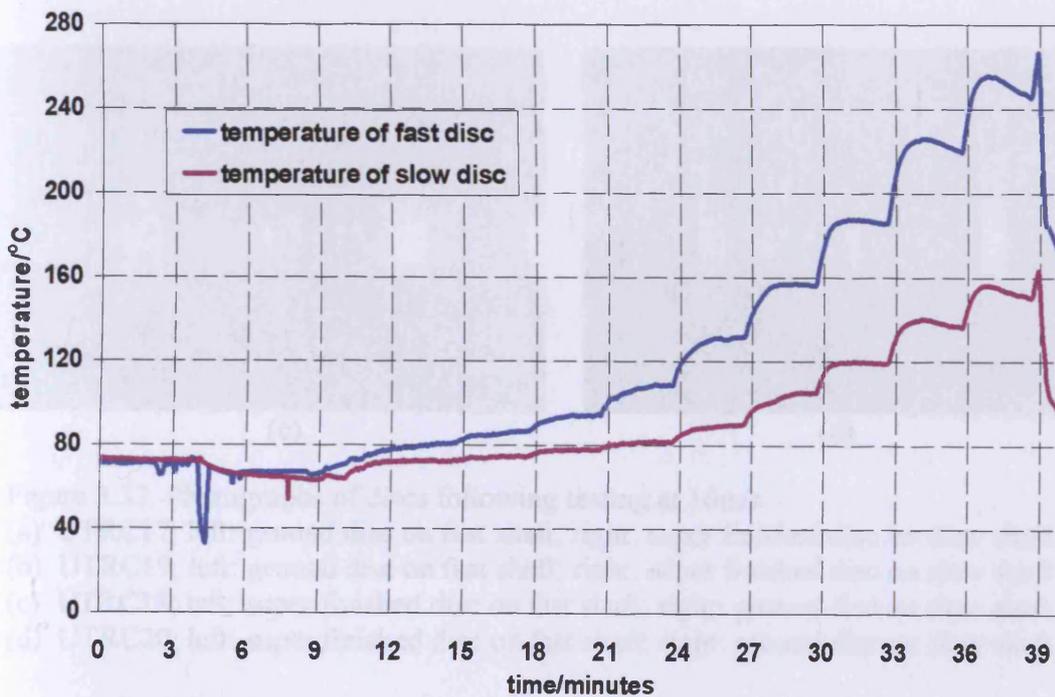
Figure 3.31. Record of scuffing test UTRC20, upper graph shows applied load and friction force; lower graph shows bulk temperatures of the two discs

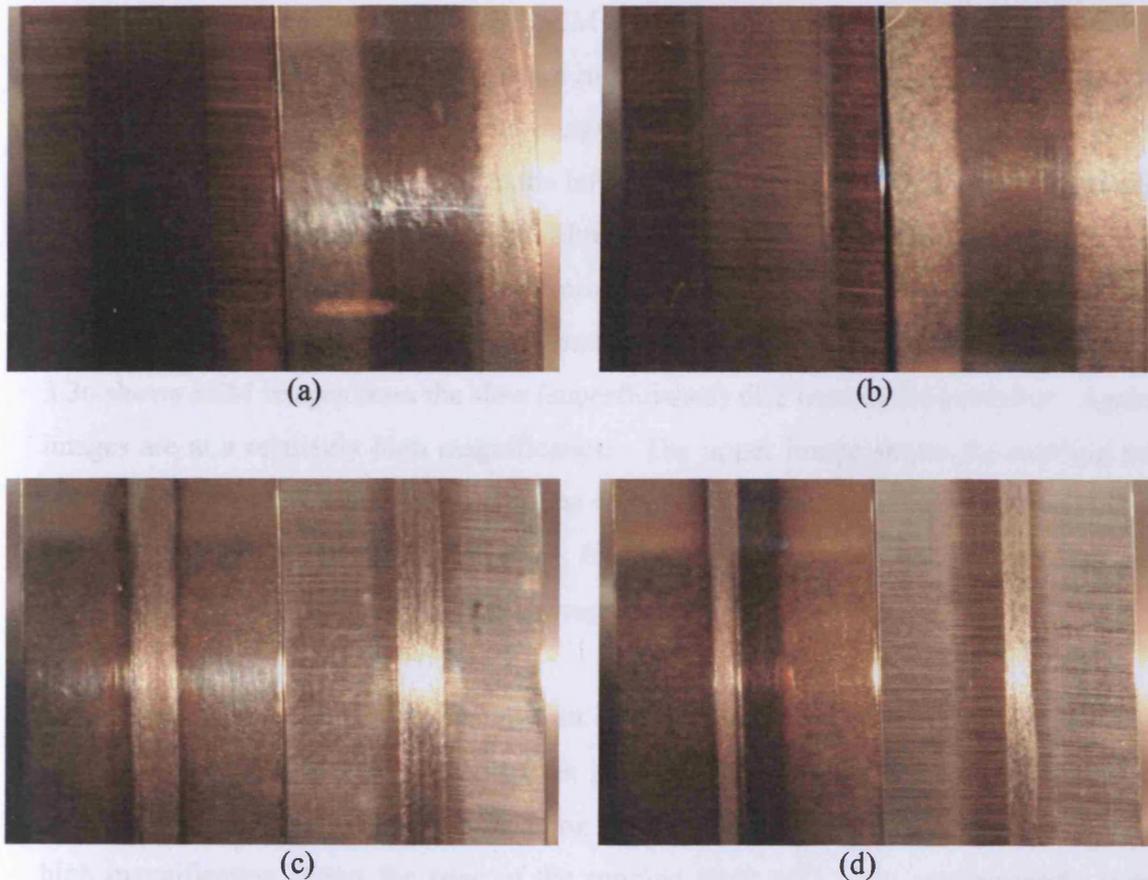
Figure 3.32. Photographs of discs following testing at 16m/s

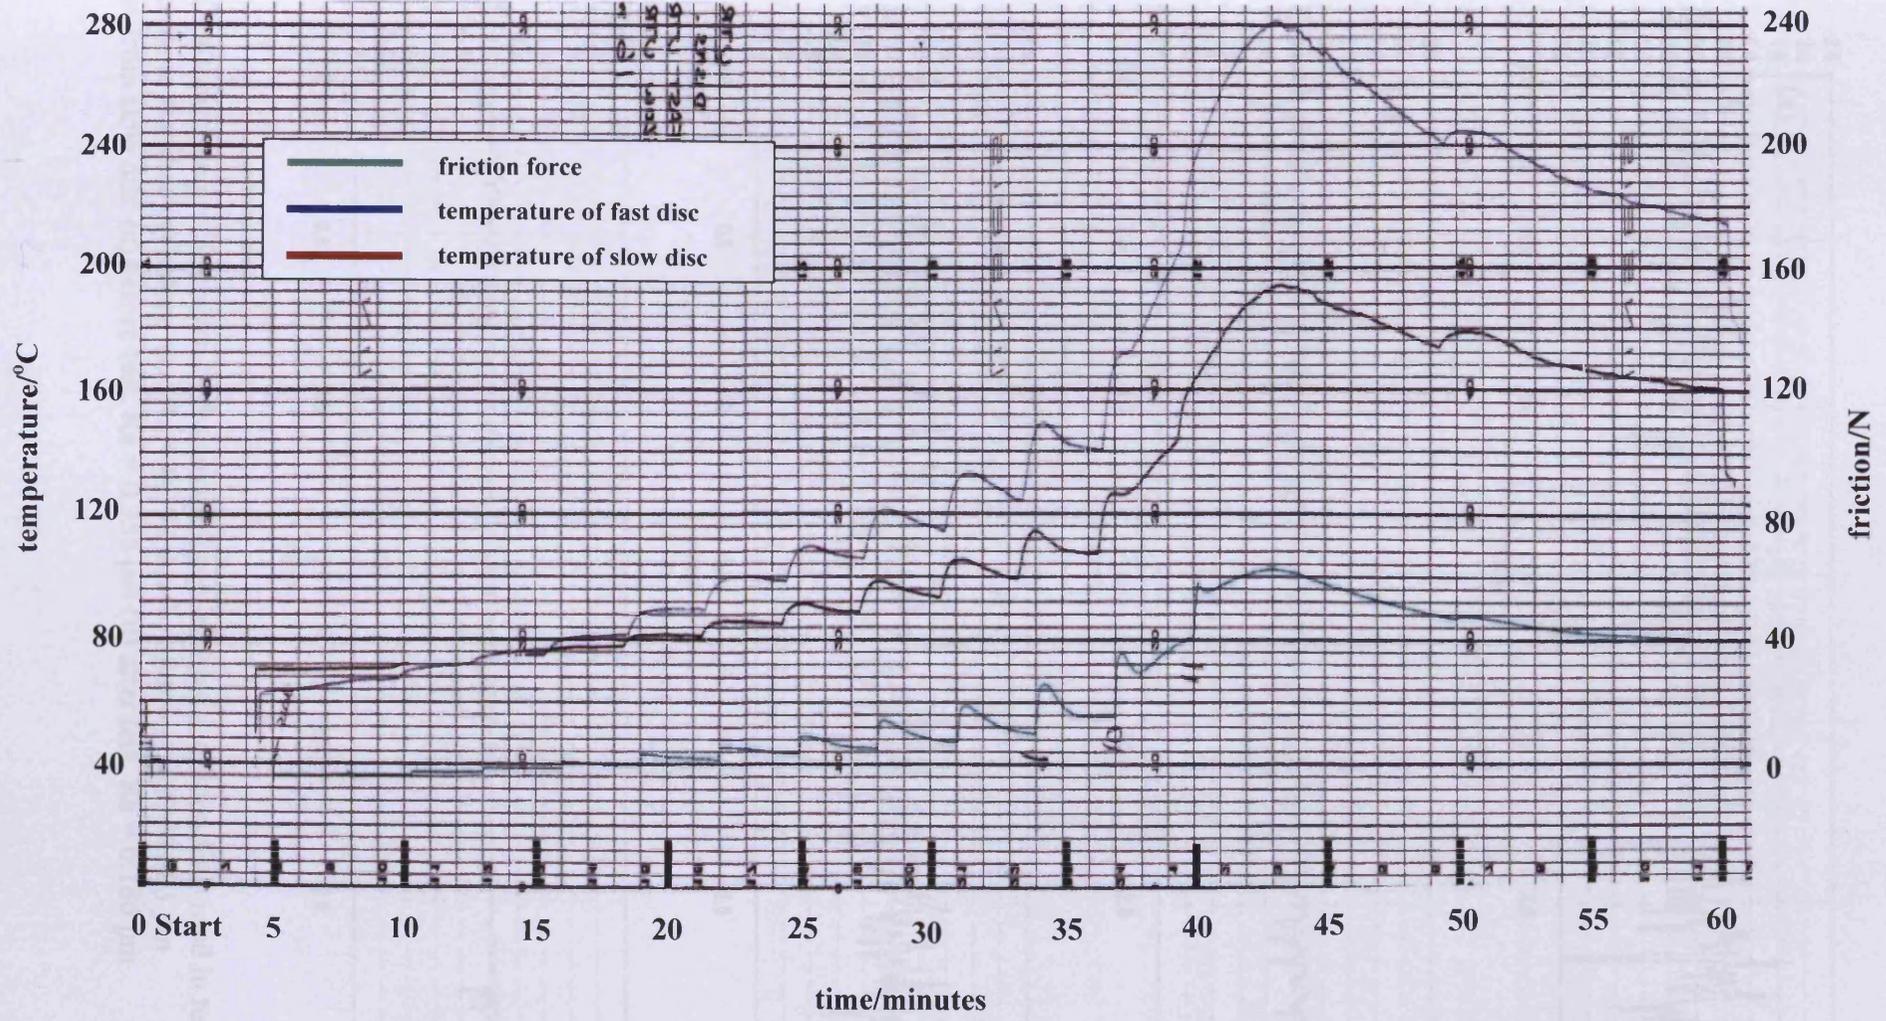
Figure 3.40. Chart recorder record of test UTRC12, graph shows friction force and bulk temperatures of two discs

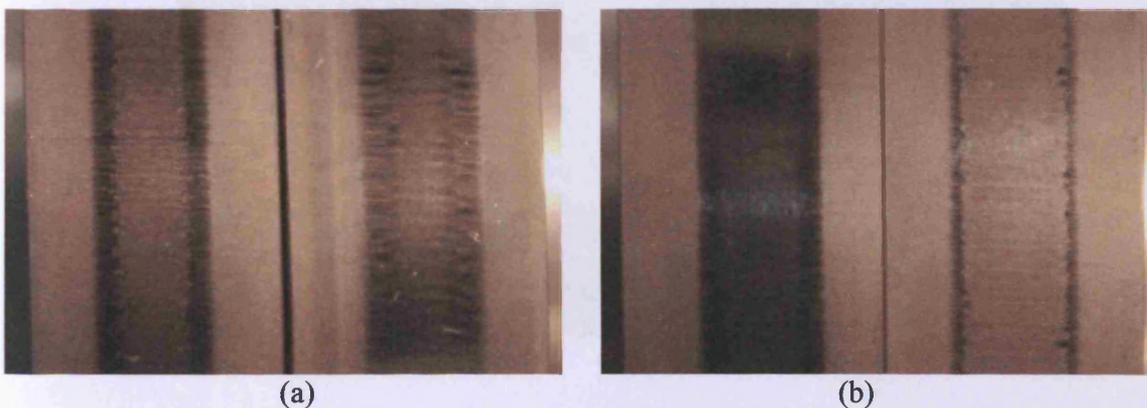
Figure 3.41. Photographs of discs following testing at 16m/s
(a) UTRC09; left: ground coated disc on fast shaft; right: ground coated disc on slow shaft
(b) UTRC12; left: ground coated disc on fast shaft; right: ground coated disc on slow shaft

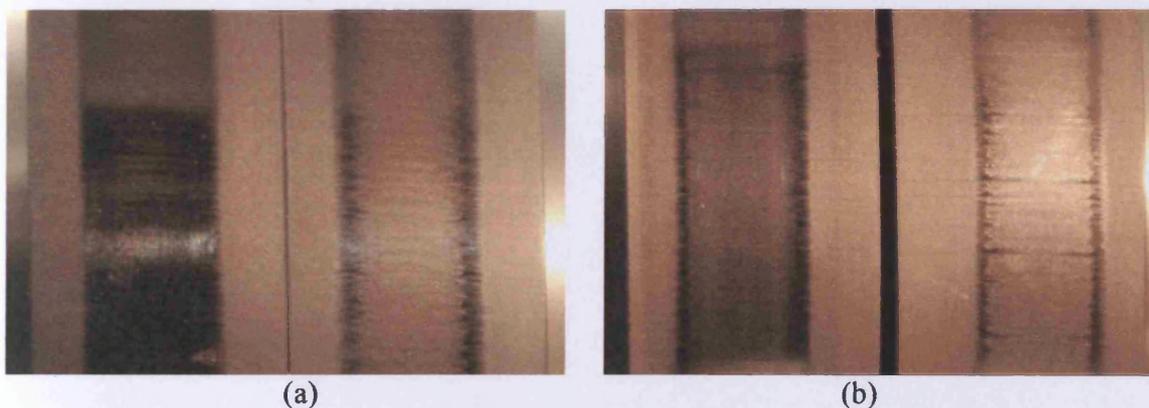
Figure 3.47. Photographs of discs following testing at 12m/s

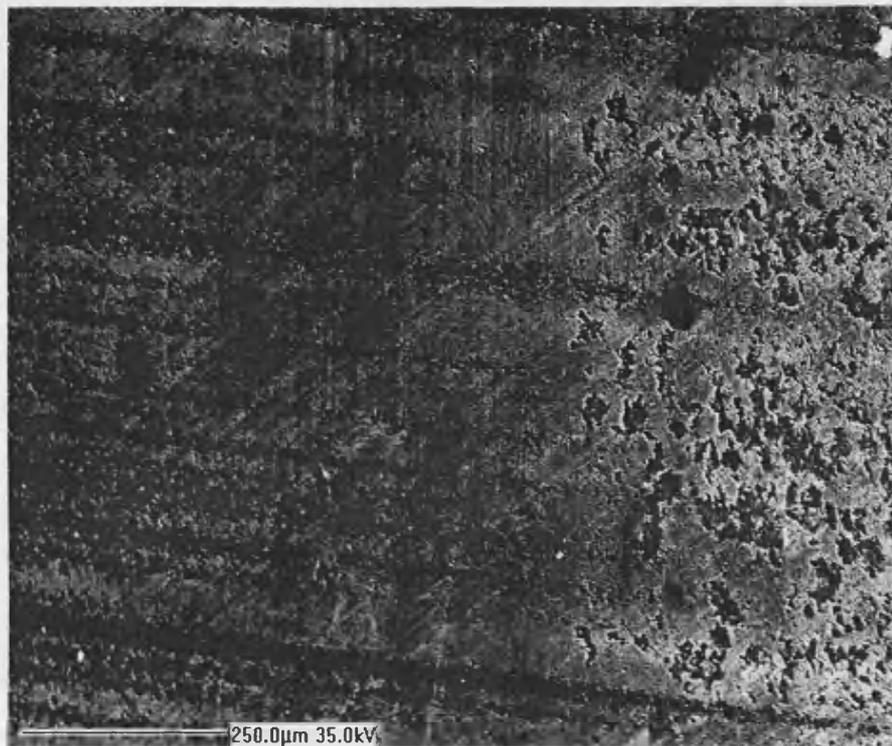
Figure 3.49. SEM images of surface of the fast disc used in test UTRC10.
(a) unrun surface to the right with the edge of running track on the left
(b) middle of the running track with coating still remaining

SEM images from the two discs used in this test are shown in Figures 3.49 and 3.50. Figure 3.49 shows the fast disc from test UTRC10. The upper image shows the edge of the contact track and illustrates the brightened appearance of the coating where contact has occurred. Again, the valley features of the ground surface remain intact. The lower image shows the middle part of the running track which has become highly polished as a result of running. The original ground finish of the disc is faintly visible. This striking improvement in surface finish is further confirmed by the profile of this disc shown in Figure 3.48(b). SEM images of the slow disc are shown in Figure 3.50. The upper image shows the edge of the running track with un-run surface to the left and the running track to the right. In this case there appears to be more deterioration of the coating in the running area. The lower image shows the opposite side of the running track and again we observe the same appearance. The slower disc does not become as polished as the faster one, and this is confirmed by the profile shown in Figure 3.48(d).

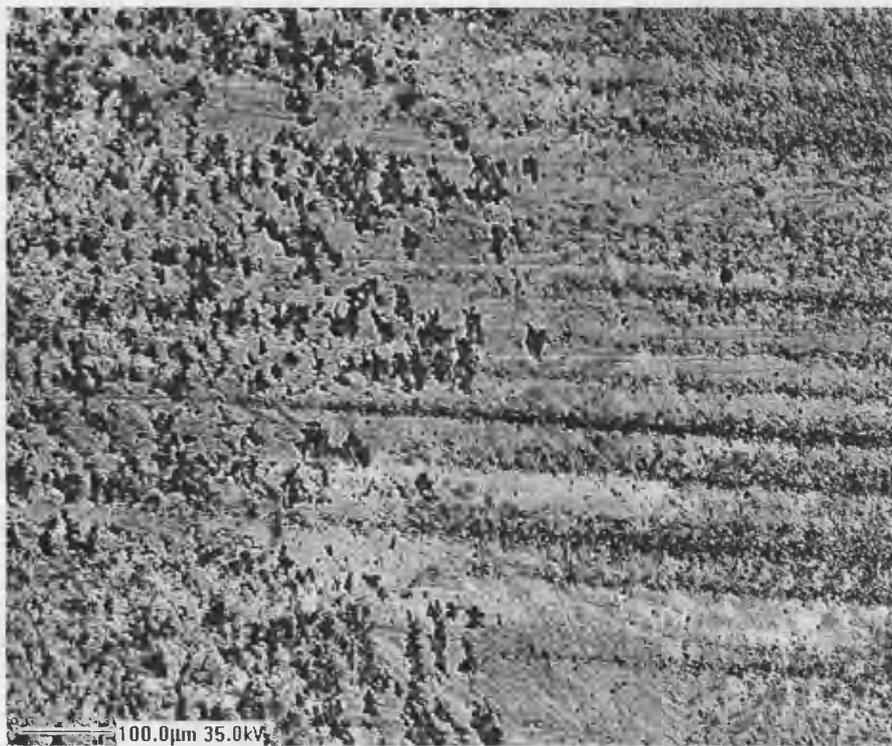
Figure 3.50. SEM images of surface of the slow disc used in test UTRC10.
(a) edge of the running track with little coating still remaining
(b) middle of the running track

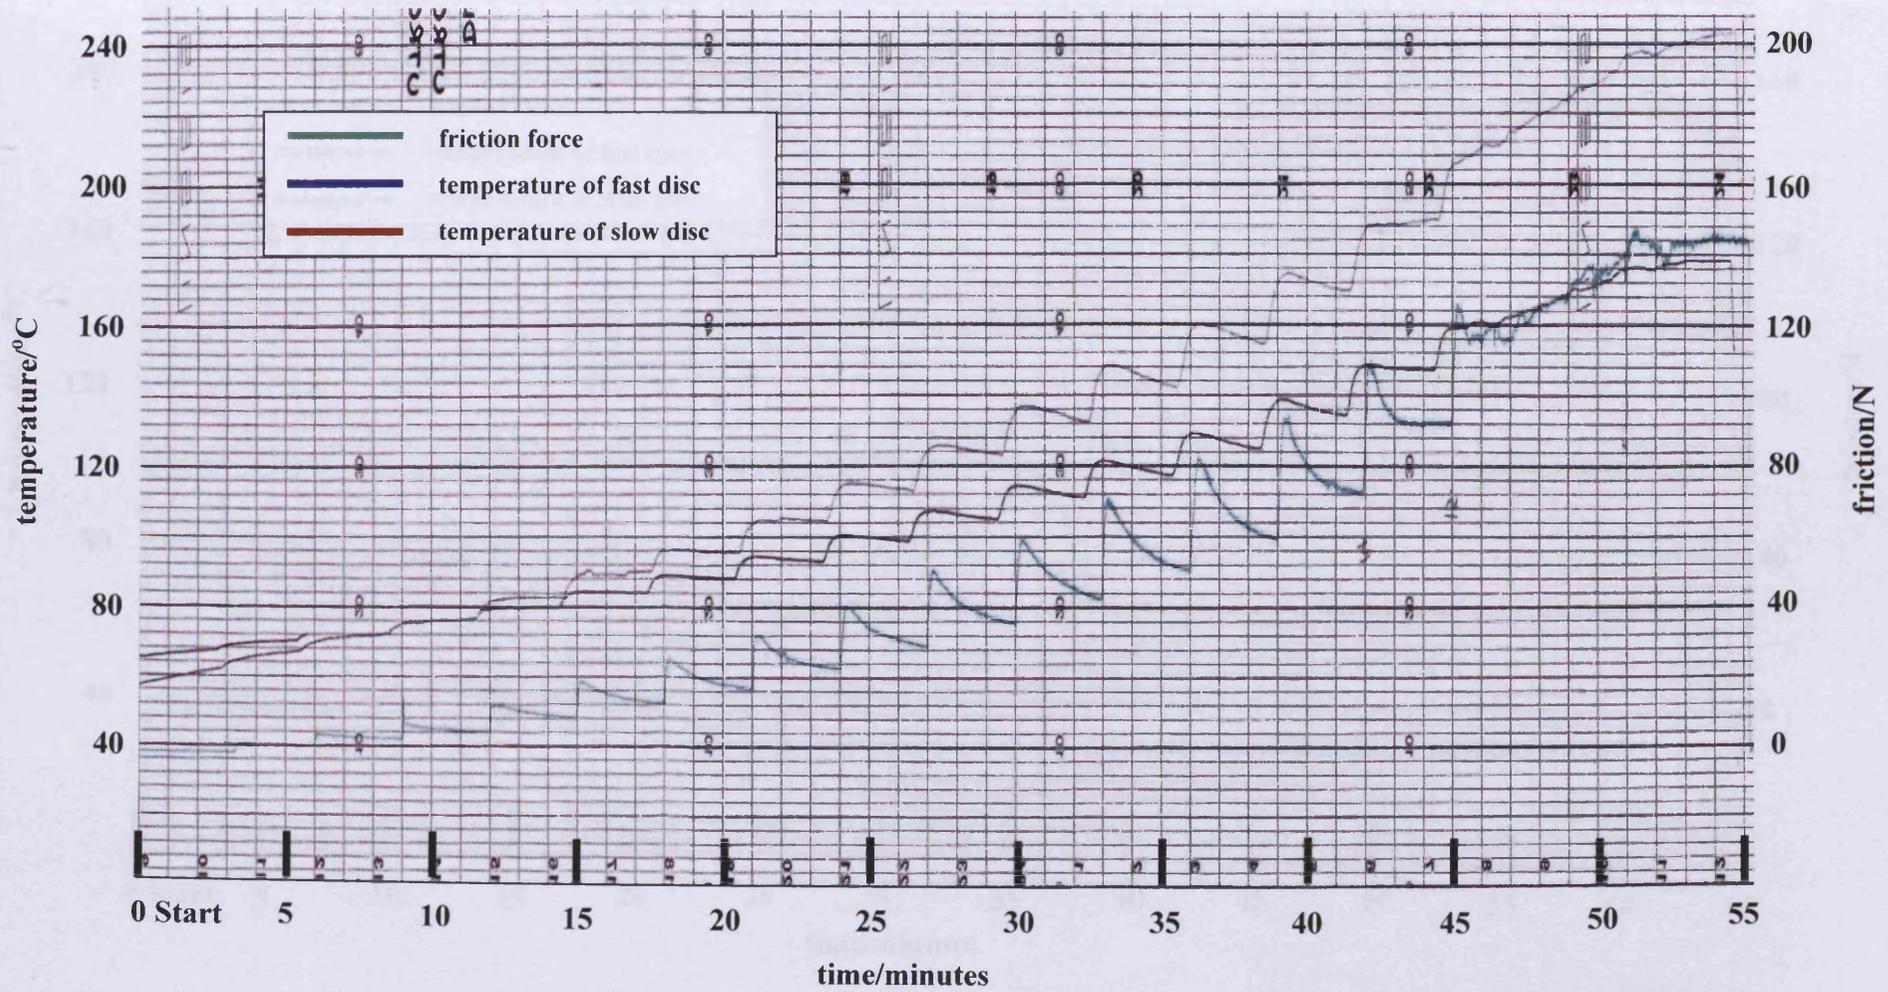
Figure 3.51. Chart recorder record of test UTRC08, graph shows friction force and bulk temperatures of two discs

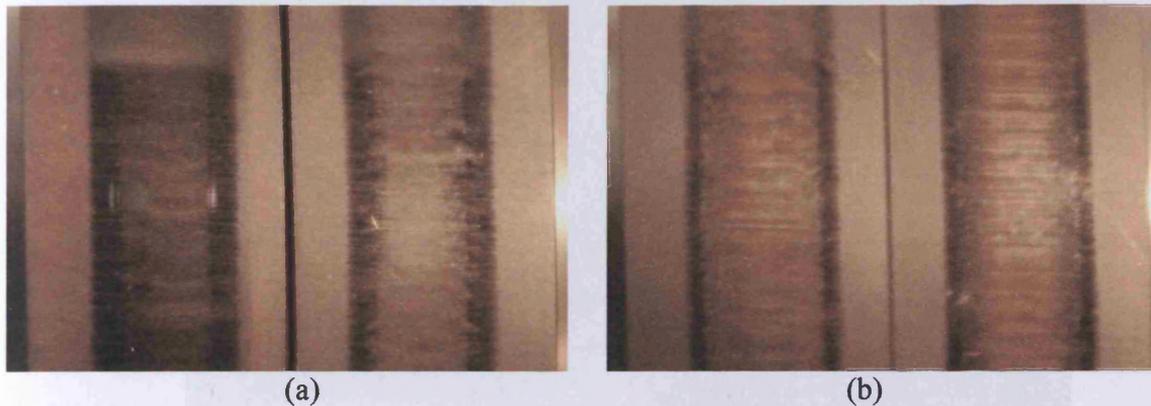
Figure 3.53. Photographs of discs following testing at 7m/s
(a) UTRC08; left: ground/hard coated disc on fast shaft; right: ground/hard coated disc on slow shaft
(b) UTRC13; left: ground/hard coated disc on fast shaft; right: ground/hard coated disc on slow shaft

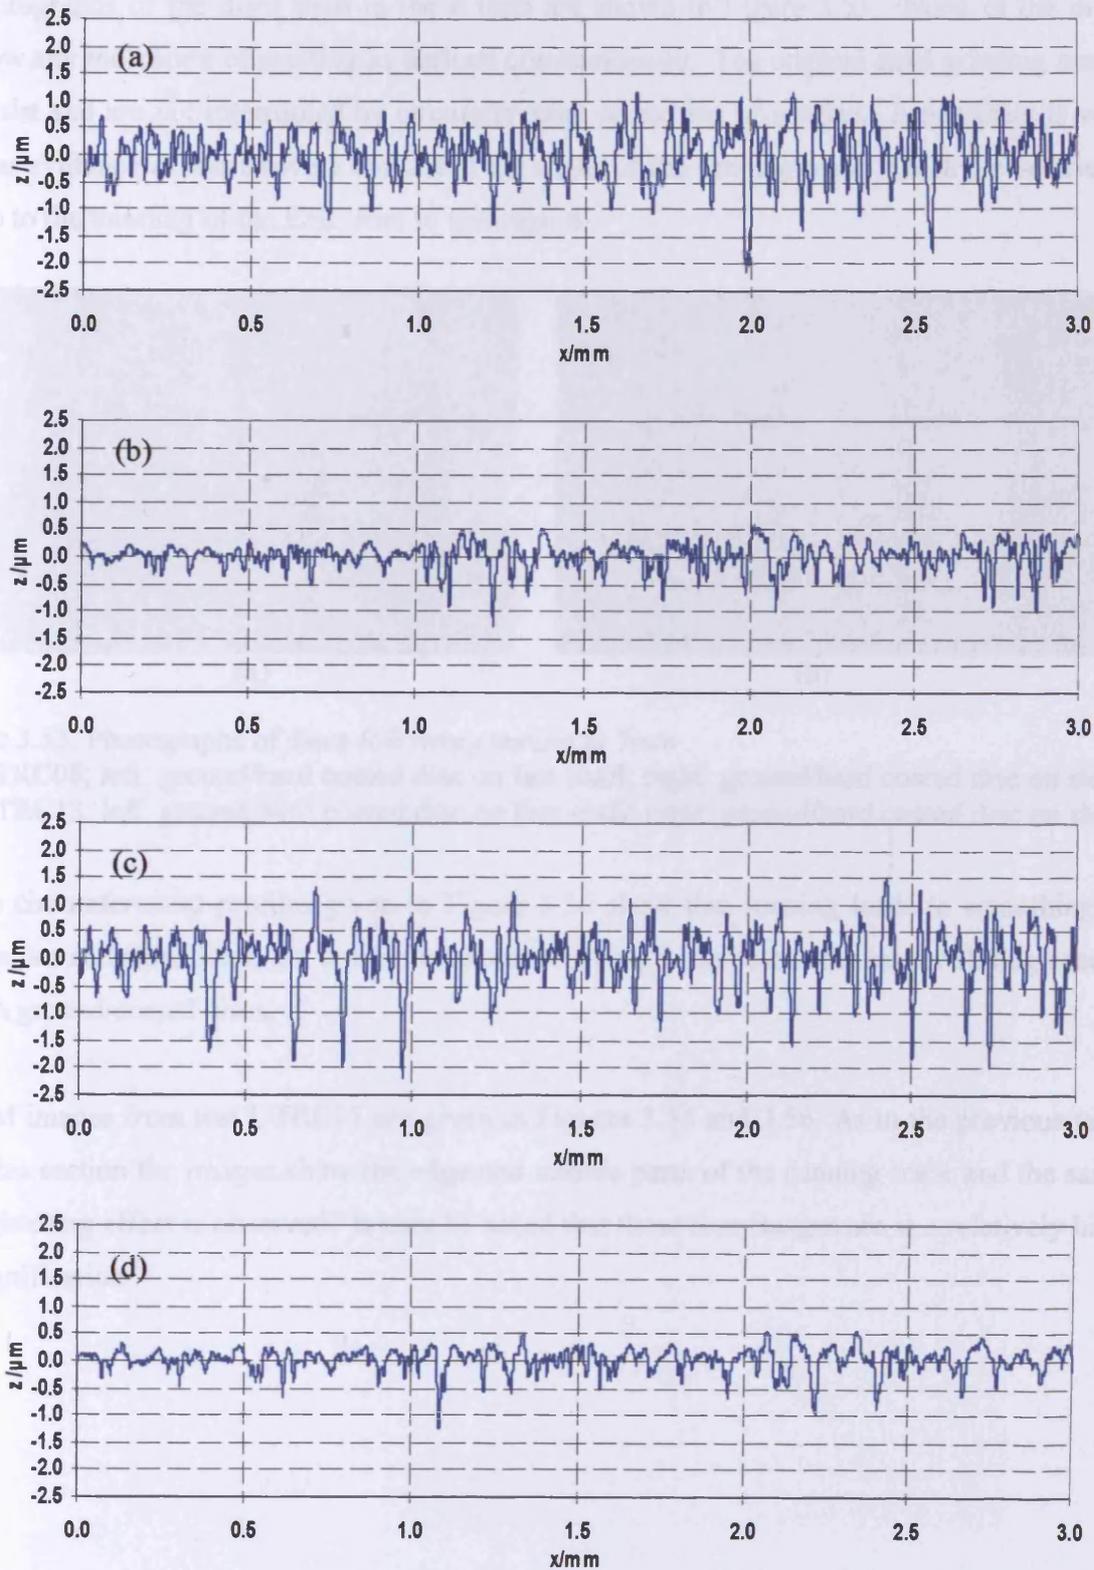
Figure 3.54. Surface profiles taken in the circumferential direction from discs used in test UTRC13
Profiles from fast disc (a) before test; $R_a = 0.380 \mu\text{m}$ (b) after test; $R_a = 0.211 \mu\text{m}$
Profiles from slow disc (c) before test; $R_a = 0.403 \mu\text{m}$ (d) after test; $R_a = 0.196 \mu\text{m}$

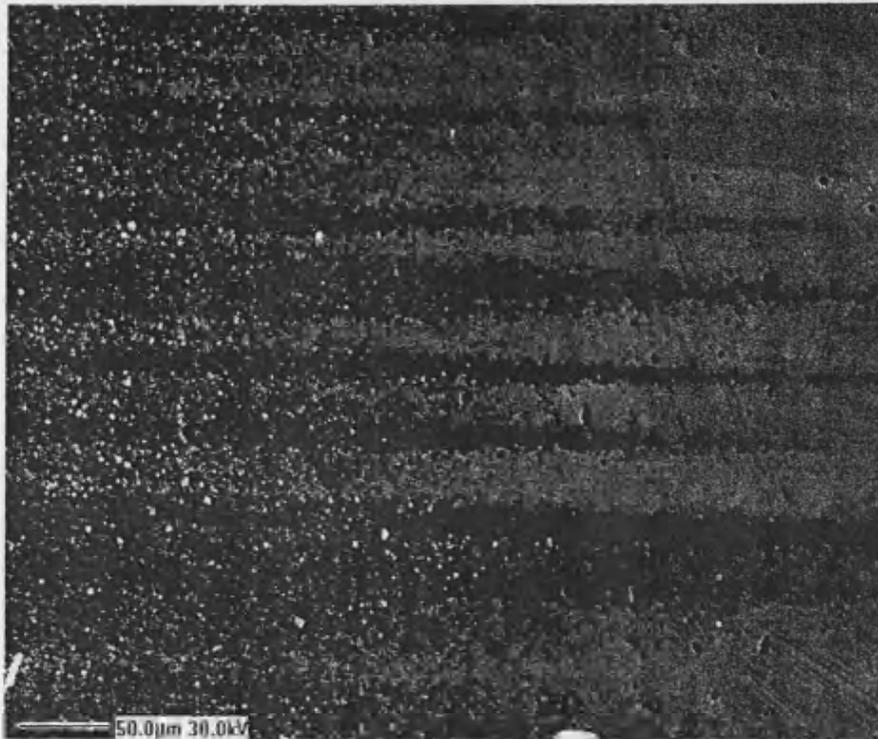
Figure 3.55. SEM images of surface of the fast disc used in test UTRC13.
(a) unrun surface with a polished running track to the right of the image
(b) middle of the running track with evidence of coating still remaining

SEM images from test UTRC13 are given in Figures 3.55 and 3.56. As in the previous tests in this section the images show the edge and middle parts of the running track and the same brightening effect is observed. It may be noted that these four images are at a relatively high magnification.

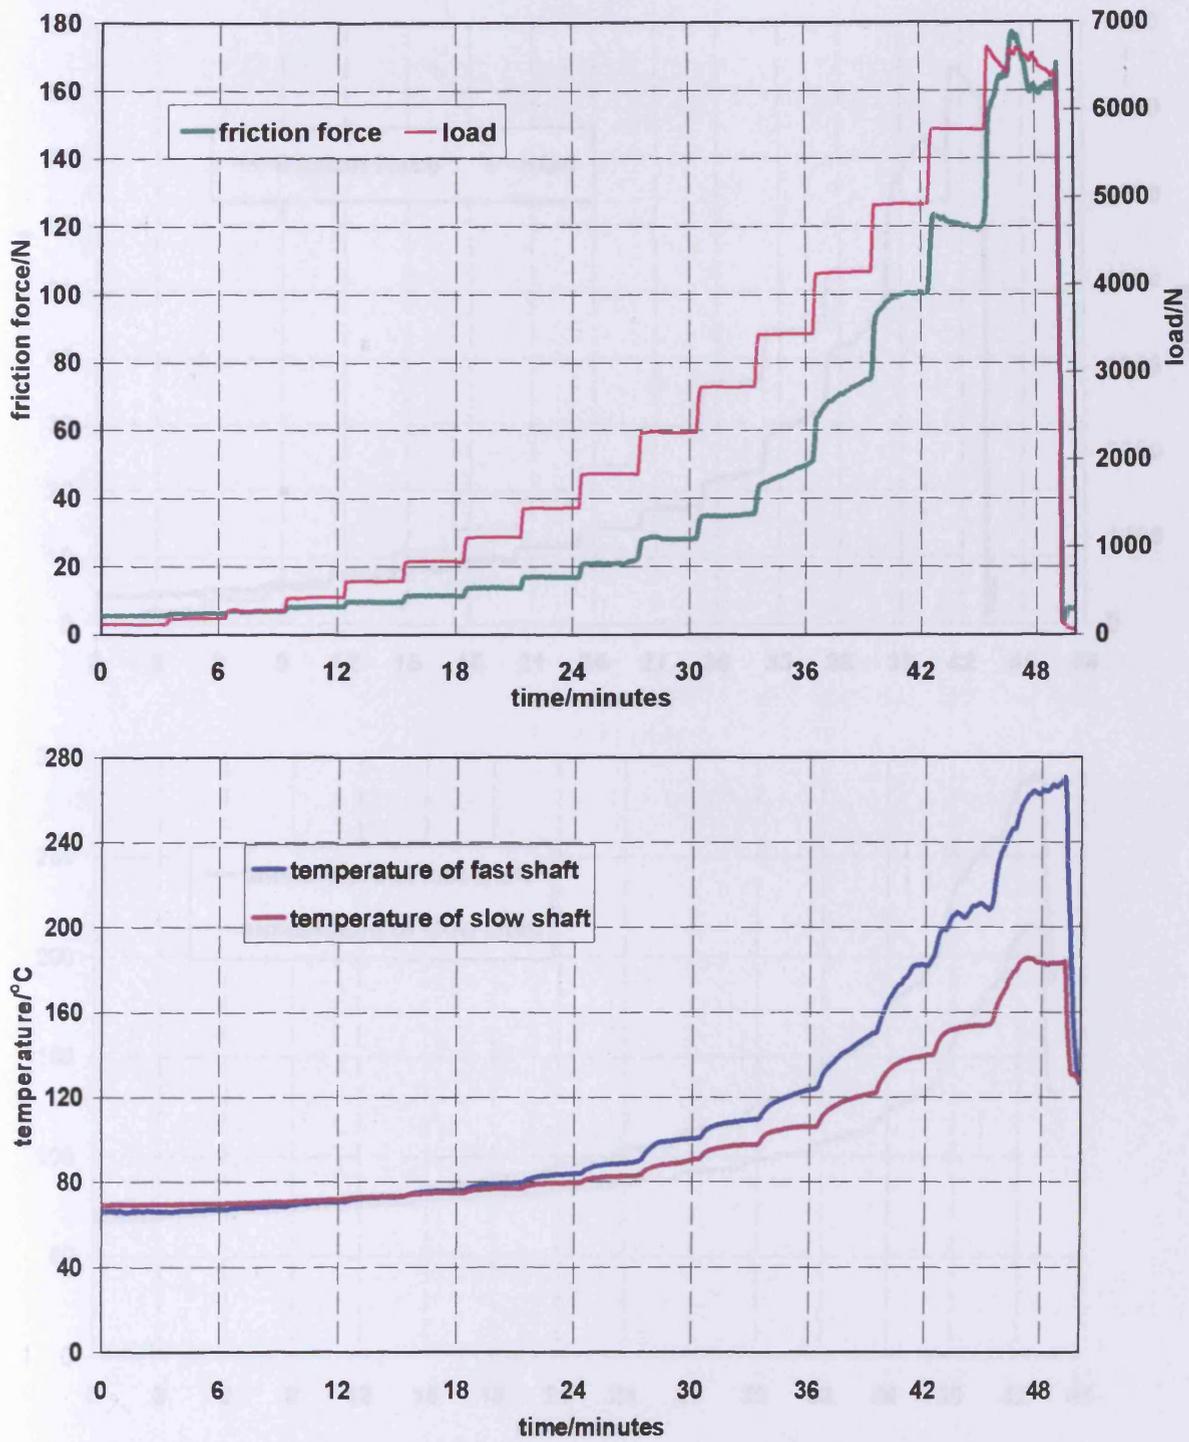
Figure 3.57. Record of scuffing test UTRC15, upper graph shows applied load and friction force; lower graph shows bulk temperatures of the two discs

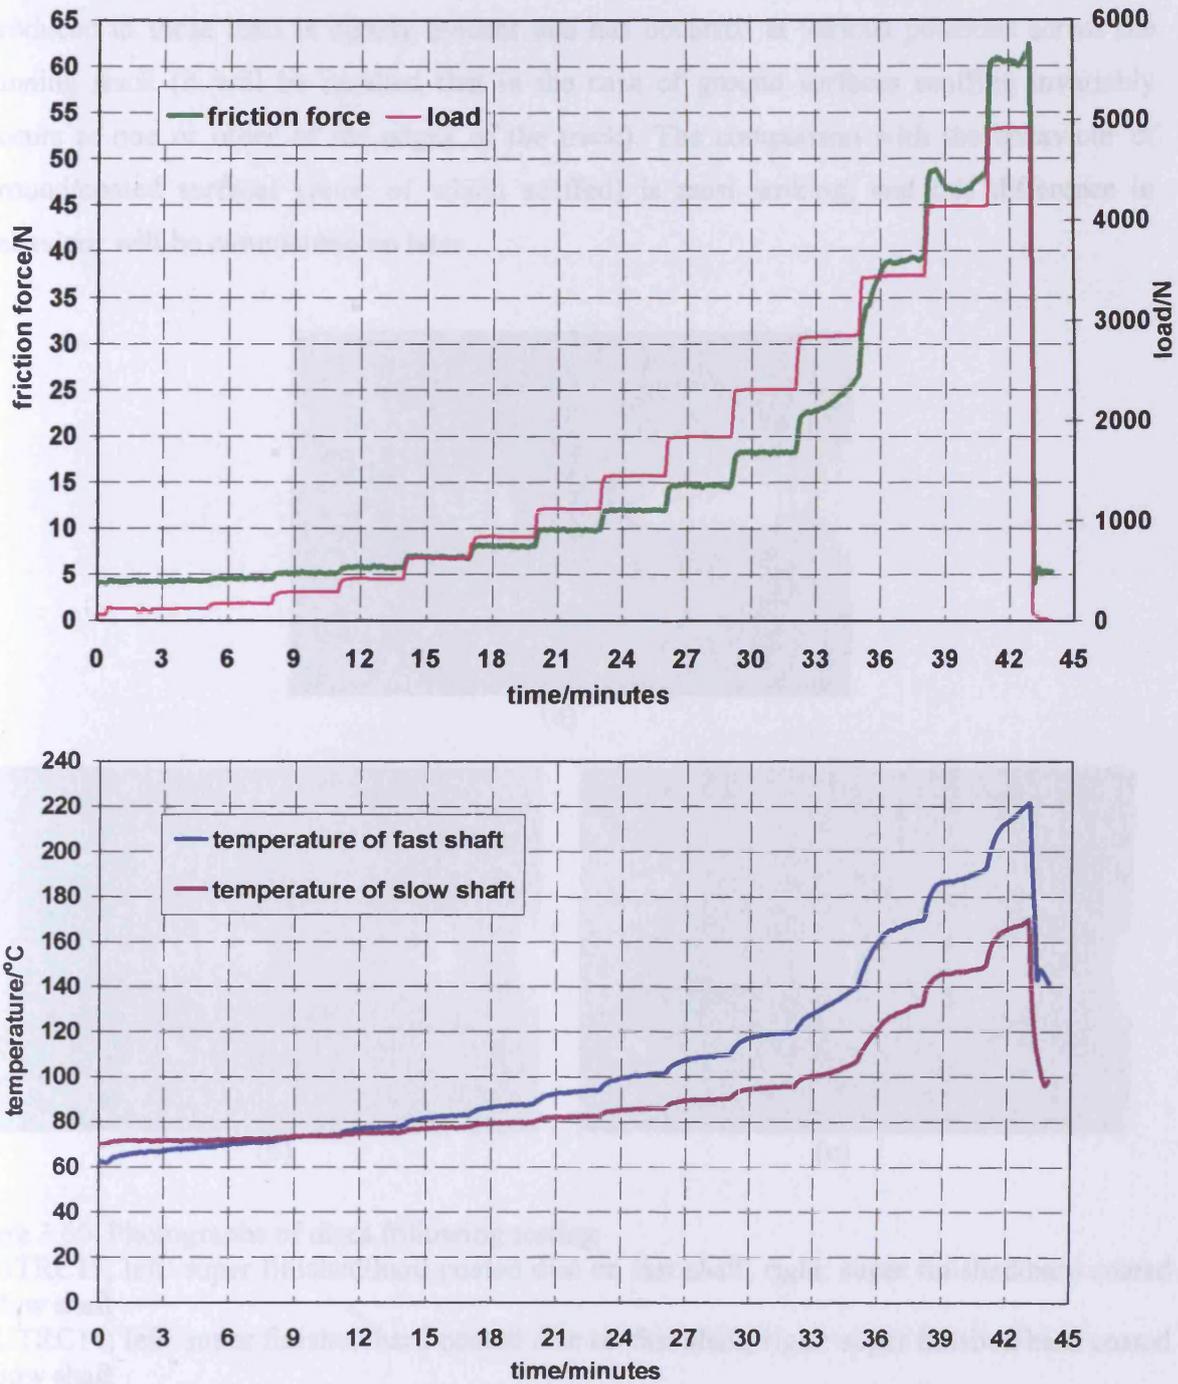
Figure 3.59. Record of scuffing test UTRC16, upper graph shows applied load and friction force; lower graph shows bulk temperatures of the two discs

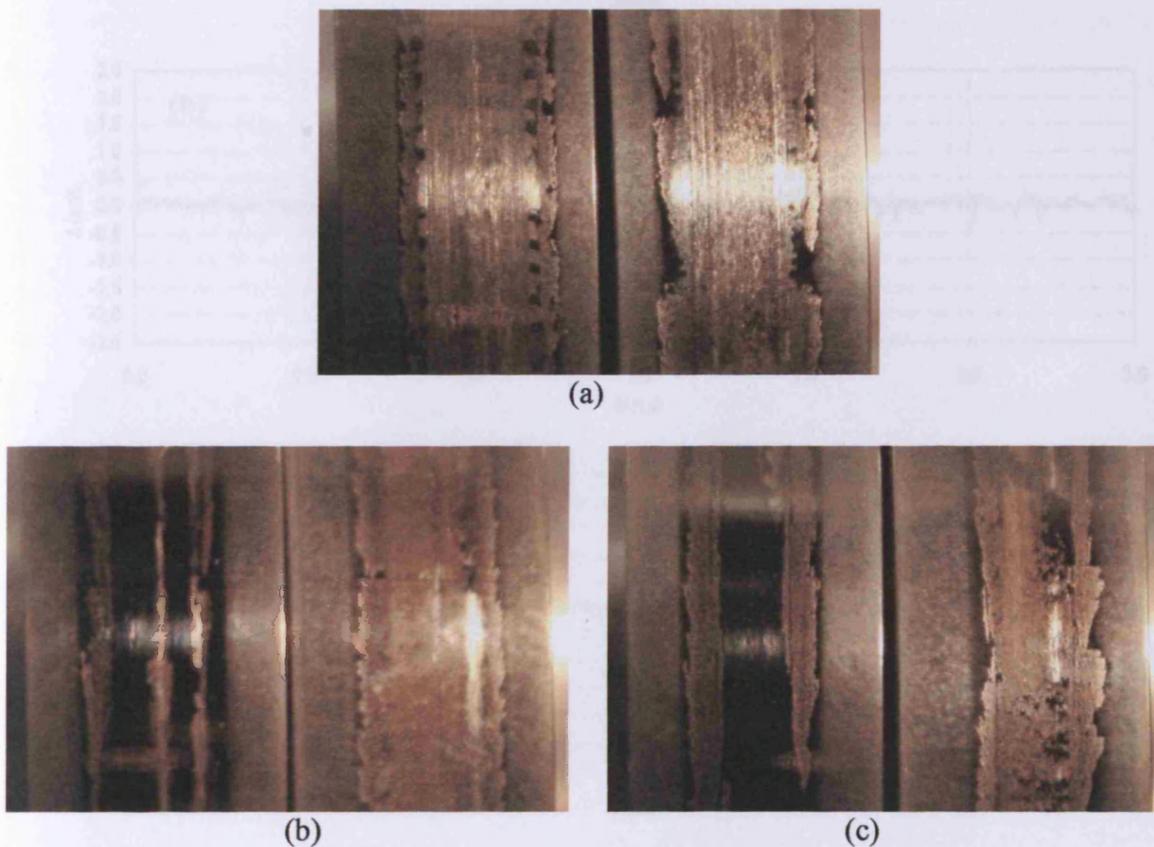
Figure 3.60. Photographs of discs following testing
