EFFECT OF SURFACE FINISH AND HARD COATINGS ON SCUFFING OF STEEL DISCS

Thesis submitted in candidature
for the degree of
Doctor of Philosophy at Cardiff University

Institute of Theoretical, Applied and Computational Mechanics
Cardiff School of Engineering
Cardiff University

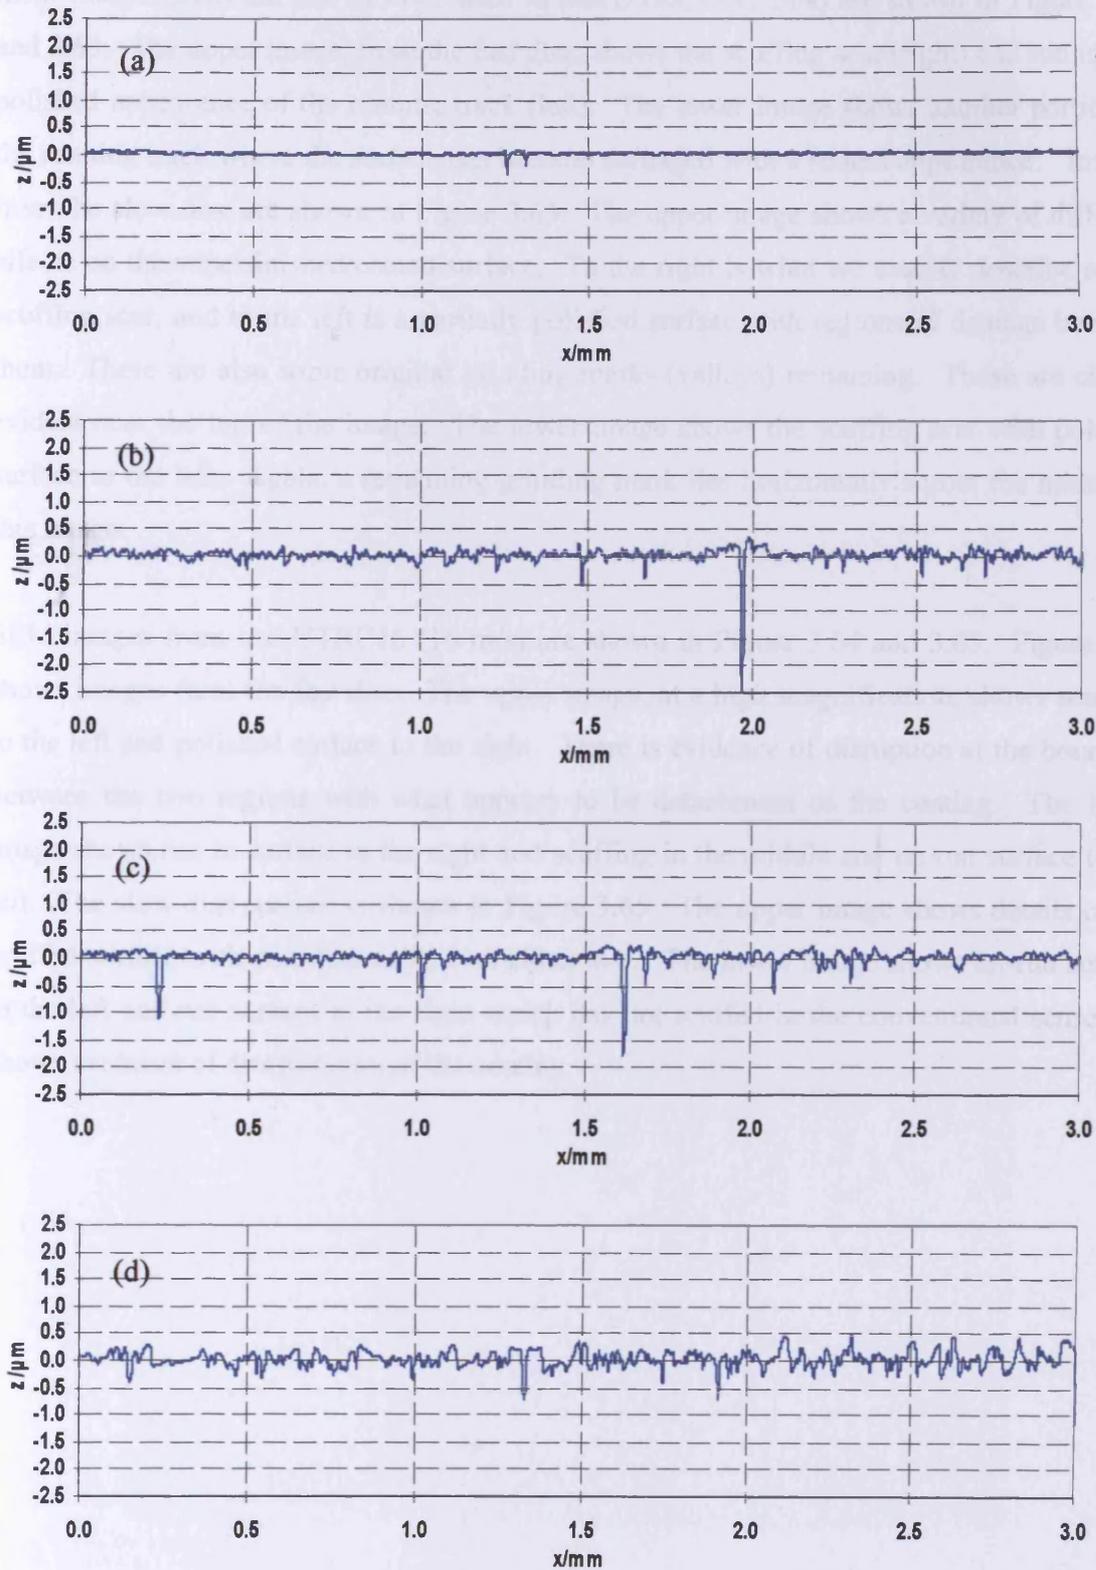
Figure 3.61. Surface profiles taken in the circumferential direction from discs used in test UTRC15
Profiles from fast disc (a) before test; $R_a = 0.084 \mu\text{m}$ (b) after test; $R_a = 0.153 \mu\text{m}$
Profiles from slow disc (c) before test; $R_a = 0.091 \mu\text{m}$ (d) after test; $R_a = 0.182 \mu\text{m}$

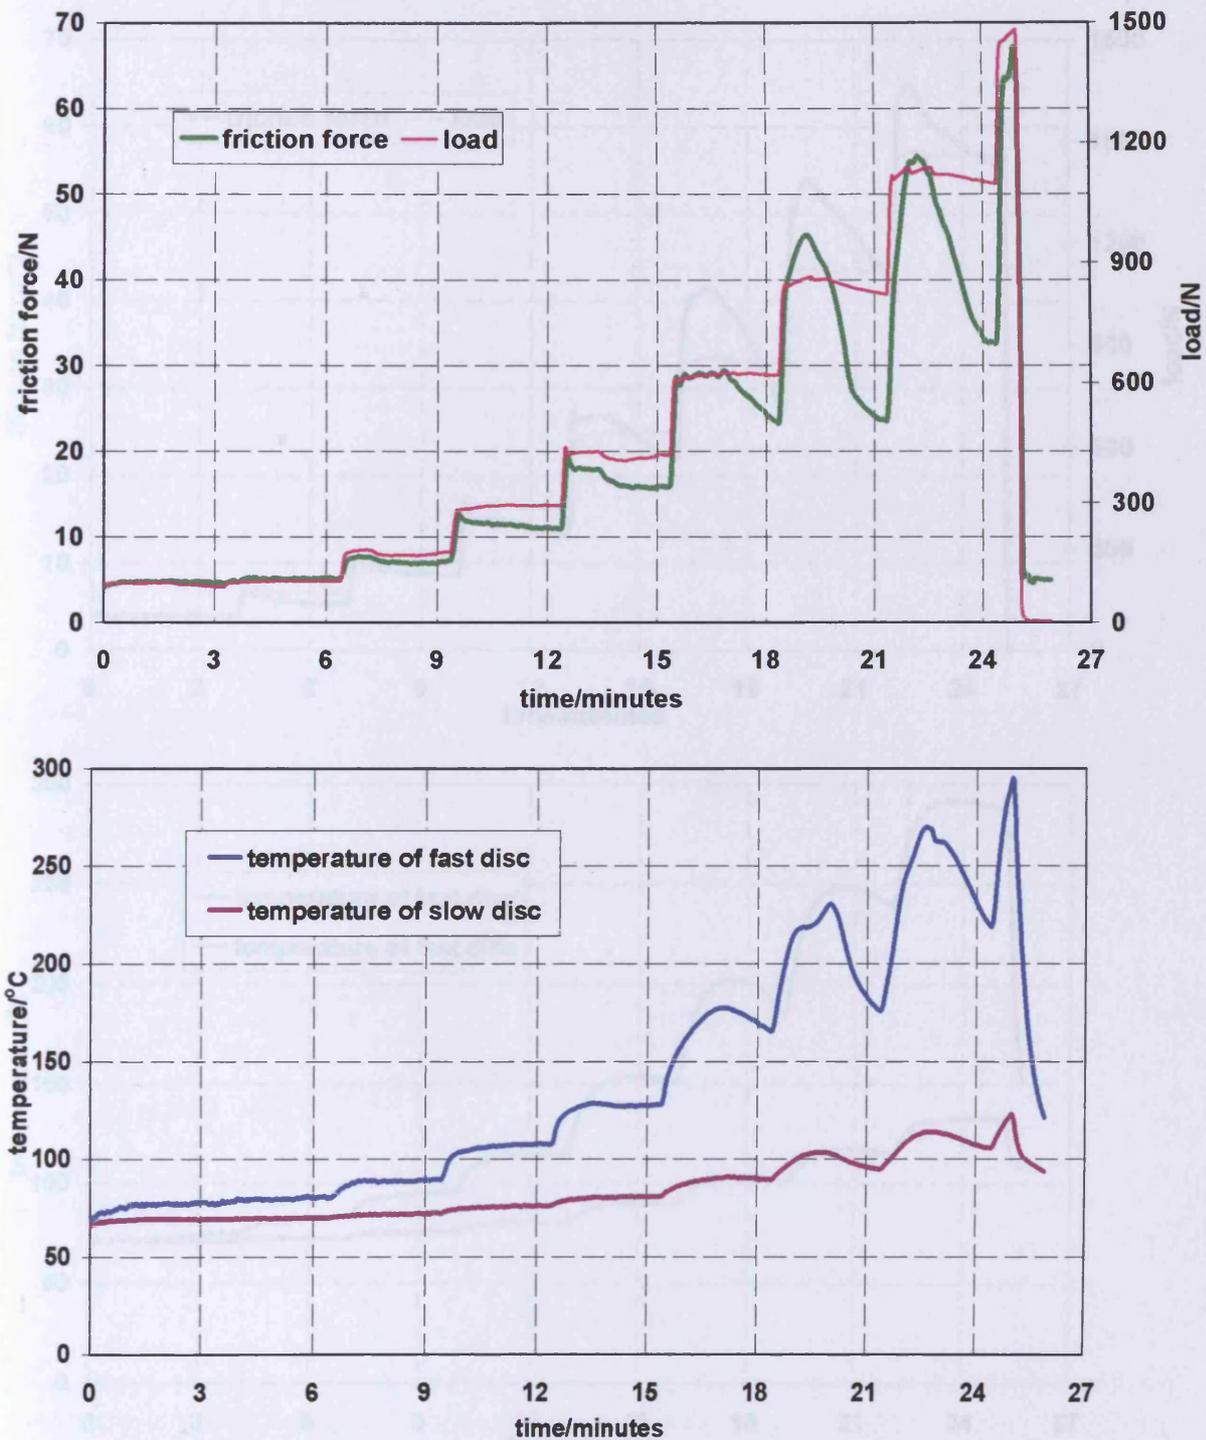
Figure 3.66. Record of test UTRC21; Upper graph shows applied load and friction force; lower graph shows bulk temperatures of the two discs

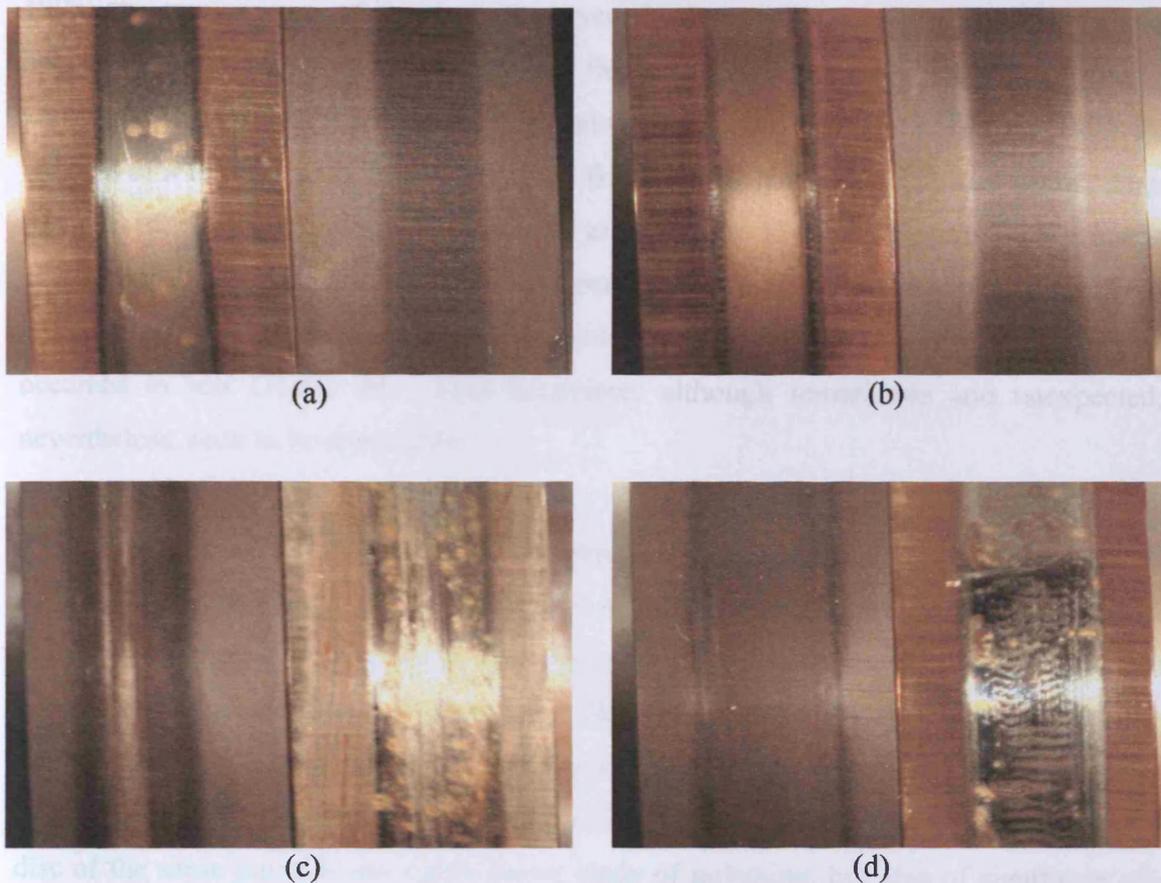
Figure 3.70. Photographs of discs following testing at a sliding speed of 16m/s
 (a) UTRC21; left: ground disc on fast shaft: right: ground/hard coated disc on slow shaft
 (b) UTRC22; left: ground disc on fast shaft: right: ground/hard coated disc on slow shaft
 (c) UTRC24; left: ground/hard coated disc on fast shaft: right: ground disc on slow shaft
 (d) UTRC26; left: ground/hard coated disc on fast shaft: right: ground disc on slow shaft

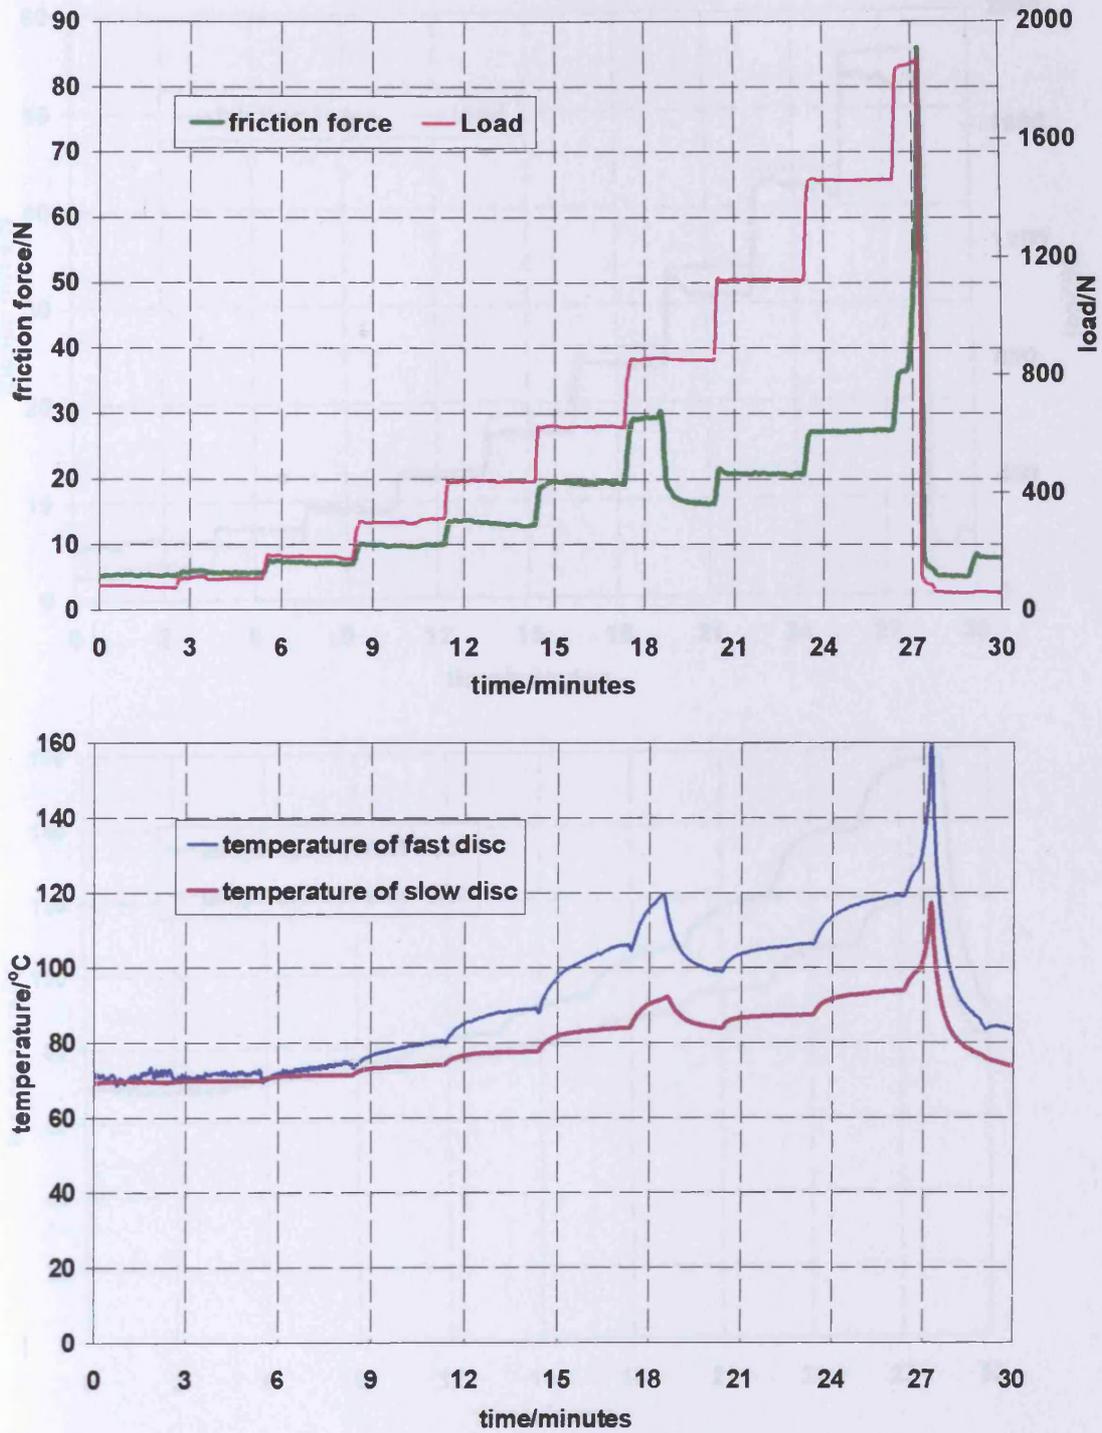
Figure 4.1. Record of test AD01; upper graph shows applied load and friction force; lower graph shows bulk temperature of the two discs.

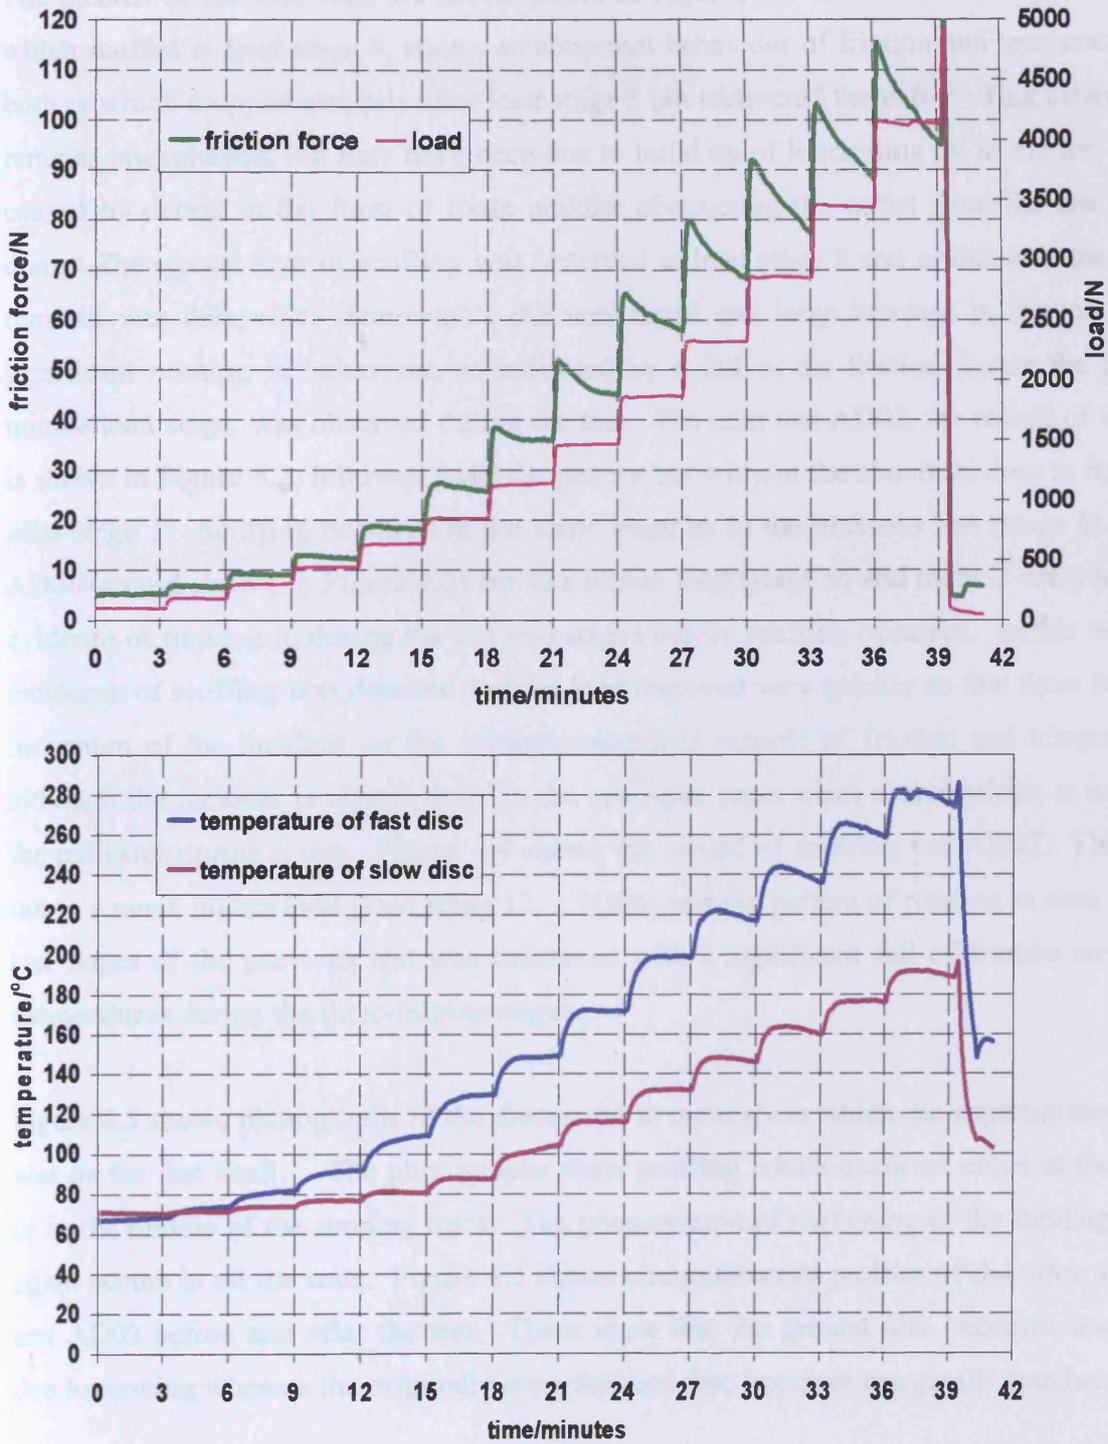
Figure 4.4. Record of scuffing test AD07, upper graph shows applied load and friction force; lower graph shows bulk temperatures of the two discs

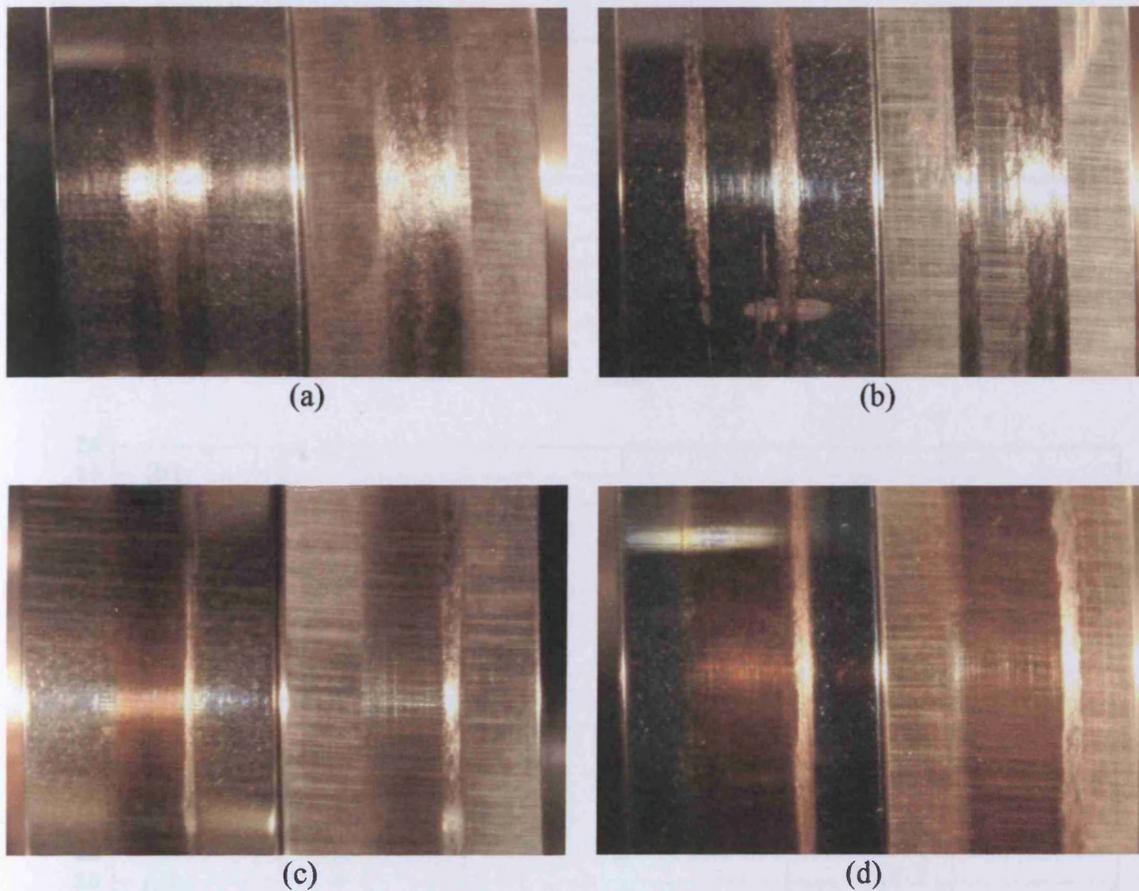
Figure 4.5. Photographs of discs following testing at 12m/s

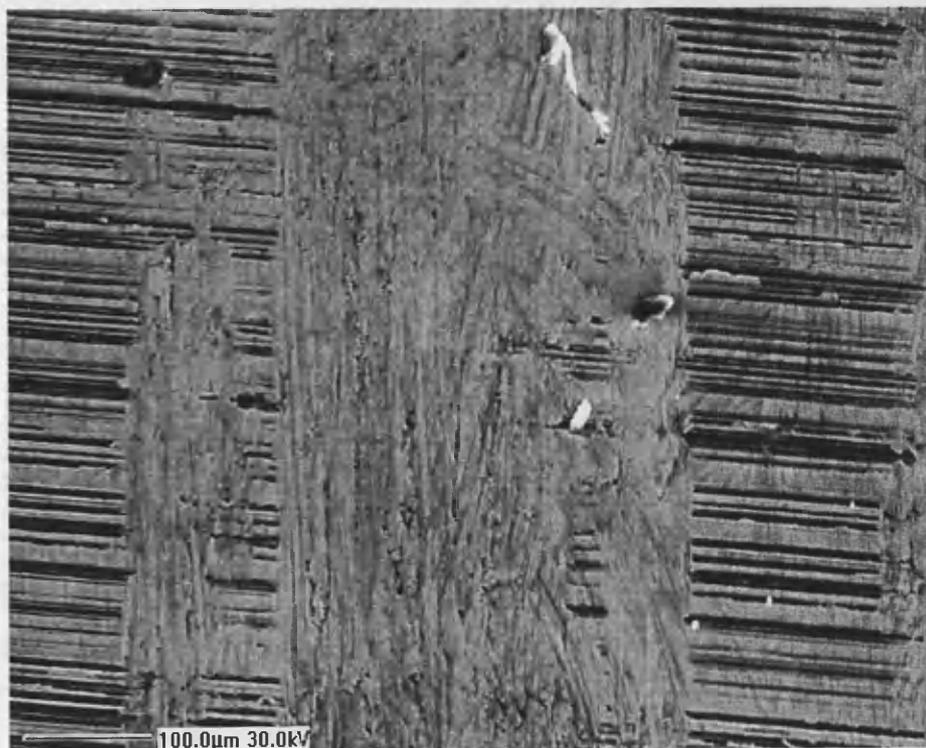
Figure 4.8. SEM images of surface of the slow disc used in test AD02.

SEM images corresponding to test AD02 are given in Figures 4.7 and 4.8. Figure 4.7 shows images from the superfinished disc used on the fast shaft. The upper image shows the edge of the scuffing region with the run part of the running track to the right. The lower image shows the other edge of the scuffing track. The upper image in Figure 4.8 shows the ground un-run surface to the right of the image and the edge of running track to the left. There is some evidence of light scoring or scratching (vertical lines) on the running track. The lower image shows the middle part of the running track with a central band of severe scuffing in the middle of the track. This image is taken from the disc shown in Figure 4.5 (b) which is an unusual case where scuffing occurred at the edges of the track and in a separate band in the middle of the track.

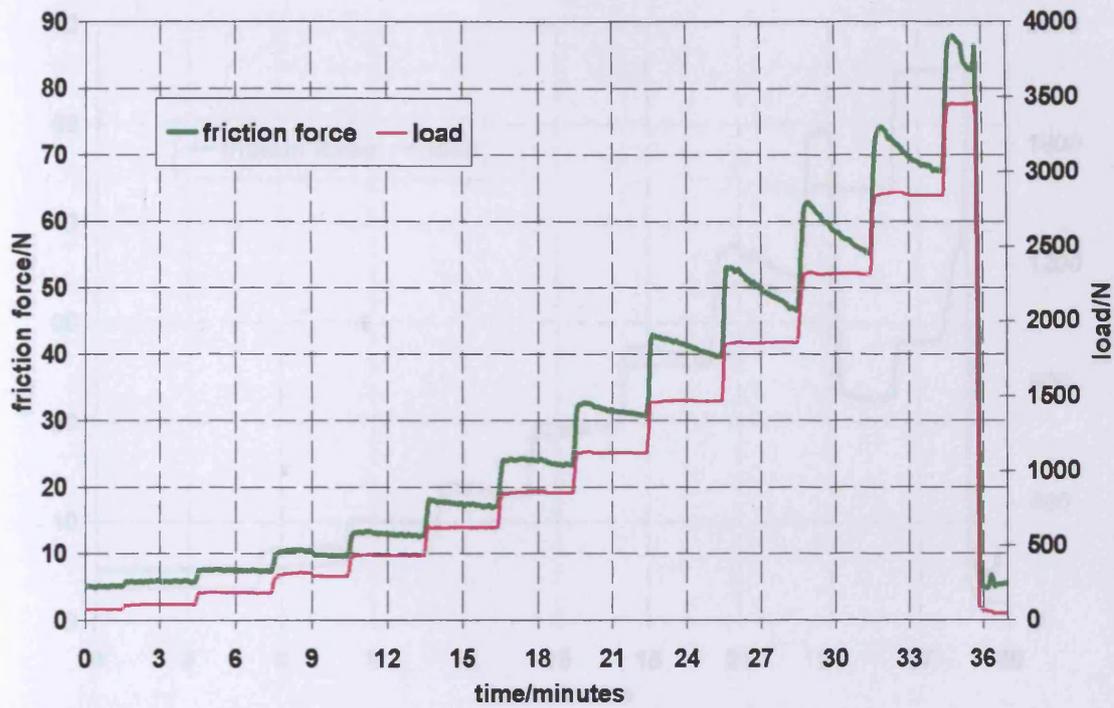
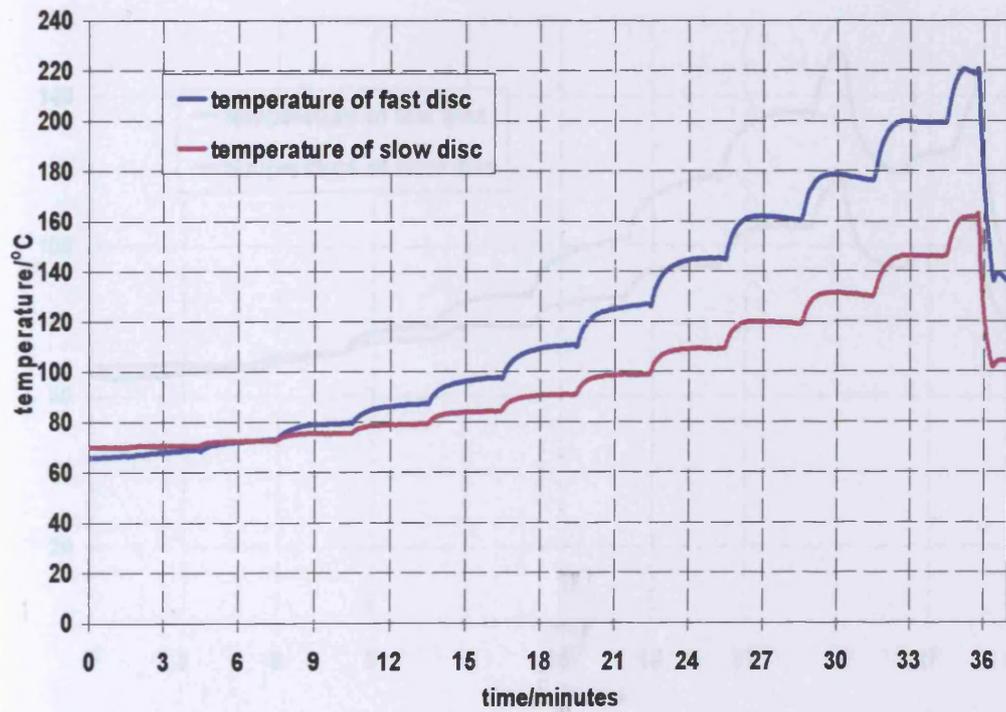
Figure 4.9. Record of scuffing test AD03, upper graph shows applied load and friction force; lower graph shows bulk temperatures of the two discs

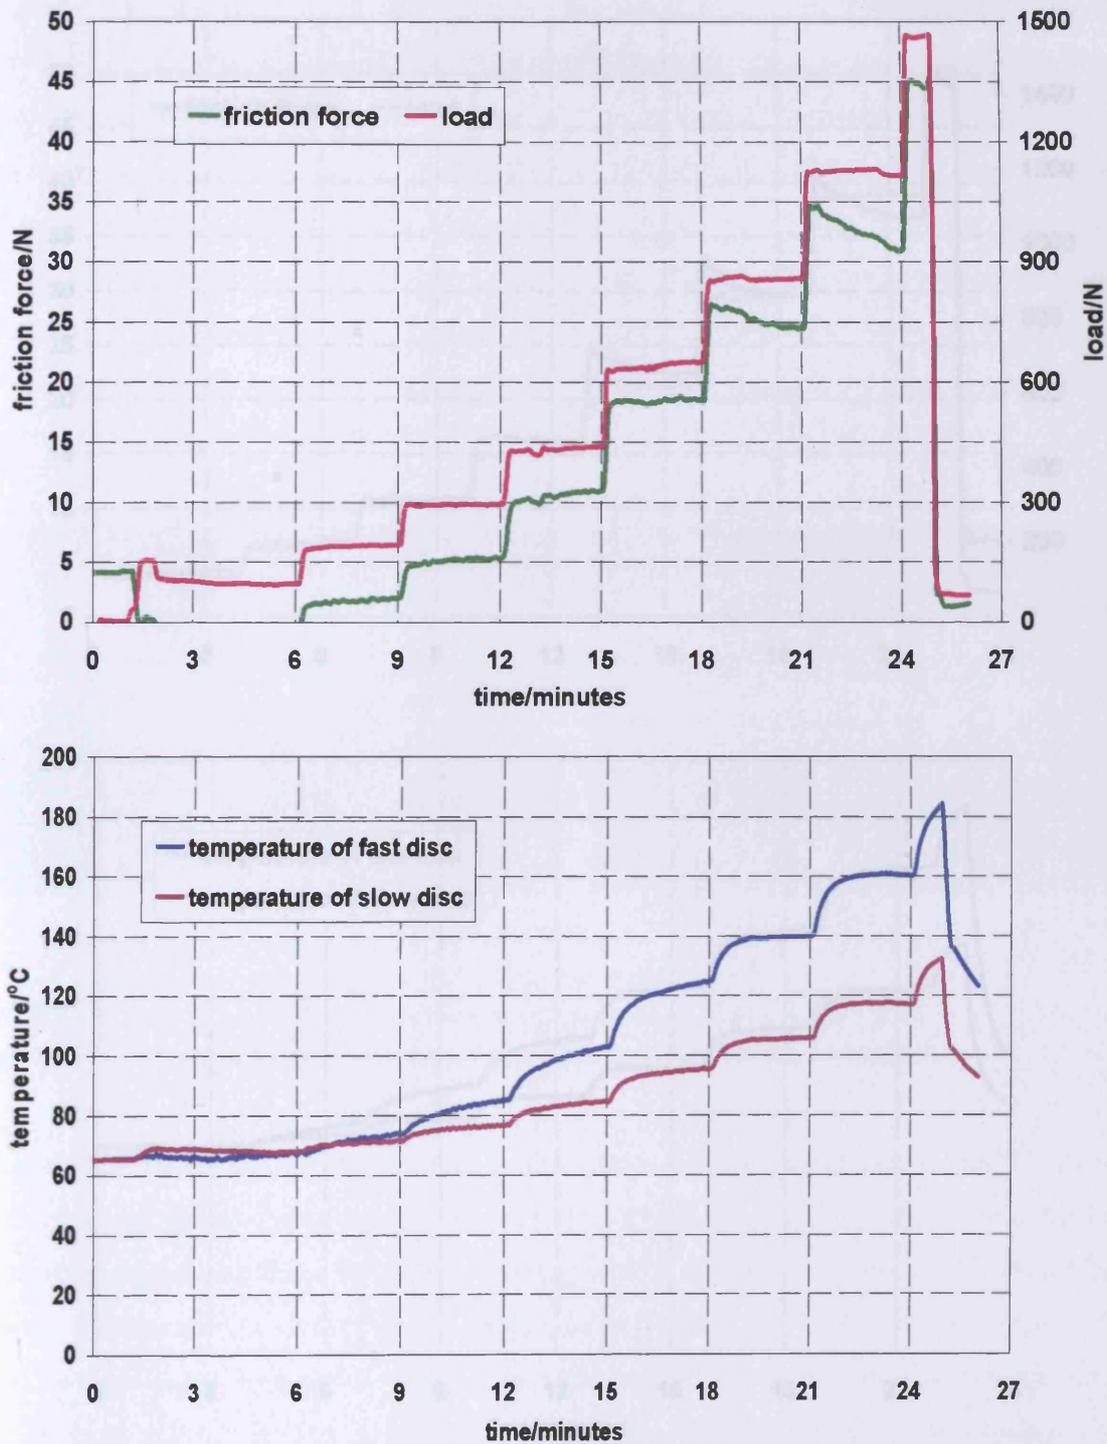
Figure 4.17. Record of scuffing test AD09(prerun), upper graph shows applied load and friction force; lower graph shows bulk temperatures of the two discs

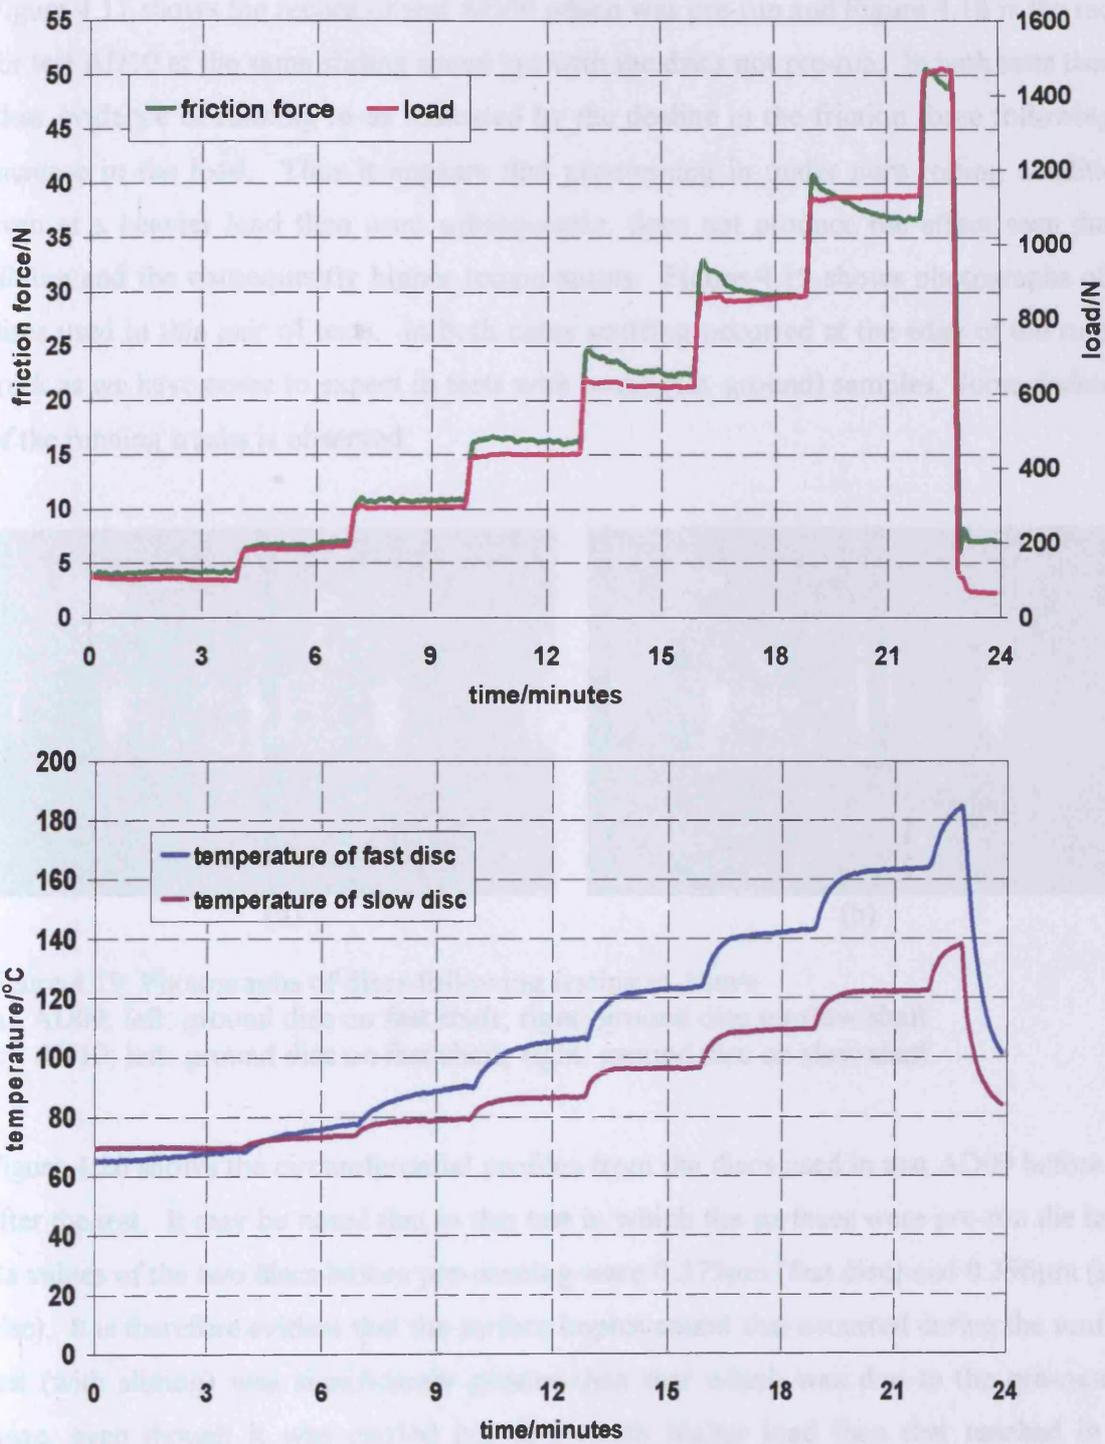
Figure 4.18. Record of scuffing test AD10, upper graph shows applied load and friction force; lower graph shows bulk temperatures of the two discs

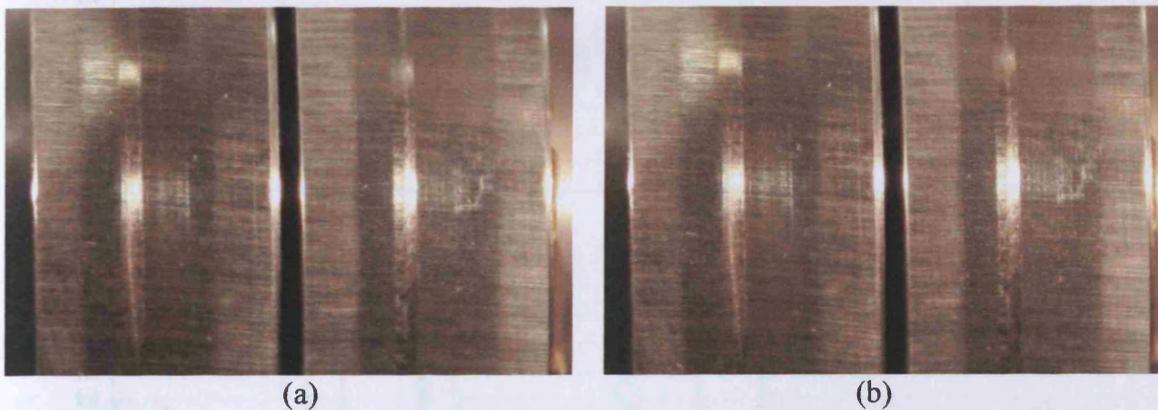
Figure 4.19. Photographs of discs following testing at 16m/s
 (a) AD09; left: ground disc on fast shaft; right: ground disc on slow shaft
 (b) AD10; left: ground disc on fast shaft; right: ground disc on slow shaft

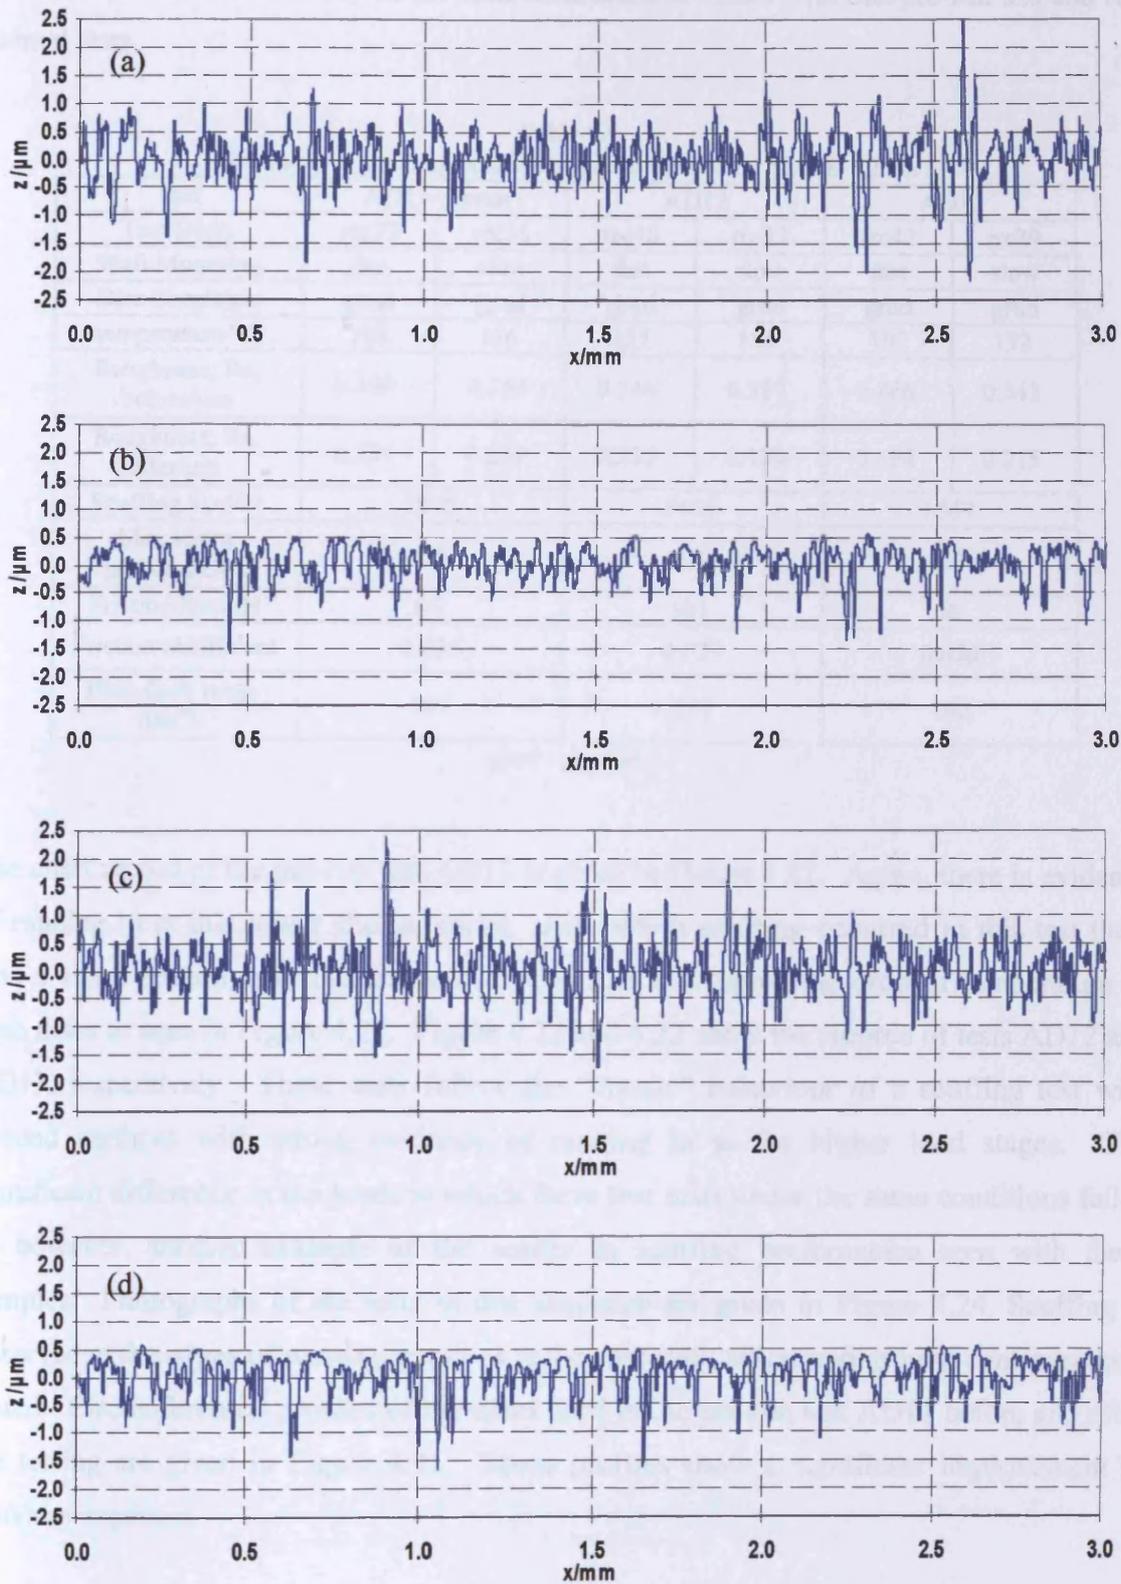
Figure 4.20. Surface profiles taken in the circumferential direction from discs used in test AD09
Profiles from fast disc (a) before test; $R_a = 0.339\mu\text{m}$ (b) after test; $R_a = 0.246\mu\text{m}$
Profiles from slow disc (c) before test; $R_a = 0.350\mu\text{m}$ (d) after test; $R_a = 0.273\mu\text{m}$

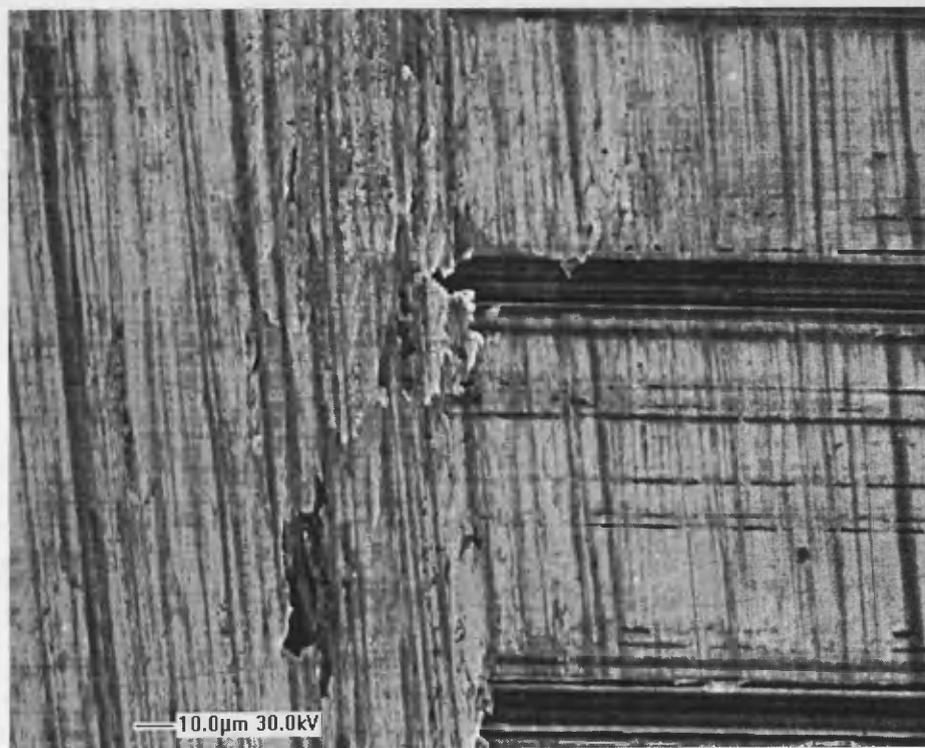
(b)

Figure 4.27. SEM images of surface of the slow disc used in test AD13.

Figures 4.26 and 4.27 show the SEM images of the discs used in test AD13. The upper image in Figure 4.26 is taken from the fast disc used in test AD13 which shows the run in but unscuffed region of the disc. This shows considerable “flattening” of asperity features to produce substantial lands on the surface. The lower image, taken at a very high magnification, shows the edge of the scuffing track with the run in region to the right. Similar images from the slow disc used in this test are shown in Figure 4.27. The lower image of Figure 4.27, taken at a high magnification, is an interesting illustration of what may be described as full scuffing on the left, and heavy scoring/incipient scuffing on the right.

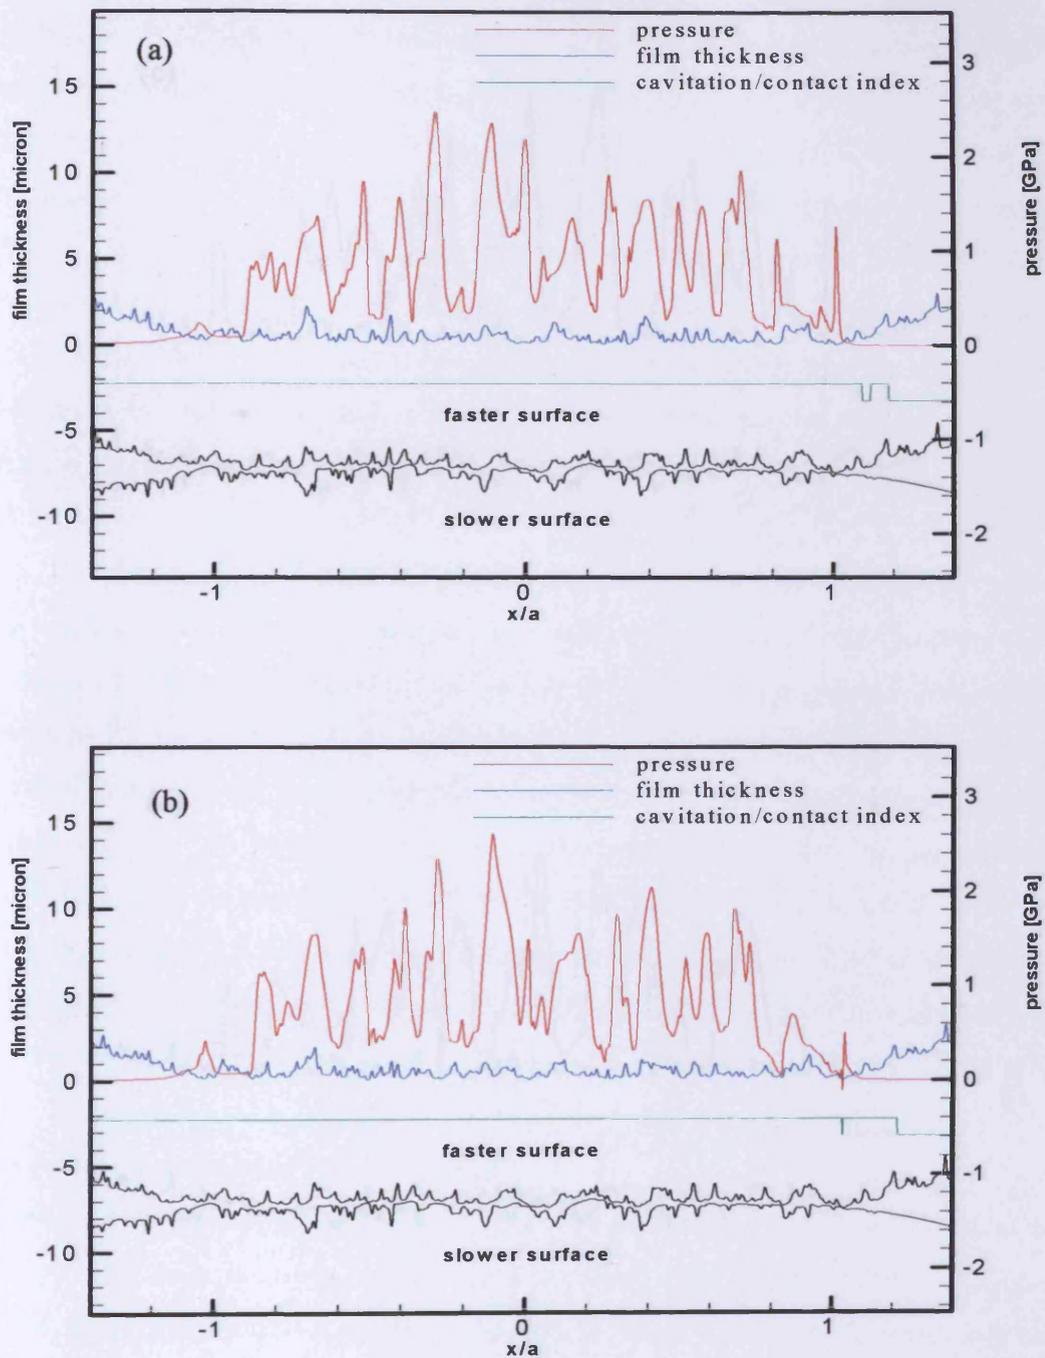
Figure 5.4. Pressure and film thickness from the analysis of contact between rough profiles from test UTRC07 at two different time steps (a) 25 time steps and (b) 50 time steps. Speed = 12 m/s; load = 1.7 GPa; temperature = 100°C.

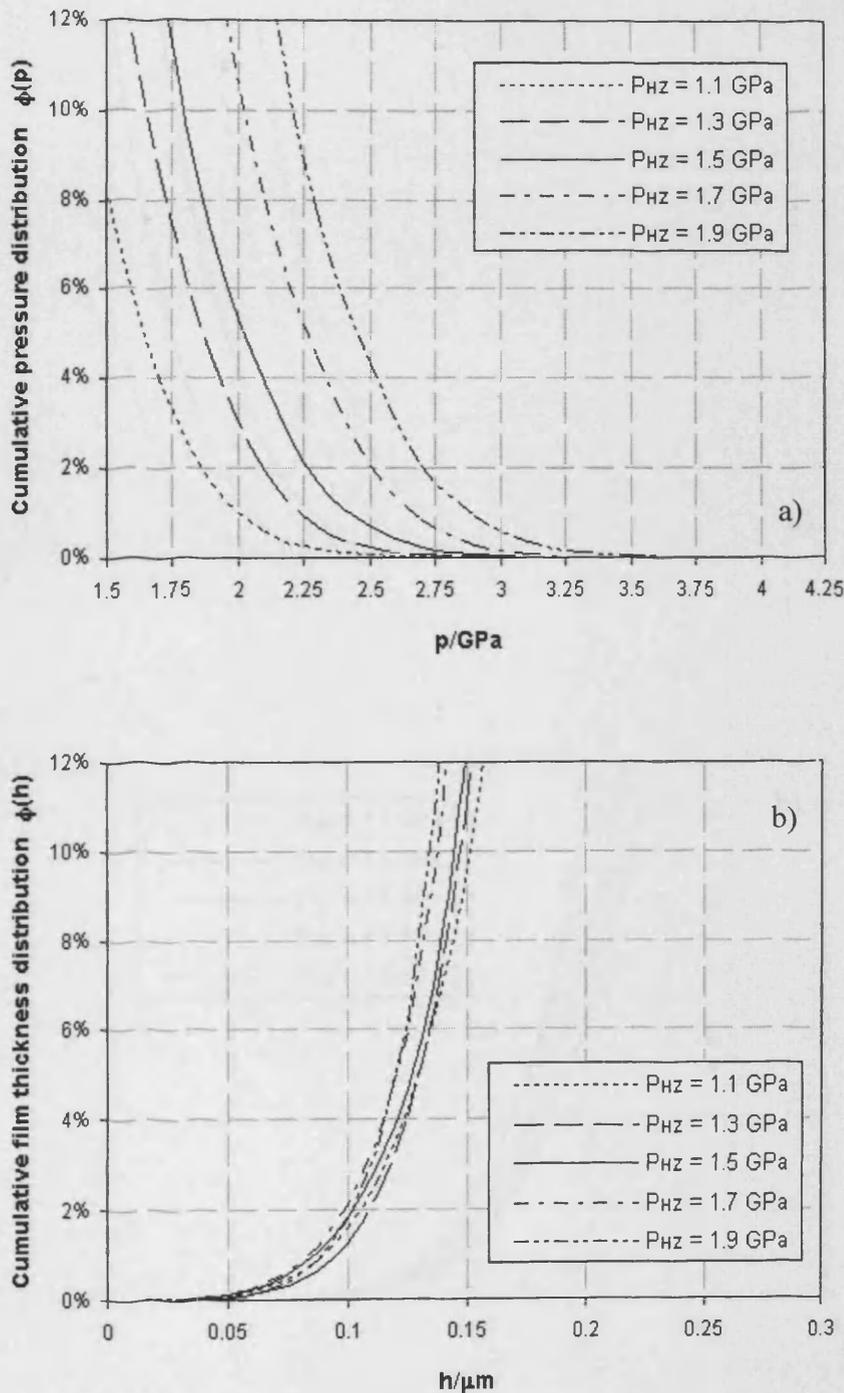
Figure 5.5. Part of cumulative pressure distribution (a) and cumulative film thickness distribution (b) over Hertzian area from EHL simulation of test UTRC01 at 7 m/s for varying loads.

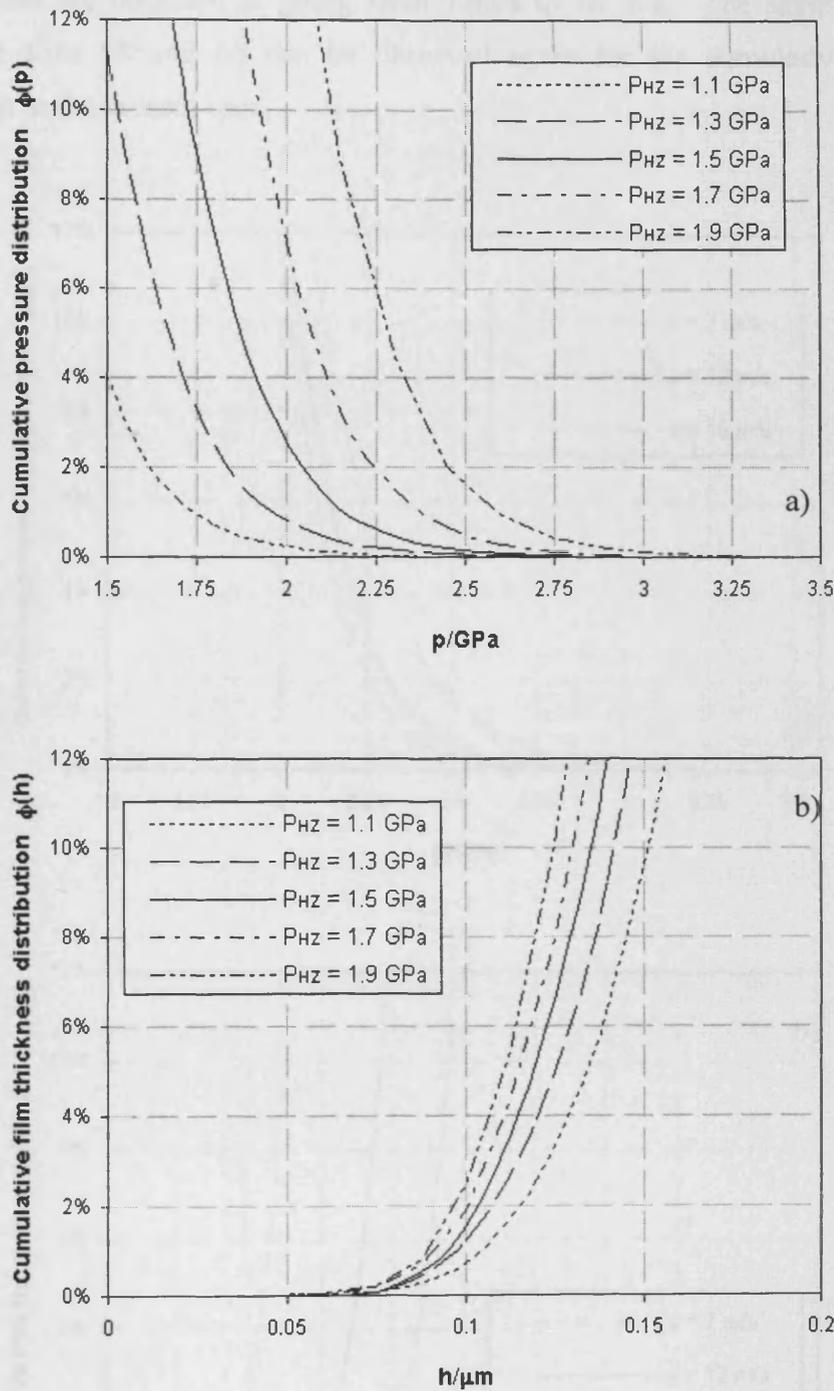
Figure 5.13. Part of cumulative pressure distribution (a) and cumulative film thickness distribution (b) over Hertzian area from EHL simulation of test UTRC27 at 7 m/s for varying loads.

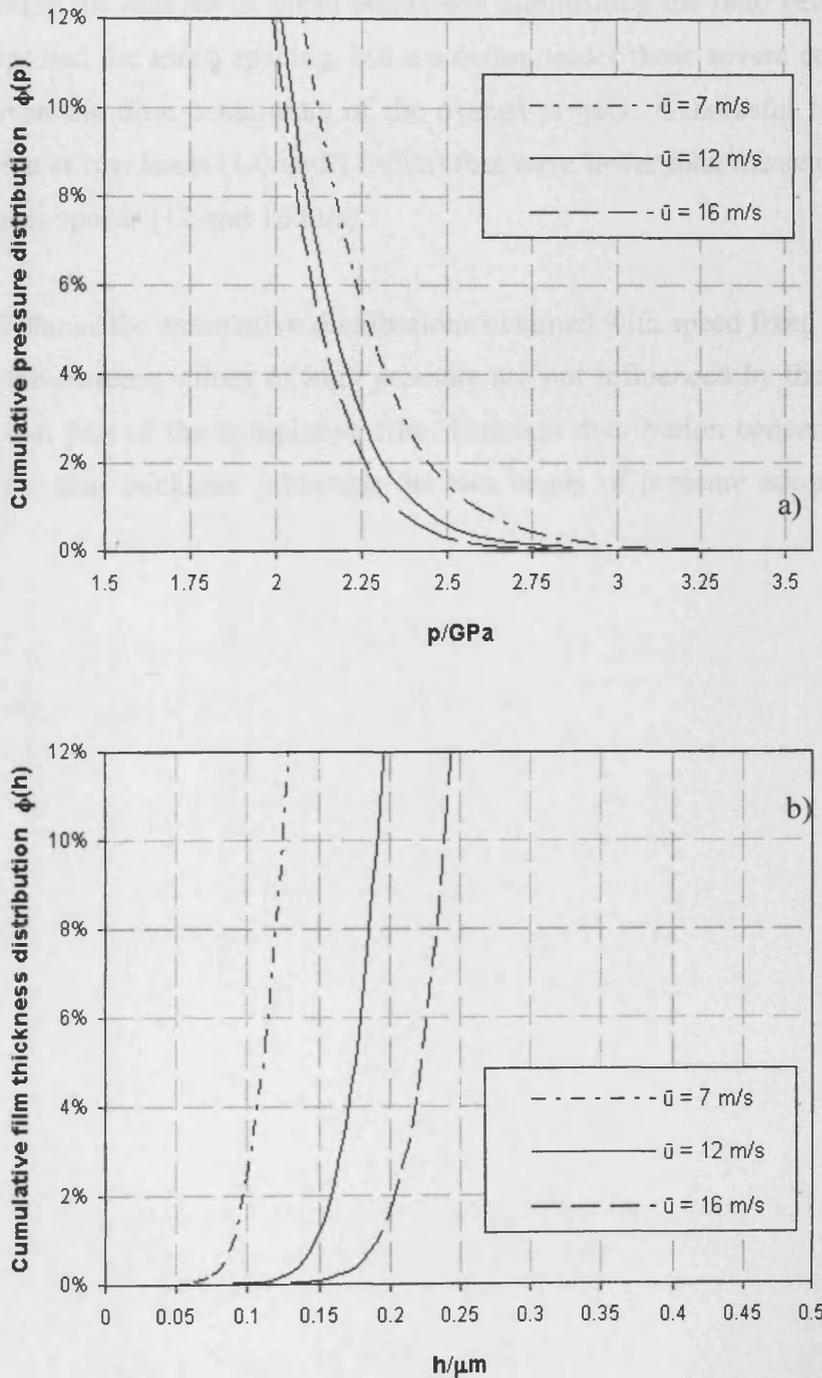
Figure 5.14. Variation with entrainment velocity of cumulative pressure distribution (a) and cumulative film thickness distribution (b) for test UTRC27 at a load corresponding to $P_{Hz} = 1.9$ GPa.
