EFFECT OF SURFACE FINISH AND HARD COATINGS ON SCUFFING OF STEEL DISCS

Thesis submitted in candidature
for the degree of
Doctor of Philosophy at Cardiff University

Institute of Theoretical, Applied and Computational Mechanics
Cardiff School of Engineering
Cardiff University

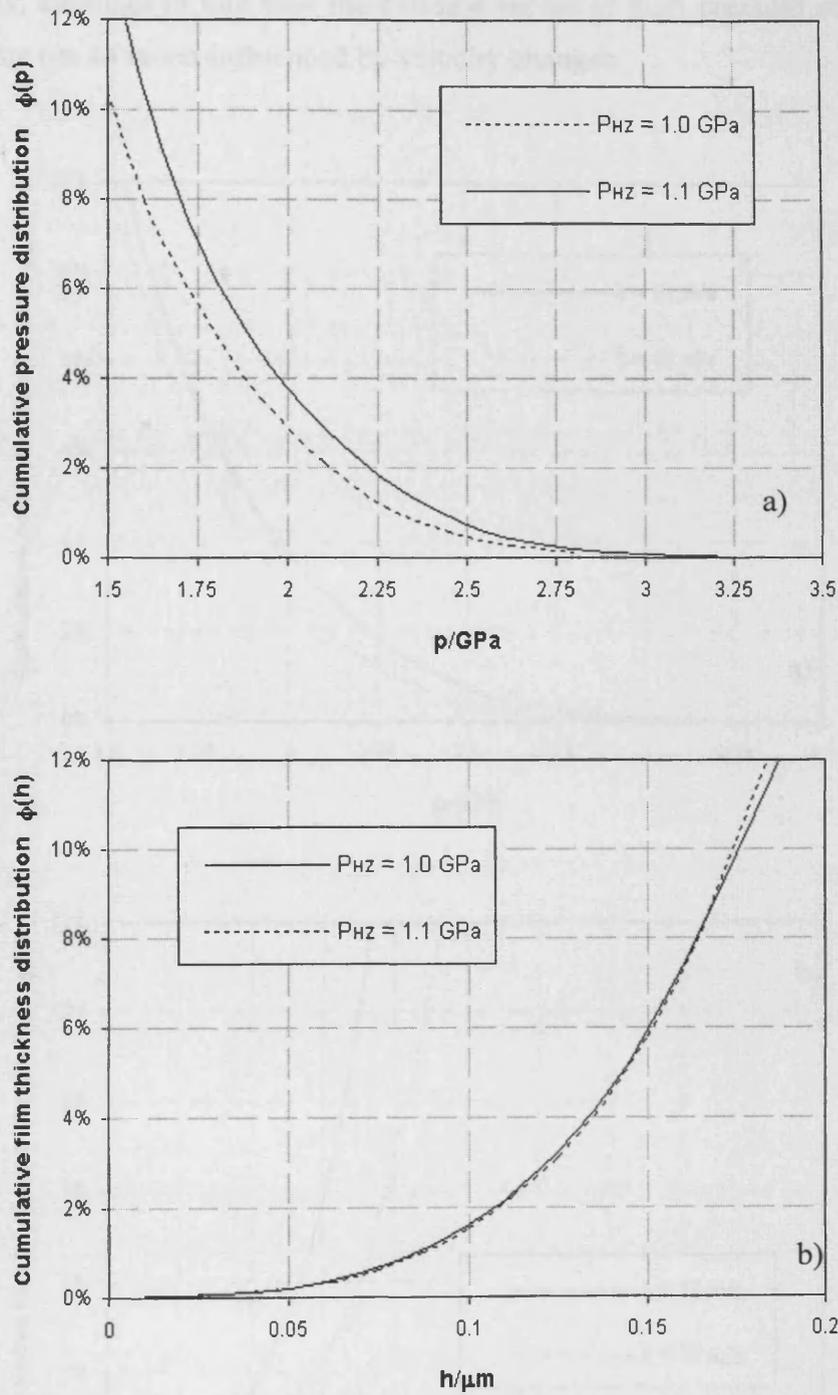
Figure 5.15. Part of cumulative pressure distribution (a) and cumulative film thickness distribution (b) for test UTRC07 at 12 m/s at two (light) loads.

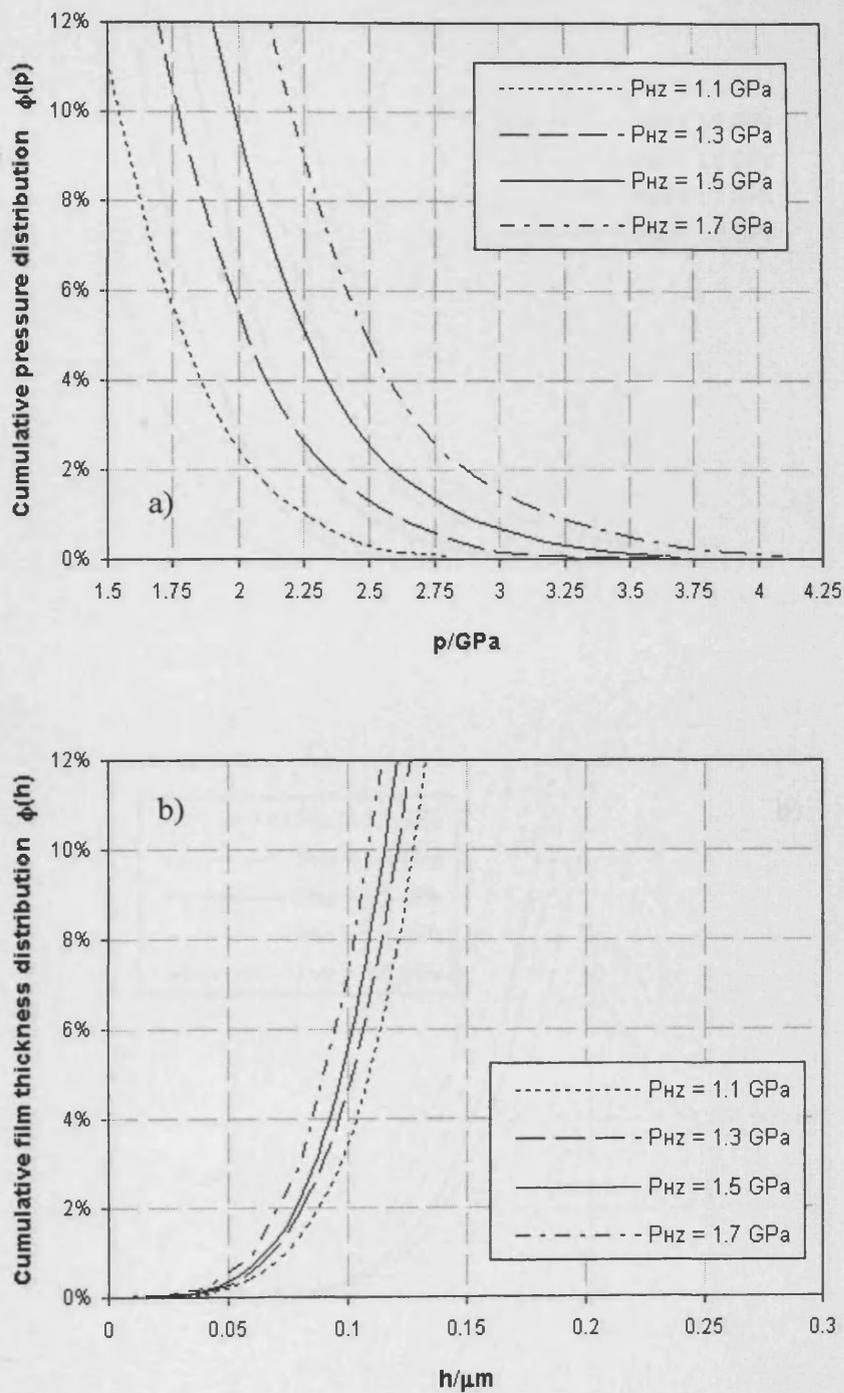
Figure 5.17. Part of cumulative pressure distribution (a) and cumulative film thickness distribution (b) from simulation of test UTRC01 with rougher profile on slower shaft at 7 m/s for varying loads.

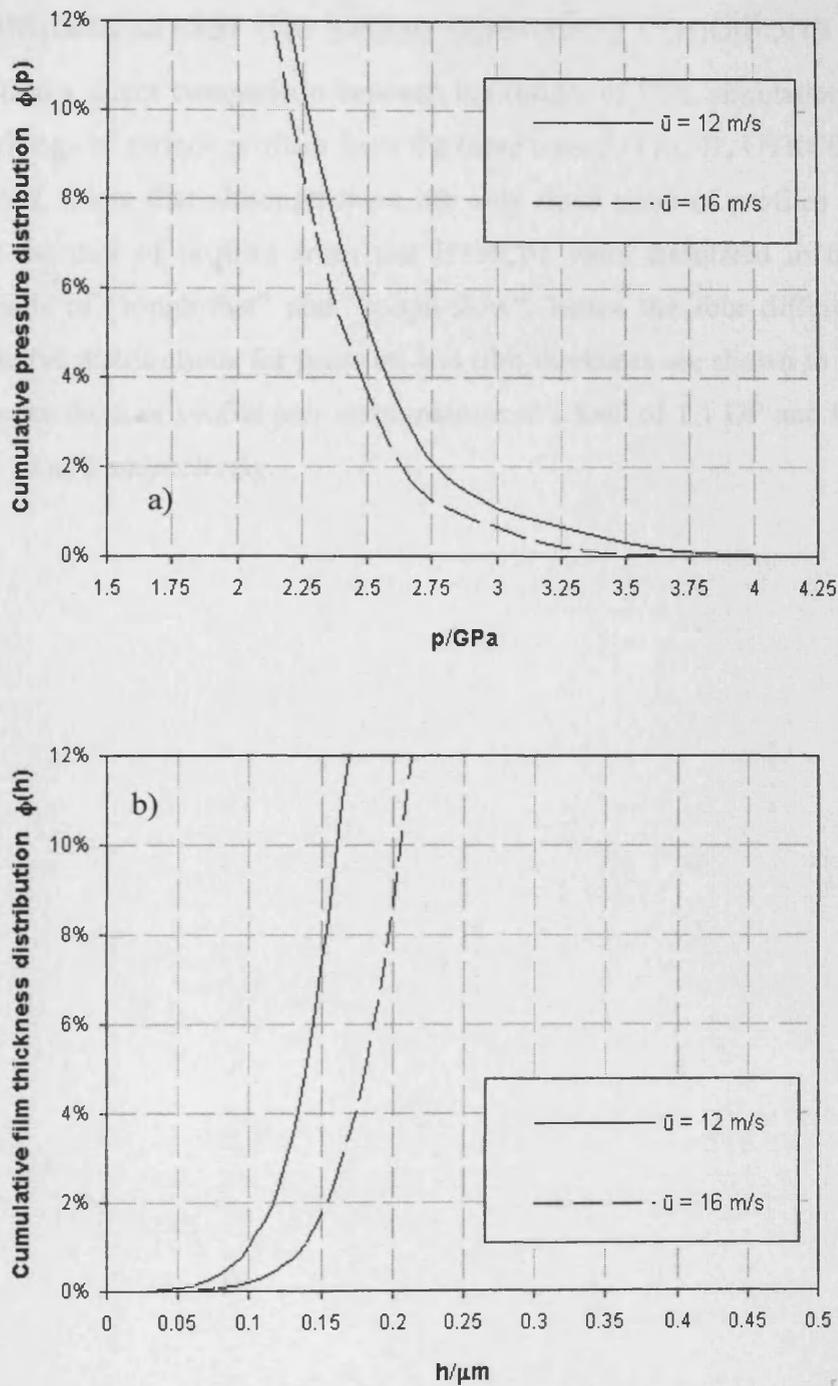
Figure 5.24. Variation with entrainment velocity of cumulative pressure distribution (a) and cumulative film thickness distribution (b) for disc 93 (fast shaft) and disc 66 (slow shaft) at load $P_{Hz} = 1.9$ GPa.

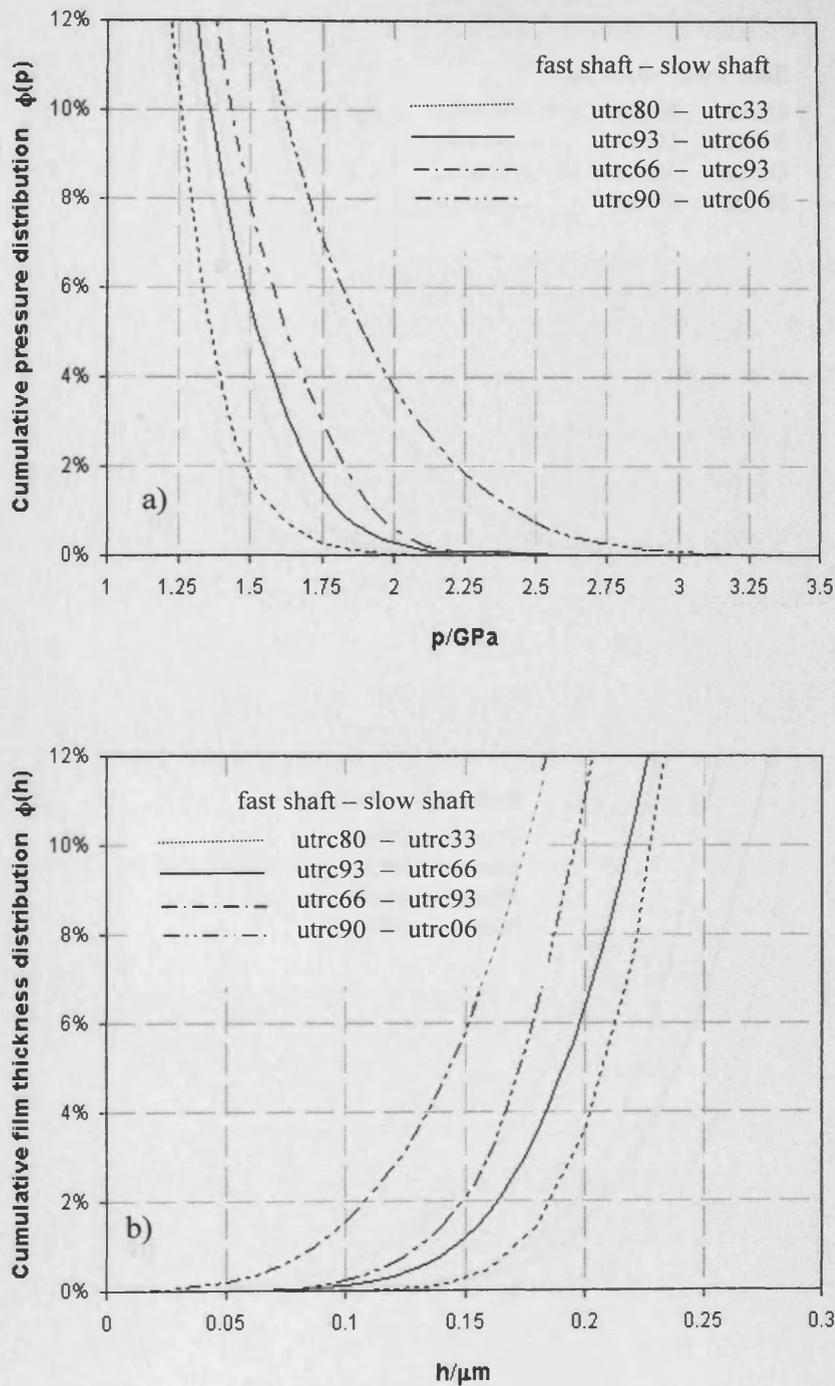
Figure 5.25. Part of cumulative pressure distribution (a) and cumulative film thickness distribution (b) for all four combinations of disc profiles at 12 m/s and $P_{Hz} = 1.1$ GPa.

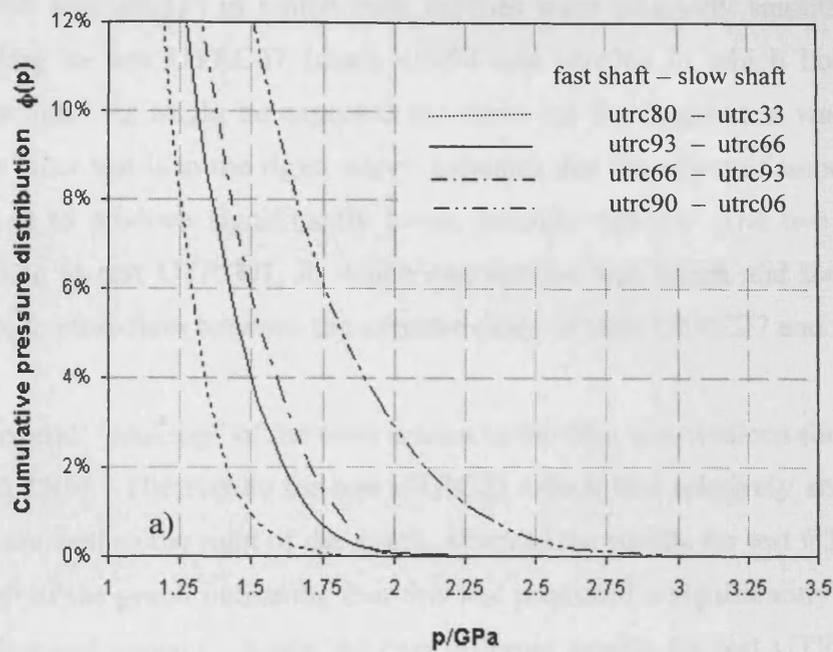
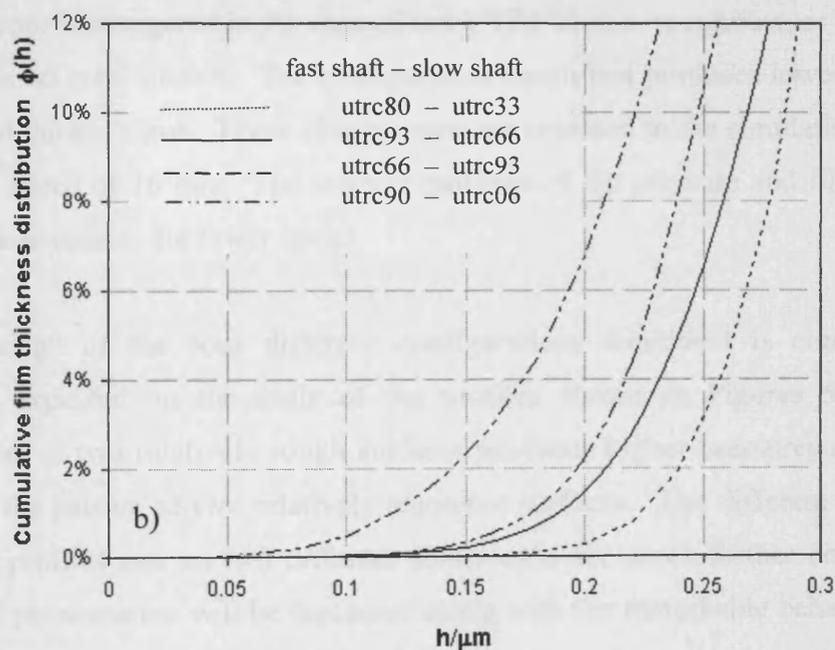
Figure 5.26. Part of cumulative pressure distribution (a) and cumulative film thickness distribution (b) for all four combinations of disc profiles at 16 m/s and $P_{Hz} = 1.1$ GPa.

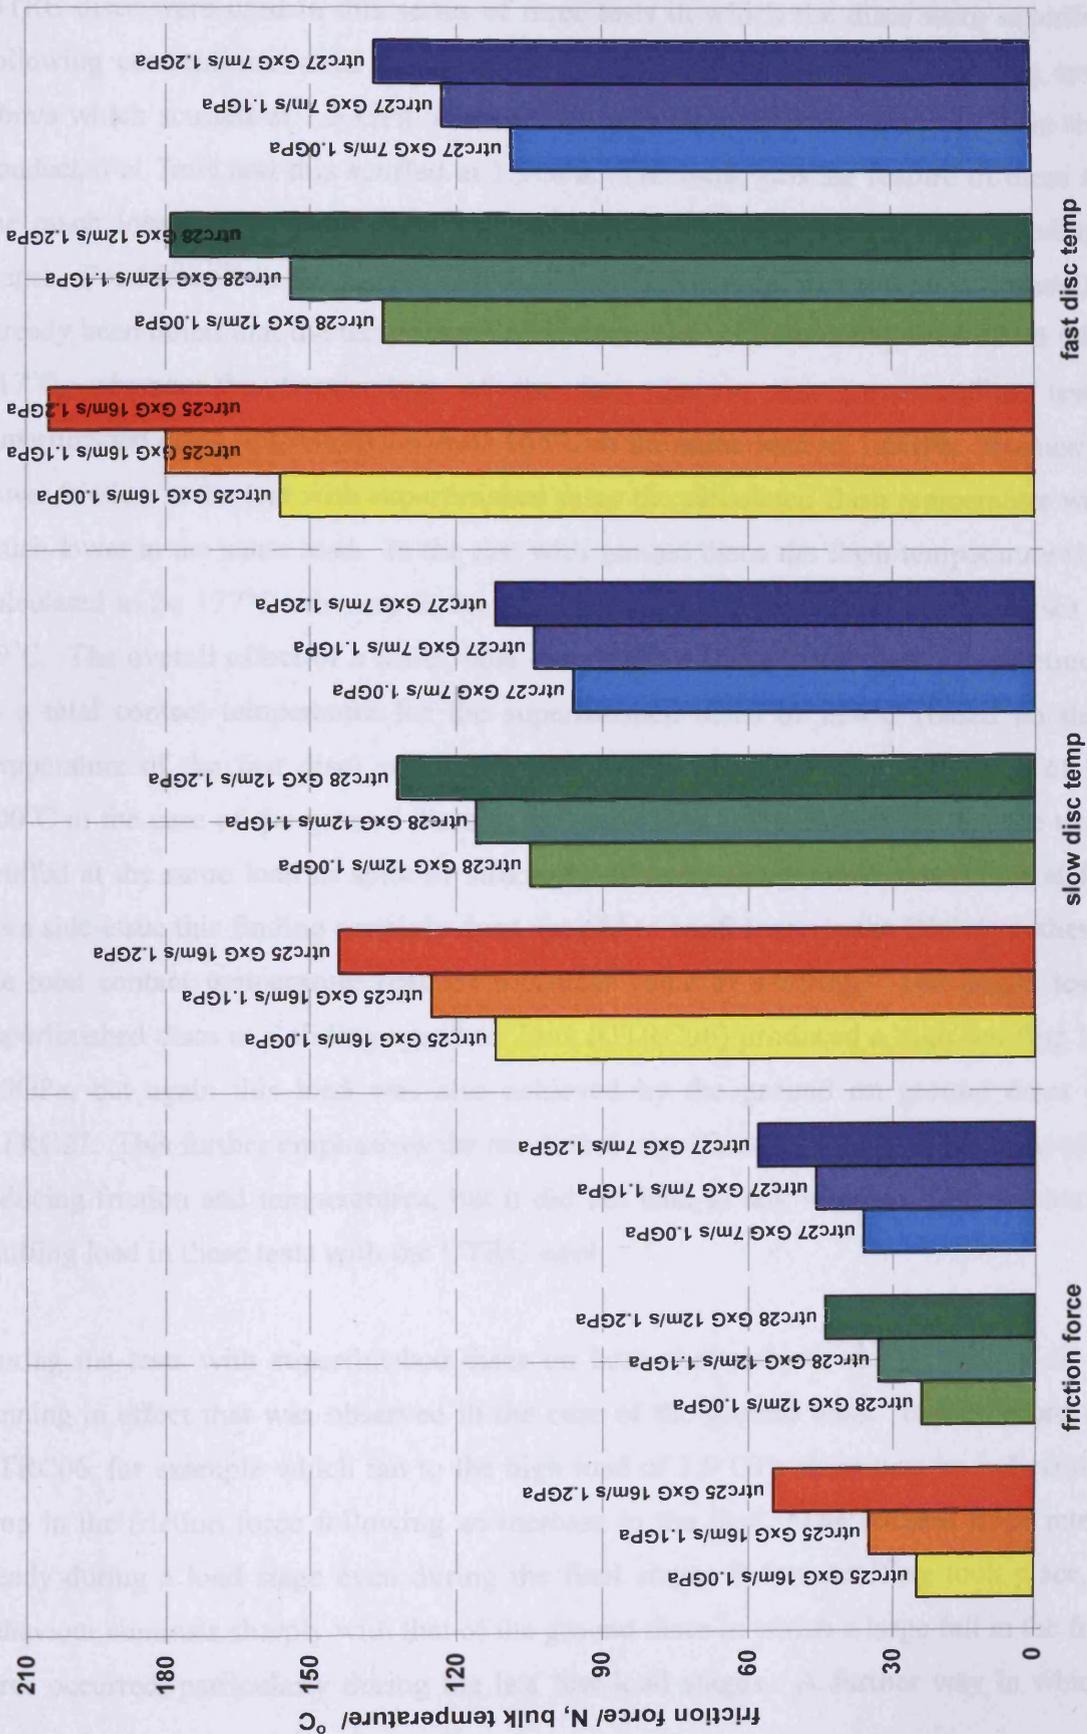
Figure 6.1. Comparison of friction force and disc temperatures at three loads and the three sliding speeds of 16m/s, 12m/s and 7m/s for experiments with ground discs running on ground discs at conditions prior to scuffing.

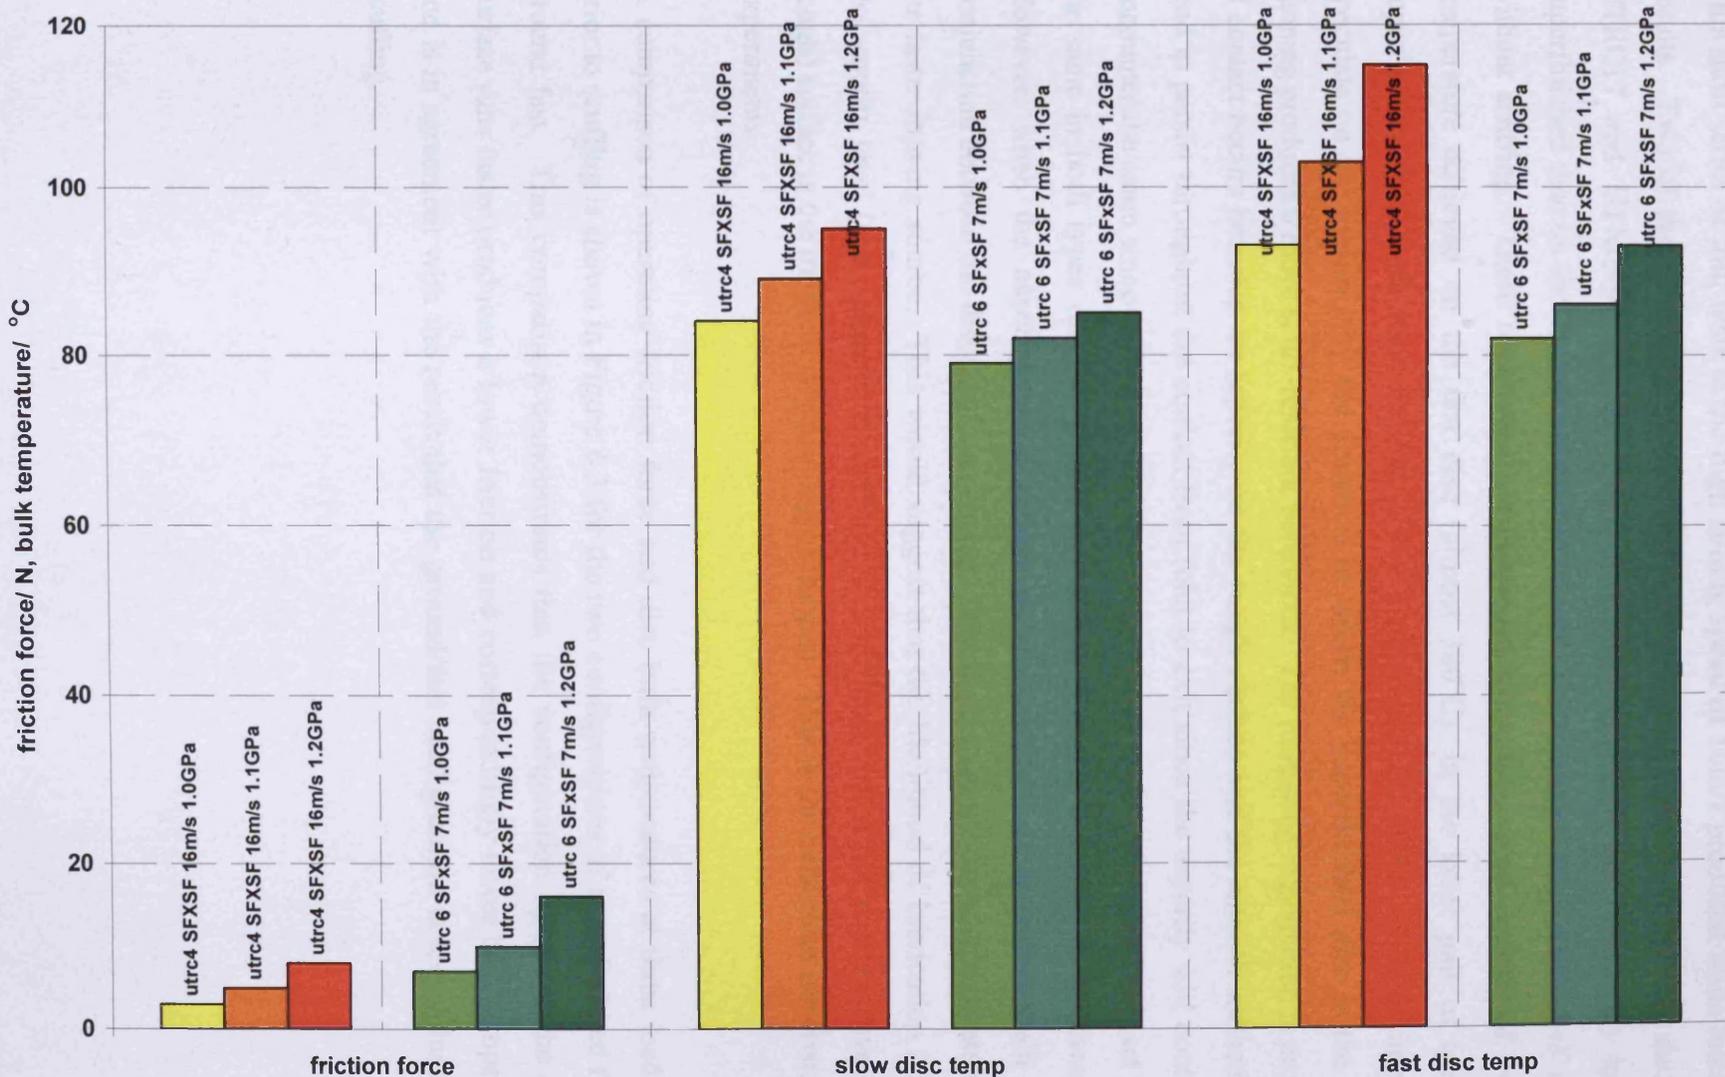
Figure 6.2. Comparison of friction force and disc temperatures at three loads and two sliding speeds of 16m/s, and 7m/s for experiments with superfinished discs running on both shafts at conditions prior to scuffing.

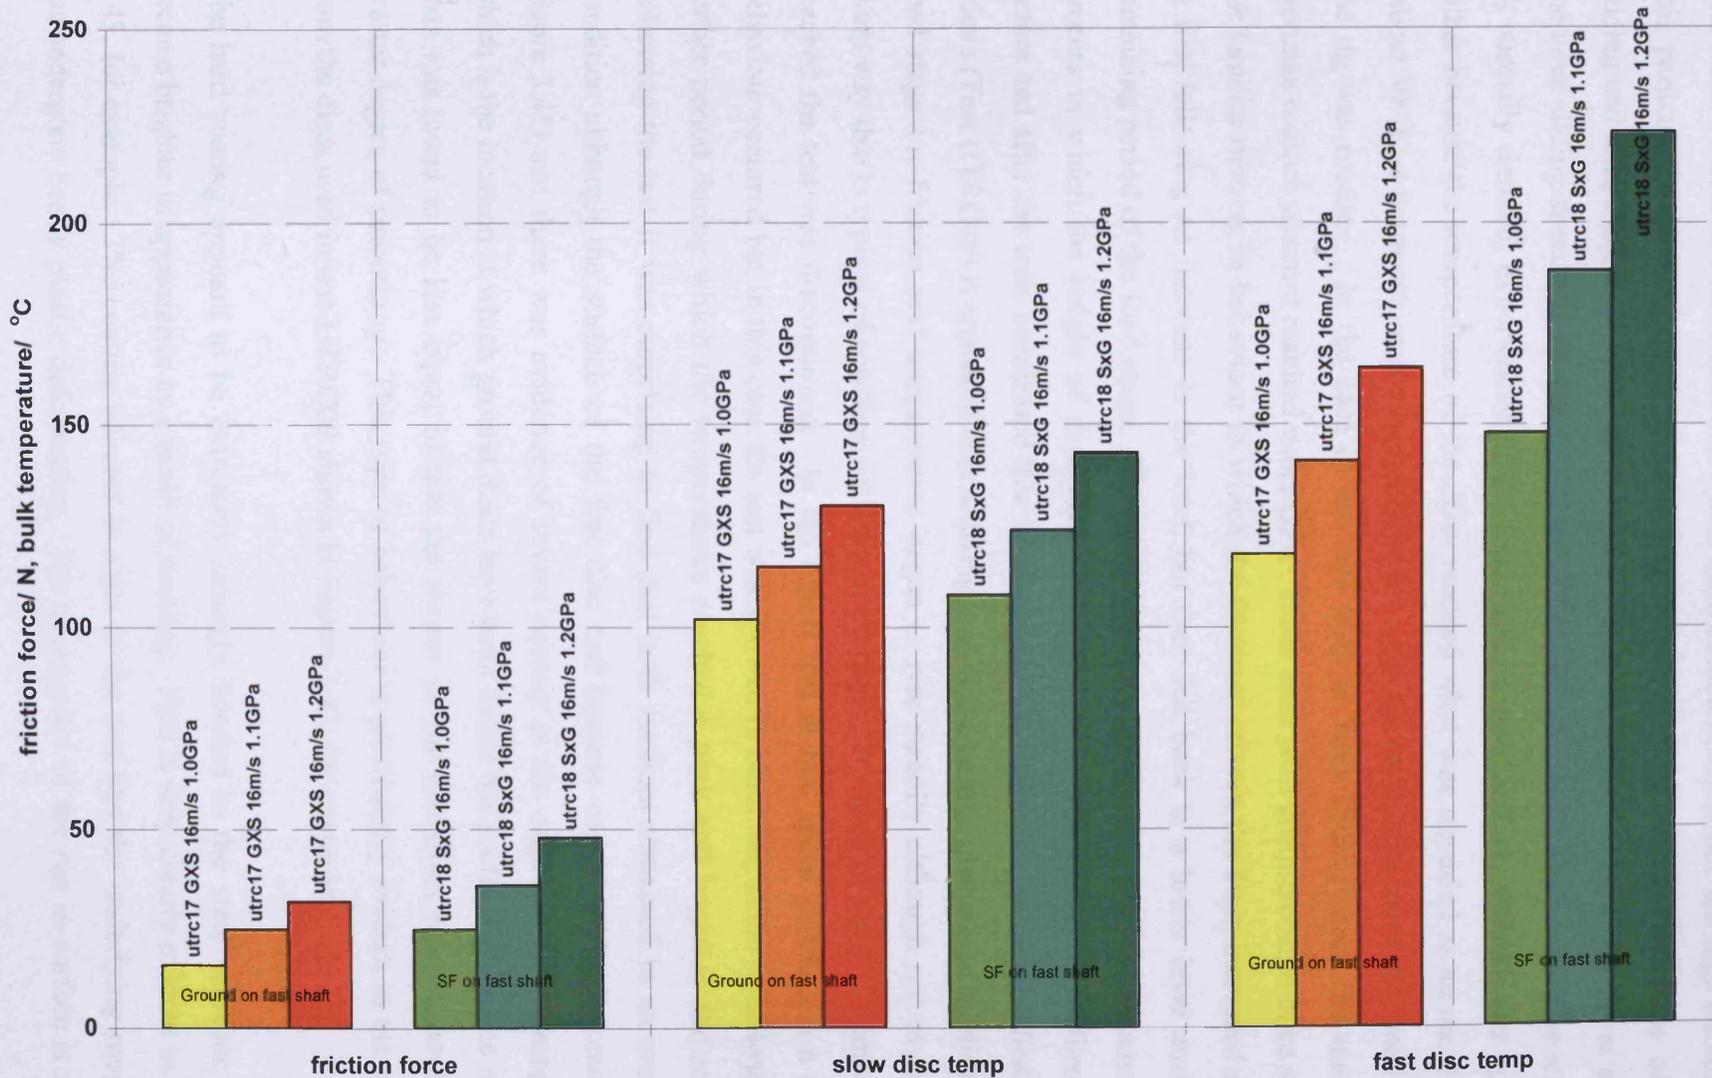
Figure 6.3. Comparison of friction force and disc temperatures at three loads and sliding speeds of 16m/s for experiments with ground discs running on superfinished discs at conditions below the scuffing load.

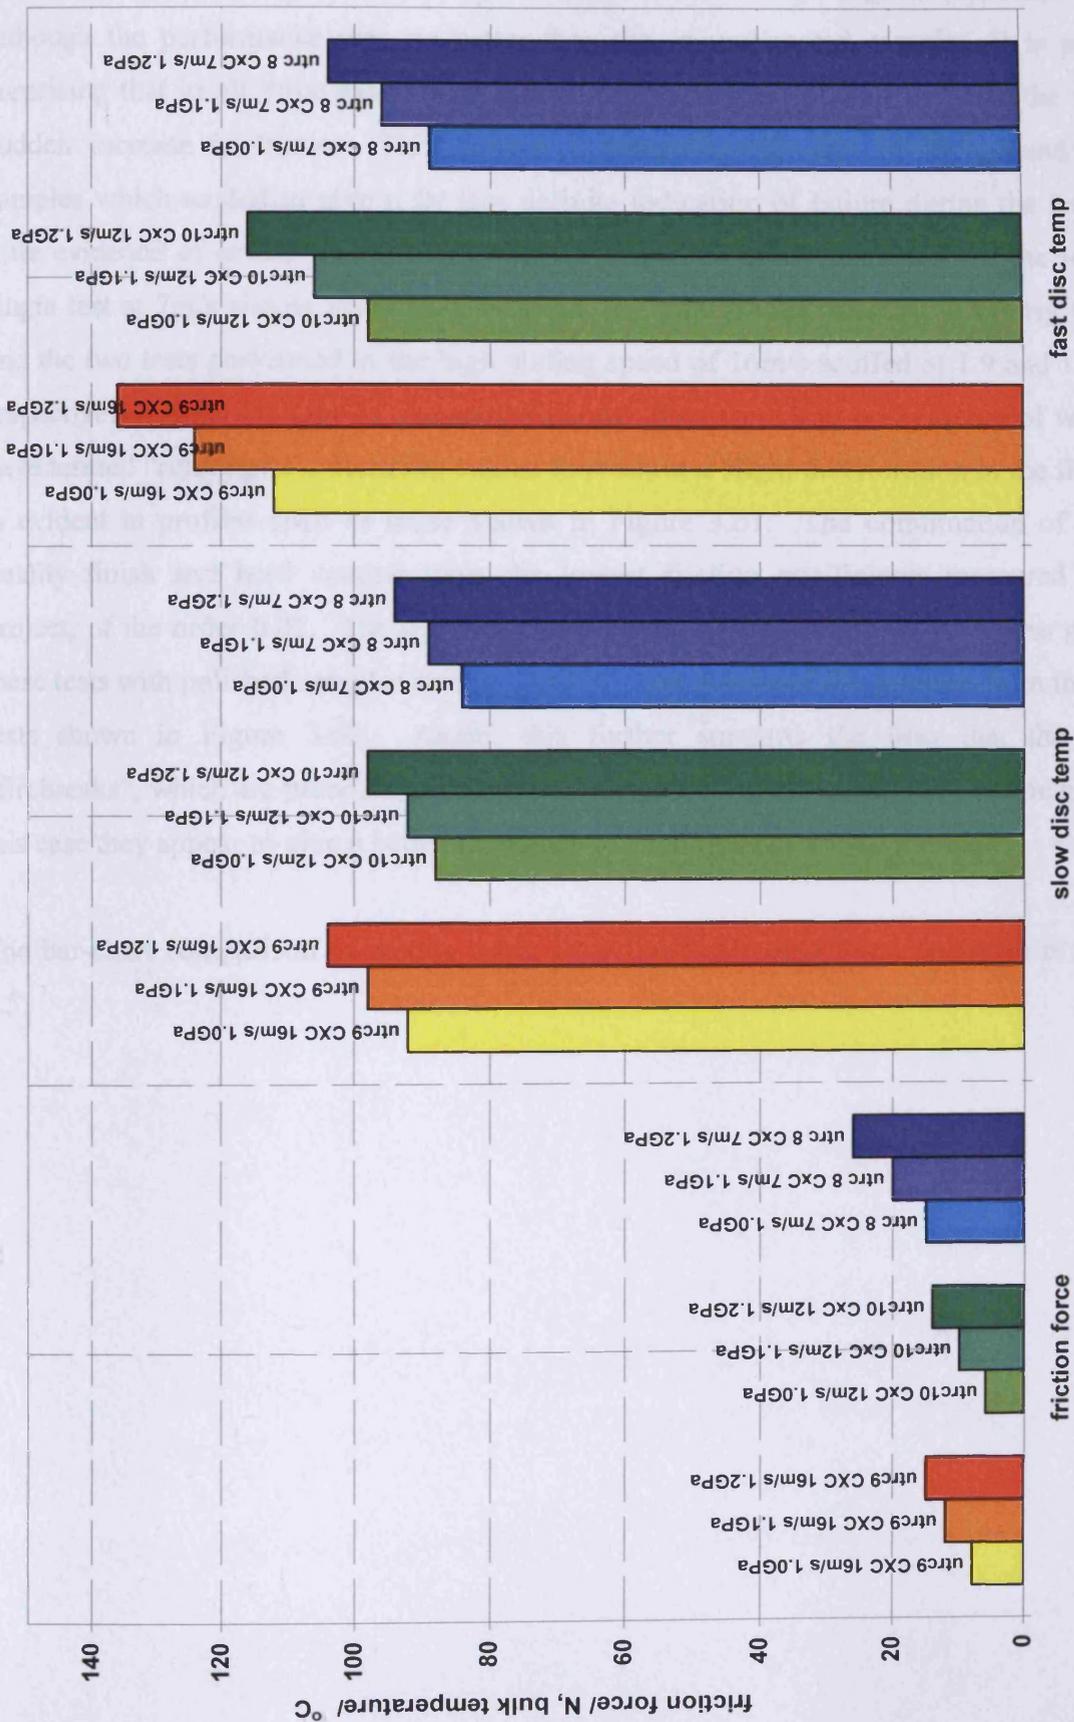
Figure 6.4. Comparison of friction force and disc temperatures at three loads and the three sliding speeds of 16m/s, 12m/s and 7m/s for experiments with ground/coated discs running on both the shafts.

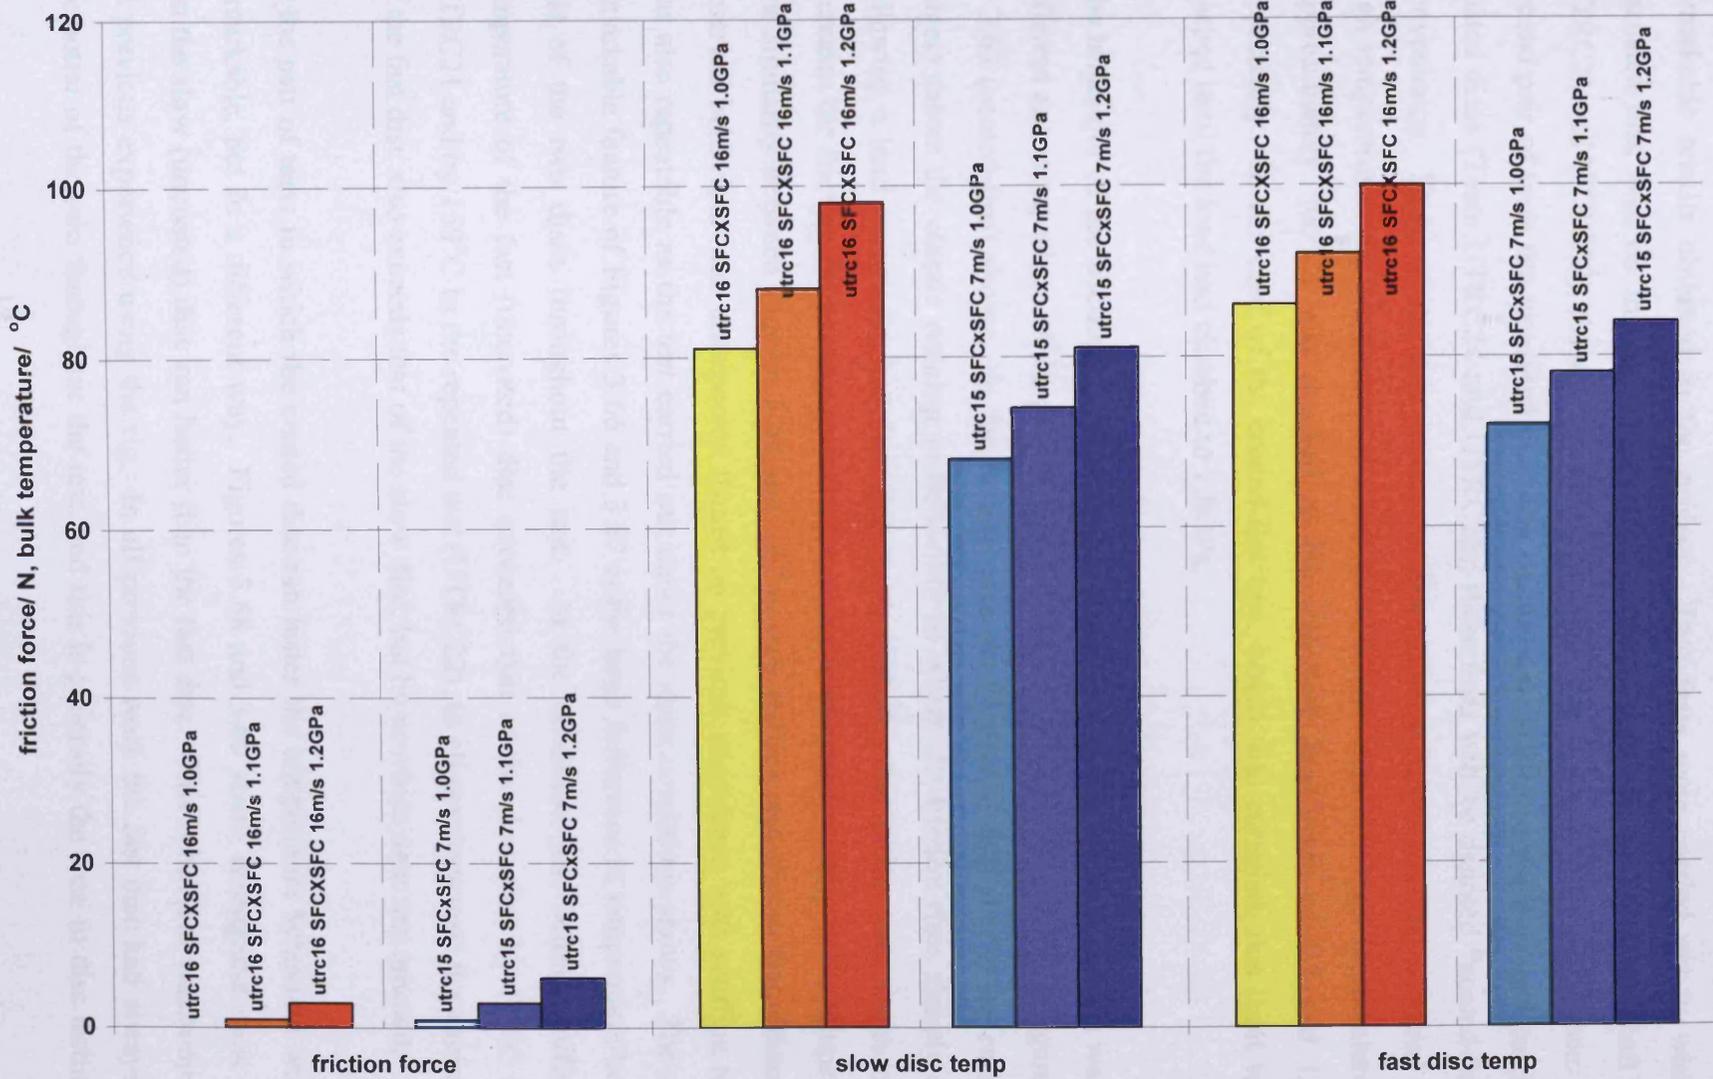
Figure 6.5. Comparison of friction force and disc temperatures at three loads and two sliding speeds of 16m/s, and 7m/s for experiments with superfinished/coated discs running on both shafts.

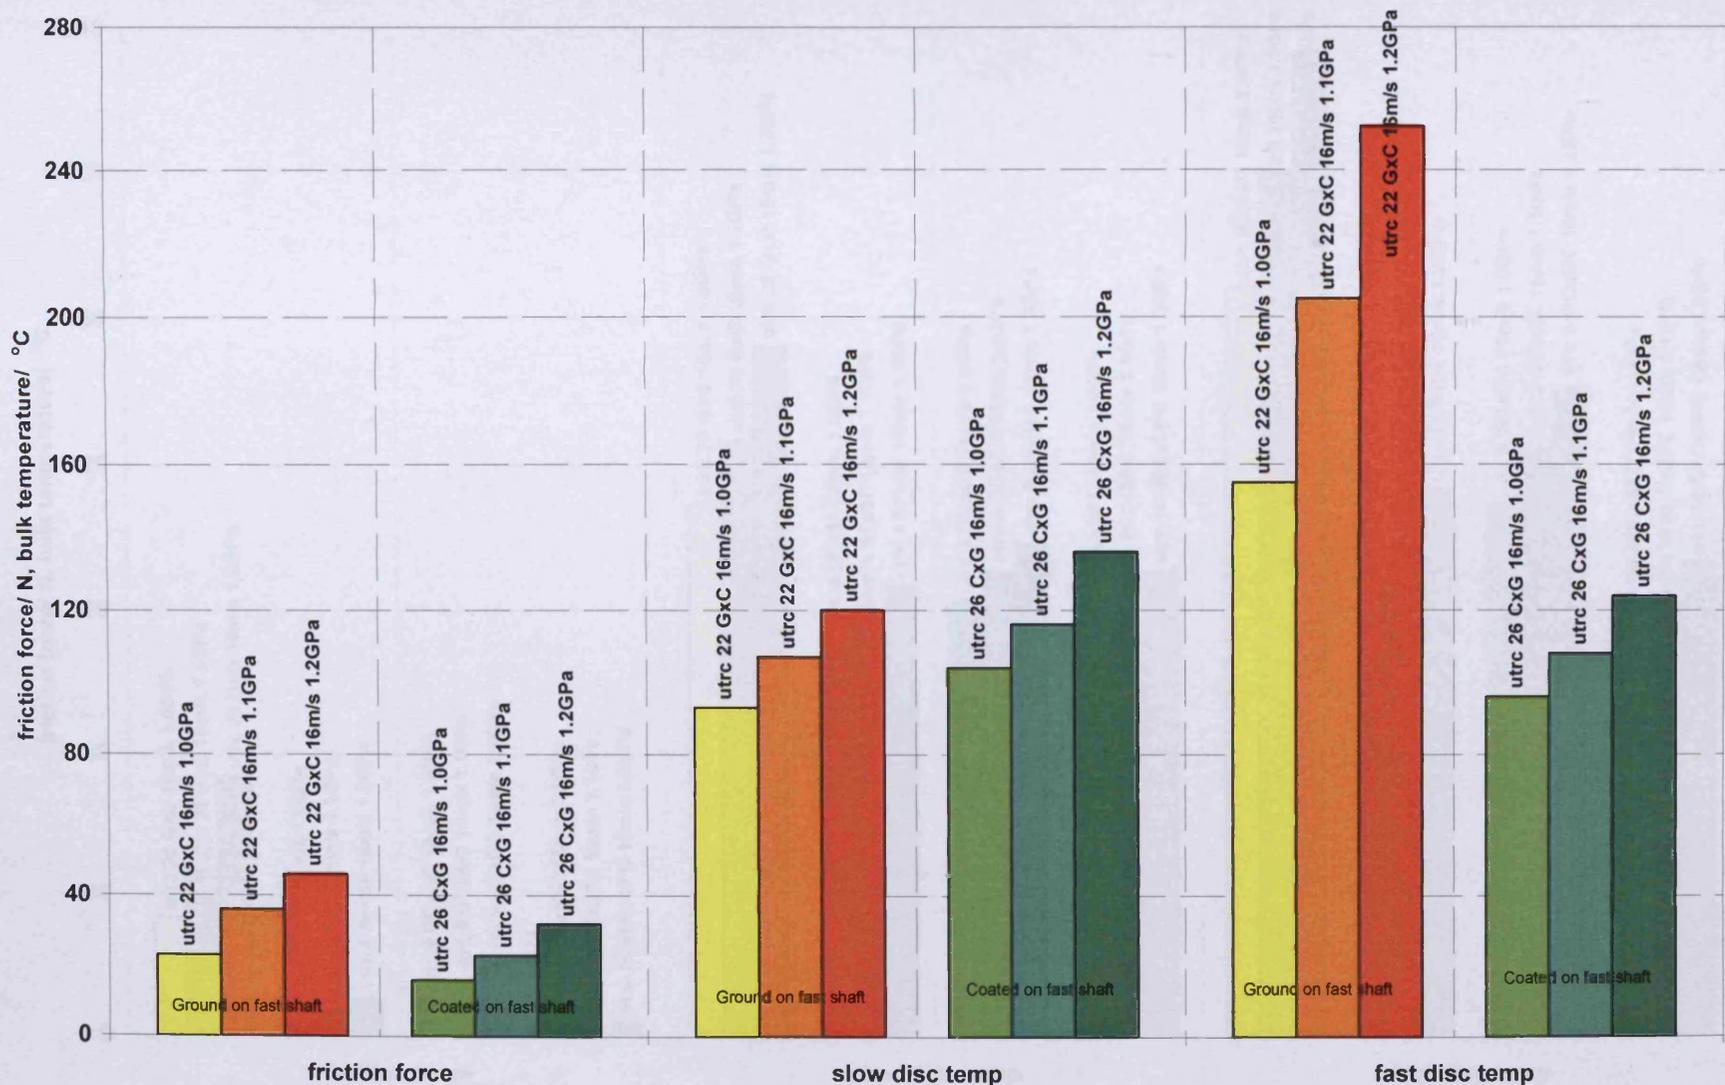
Figure 6.6. Comparison of friction force and disc temperatures at three loads and sliding speeds of 16m/s for experiments with ground/coated discs running against ground/uncoated discs in the two different configuration of coated-fast and coated-slow.
