# Barely visible impact damage detection in a composite turbine blade using 3D Scanning Laser Vibrometry

R. Marks<sup>1</sup>, C. Gillam<sup>1</sup>, A. Clarke<sup>1</sup>, R. Pullin<sup>1</sup>  
Cardiff School of Engineering, Cardiff University, UK

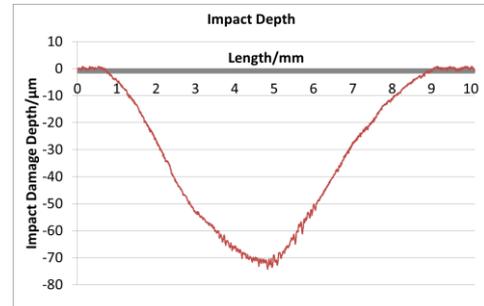
Figure 3: Surface profile measurement of the resulting BVID after the impact damage

The results from the 2D surface profile measurement presented in Figure 3 show that induced impact caused BVID of 73µm deep. BVID is typically classified as impact damage that causes an indentation in the region of 0.25-0.5mm. This impact damage therefore is substantially shallower than what is normally considered as BVID.

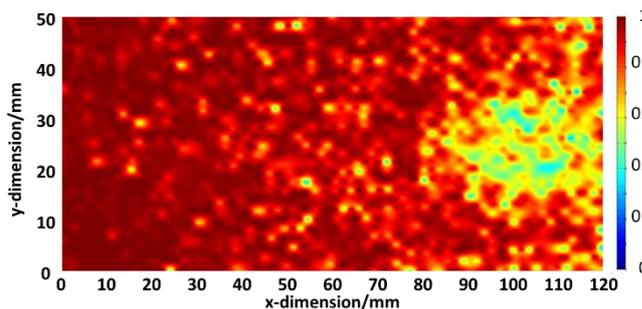
Figure 5: 200kHz Out-of-plane cross correlation plot. Note the low correlation in the region around the impact area

As the measurement points for both scans were in nominally identical places it was possible to make a direct comparison of the measured waves. A cross-correlation technique was used to compare the similarity of the measured waveforms at each point. It was then possible to plot a graphical representation of these cross-correlation values giving visual identification to the location of the damage. The out-of-plane cross-correlation plot for the 200kHz measurements is shown in Figure 5. Identifying the region of low correlation enables the damage to be located as well as highlighting a suitable region for the placement of a sensing transducer.

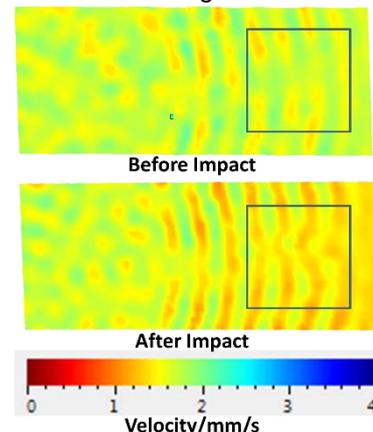
Figure 4: 3D velocity result plots of the turbine blade before and after impact when excited at 100kHz

The results plots presented in Figure 4 show the 3D measurement plots of the 100kHz Lamb wave from the vibrometer before and after impact. Comparing the two plots, the induced lamb wave clearly interacts with the damage causing a change to the shape of the wave front.
