# Experimental and Numerical Study of Micropitting Initiation in Real Rough Surfaces in a Micro-elastohydrodynamic Lubrication Regime

M. F. AL-Mayali<sup>1</sup> · S. Hutt<sup>2</sup> · K. J. Sharif<sup>2</sup> · A. Clarke<sup>2</sup>

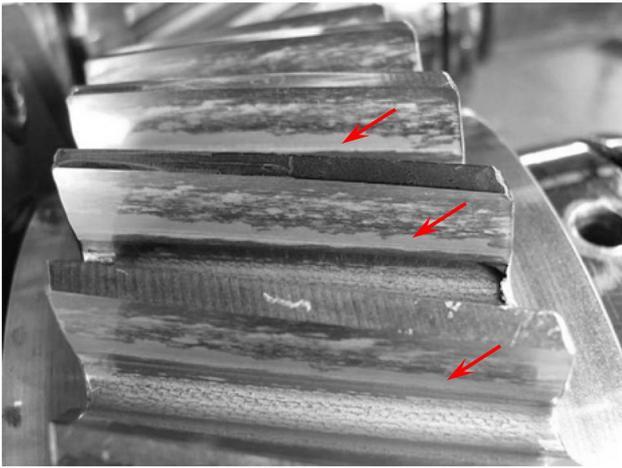
**Fig. 1** A helical gear with micropitting visible as a matted region on the dedendum of the teeth (arrowed), from [5]

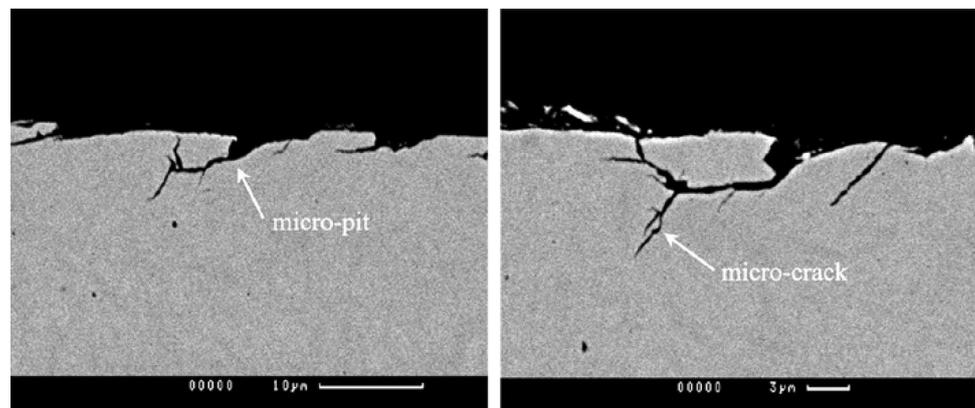
**Fig. 2** Sections through micropits showing crack growth, from [5]

deformation due to the running in process [8, 9]. Micropits are typically 10–30  $\mu\text{m}$  in diameter and can be up to 10  $\mu\text{m}$  deep, as can be seen in the fatigue damaged metallurgical sections of the gear surface teeth in Fig. 2. In the current paper, the observed micropits are shallower and about 2  $\mu\text{m}$  deep. This observation is compatible with Fig. 2, where the region of the micropits measurable by stylus profilometry are around 2–3  $\mu\text{m}$  deep. These cracks occur at the tips of the asperities and extend at a shallow angle (typically 10–30°) to the surface, opposite to the direction in which sliding frictional traction acts on the surface [7, 9].

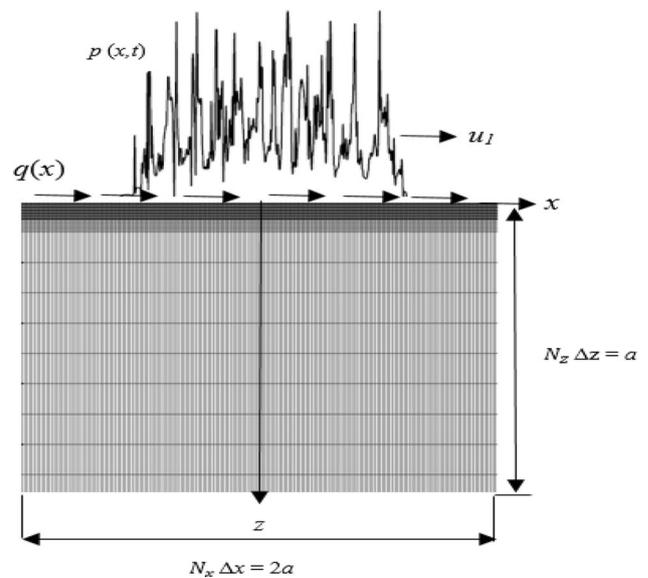
Fig. 3 Schematic illustration of the computational domain and grid mesh used

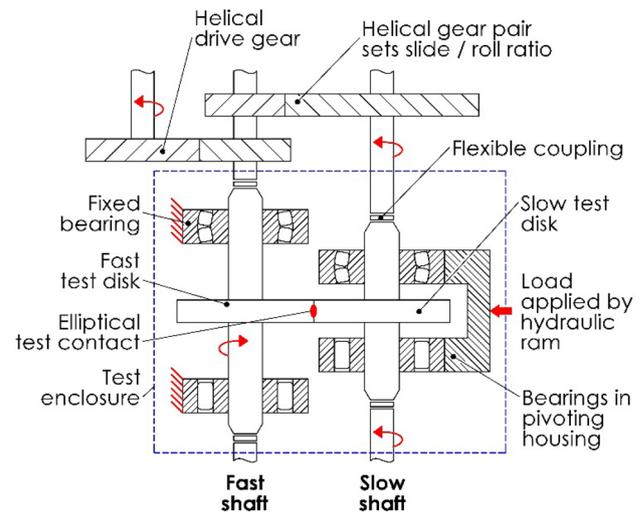
**Fig. 4** Schematic of the main components of the twin disk rig

Figure 4 shows a schematic of the main components of the rig, which is described in detail in [8, 30]. The test contact is made between two geometrically identical disks driven by a helical gear pair, the ratio of which determines the slide / roll ratio (SRR) of the contact. A constant SRR, as generated by this rig, differs from that of meshing gear teeth, where it varies over the tooth contact cycle; however, it significantly reduces the complexity of the measurement and analysis techniques required to study the contact.

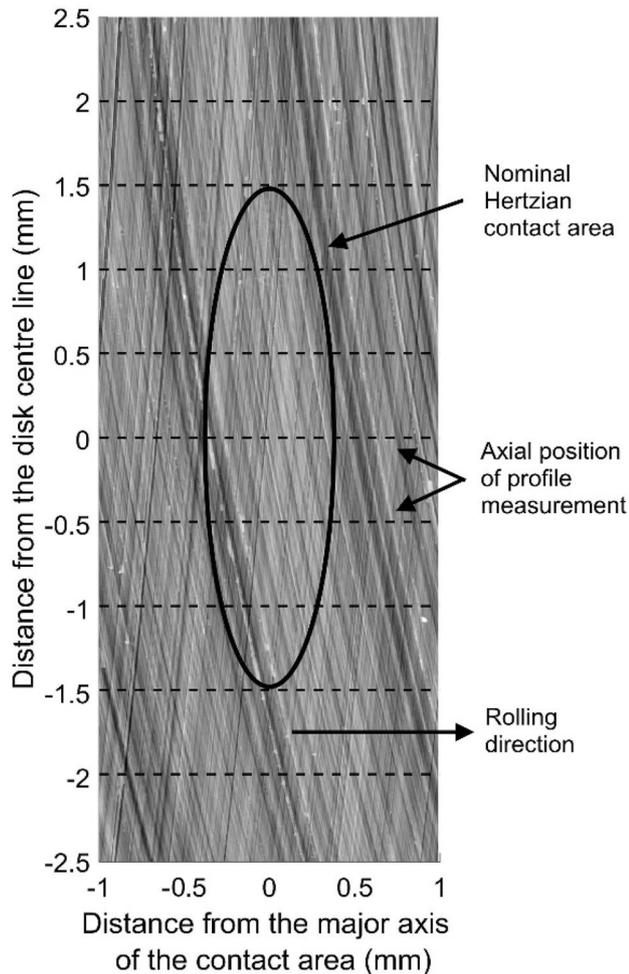
**Fig. 5** Composite surface roughness of the disks prior to testing, valleys are dark, peaks are light. Also shown are the nominal Hertzian contact area for the test load and the axial positions of the profile measurements

Three dimensional surface height measurements of the disks used in this paper were taken before and after testing using a Taylor Hobson profilometer. Figure 5 shows their pre-test composite (sum) roughness as orientated in the contact. It can be seen that grinding process produces a roughness profile that is ‘extruded’ across the disk width along a slightly curved path. The disks were orientated in the rig such that the resulting roughness features cross at a shallow angle producing a cross-hatched composite roughness which is a feature of the contact roughness of helical form ground gears [31]. The Vickers hardness and initial surface roughness of the disks used for this work were measured. Both disks had a surface hardness of 760 Hv, with initial  $R_q$  of 0.42  $\mu\text{m}$  for the fast disk and 0.48  $\mu\text{m}$  for the slow disk.

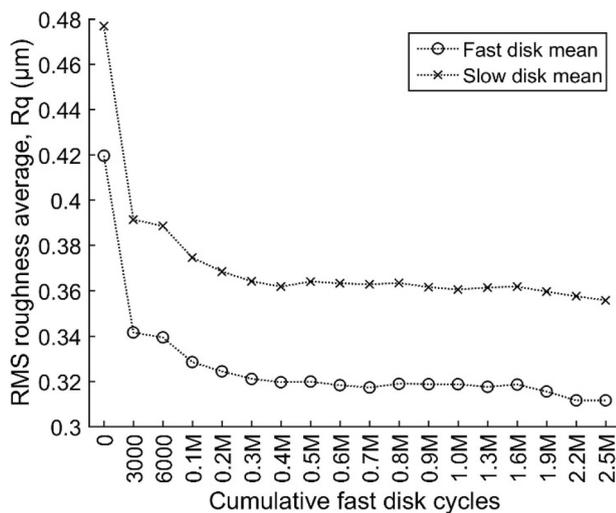
**Fig. 6** The RMS roughness,  $R_q$ , from the contact area of each disk versus the cumulative number of fast disk cycles. Each roughness value is calculated as the mean of the five profiles with axial positions within the contact (see Fig. 5)

Figure 6 shows points when the test was paused and roughness measurements were taken, in terms of cumulative

fast disk cycles. As expected, a relatively large decrease in the  $R_q$  roughness of both disks occurred within the first 3000 fast disk cycles due to running-in, in agreement with previous observations [8]. After this,  $R_q$  continued to decrease but at a much slower rate due to different wear mechanisms. For a large part of the experiment, the surfaces can be considered to be stable in terms of their geometry.

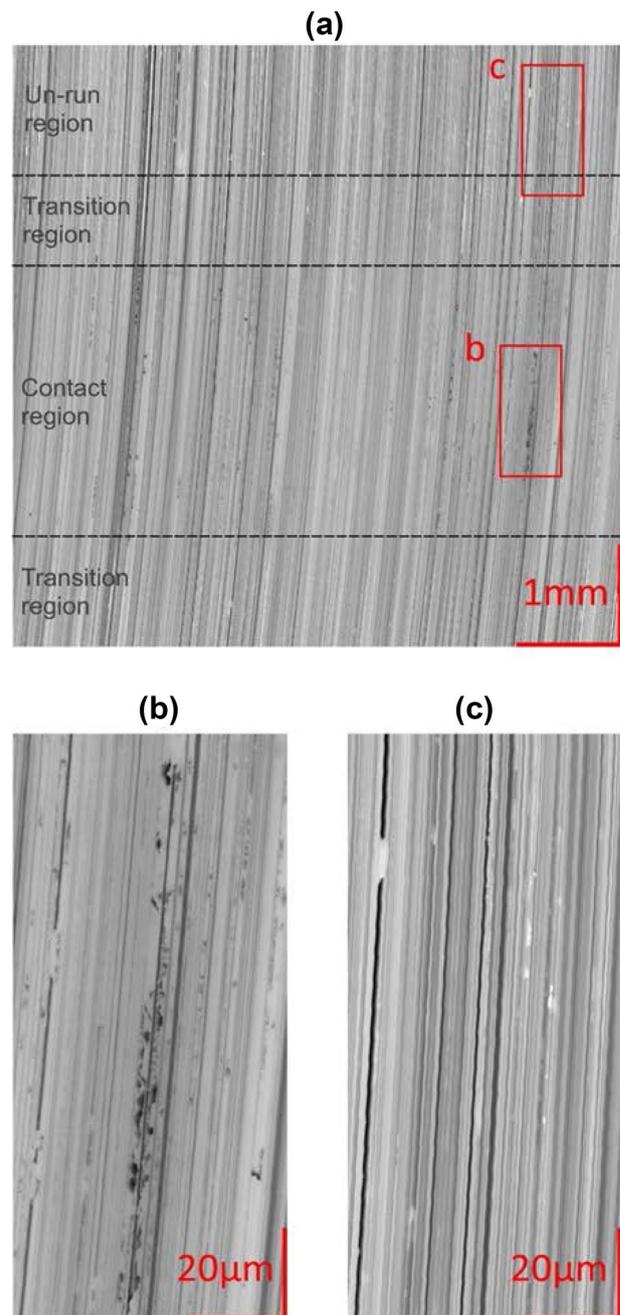
**Fig. 7** a 3D roughness measurement of the fast disk taken at the end of the test, valleys are dark, peaks are light. **b** Close-up of the wear track showing a prominent series of micro-pits, visible as dark speckles, aligned along a section of profile. **c** Close-up of the profile section outside of the contact area for comparison

Figure 7 shows the 3D roughness of the fast disk at the end of the test, after 2.5 million cycles. Micro-pits were found across the entire width of the contact area and tended to be clustered along the positions of previously prominent asperities. These observations are largely consistent with previous work [8]; however, since this experiment was designed specifically for comparison with numerical fatigue calculations, it was run under constant operating conditions to simplify comparisons, compared to the previous work where micropitting was the outcome of a complex series of tests under a wide range of operating conditions. Further discussion of the detailed evolution of surface profiles during the test may be found in the Fatigue Modelling section.

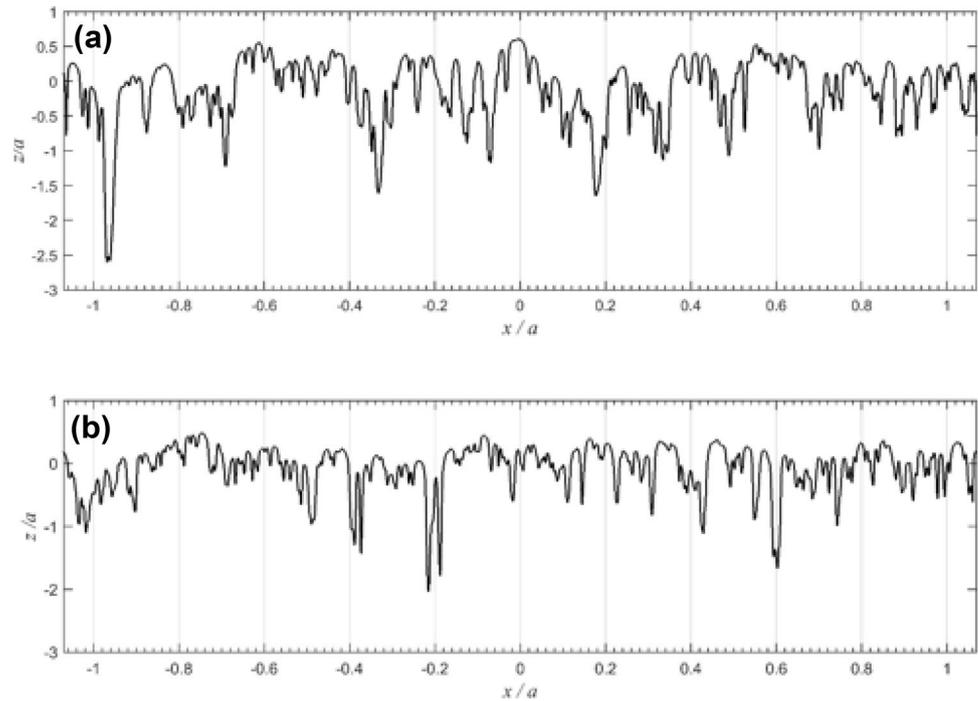
**Fig. 8** Roughness profile for **a** slow and **b** fast disks, with metal below the trace

The sections of disk profiles considered for this analysis are shown in Fig. 8. These were taken from the profiles measured following the initial running-in load stage, LS1, given that previous work [8] has shown that the majority of surface modification which affects micro-EHL behaviour occurs during the first few cycles of operation.

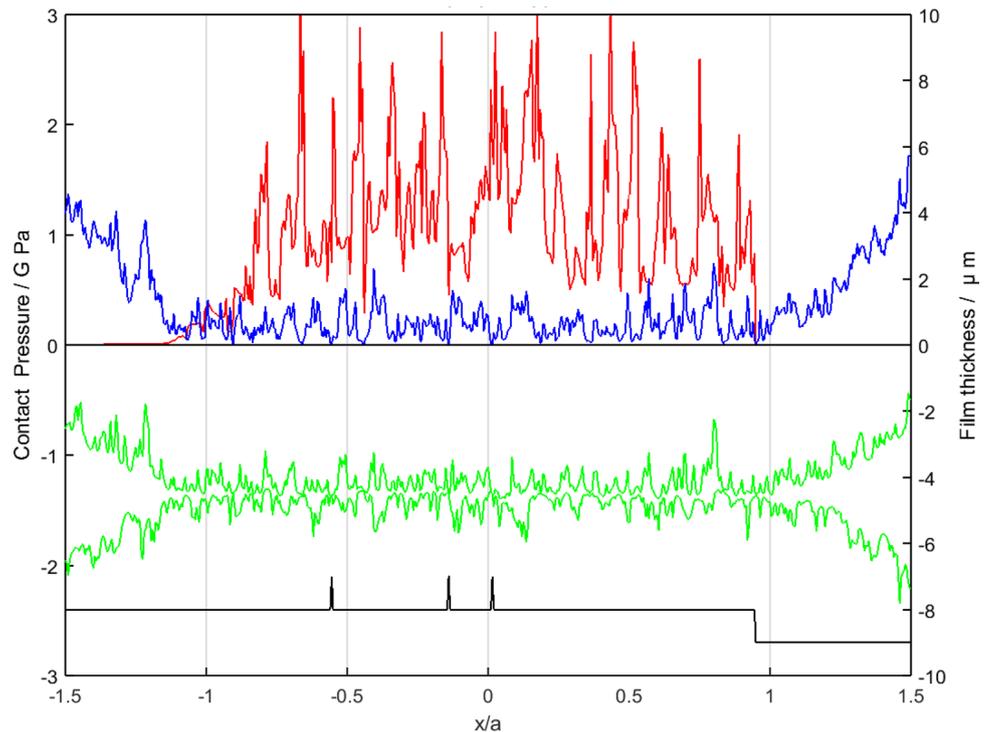
**Fig. 9** A particular time step during the micro-EHL simulation: pressure distribution (red curve), film thickness distribution (blue curve), in-contact cavitation (black curve) and deflected surface profiles (green curves offset for clarity). (Color figure online)

These stress concentrations occur during the short times that asperity features are in close proximity and cause intense cyclic loading that may lead to fatigue damage in the form of surface and subsurface micropitting and surface crack formation.

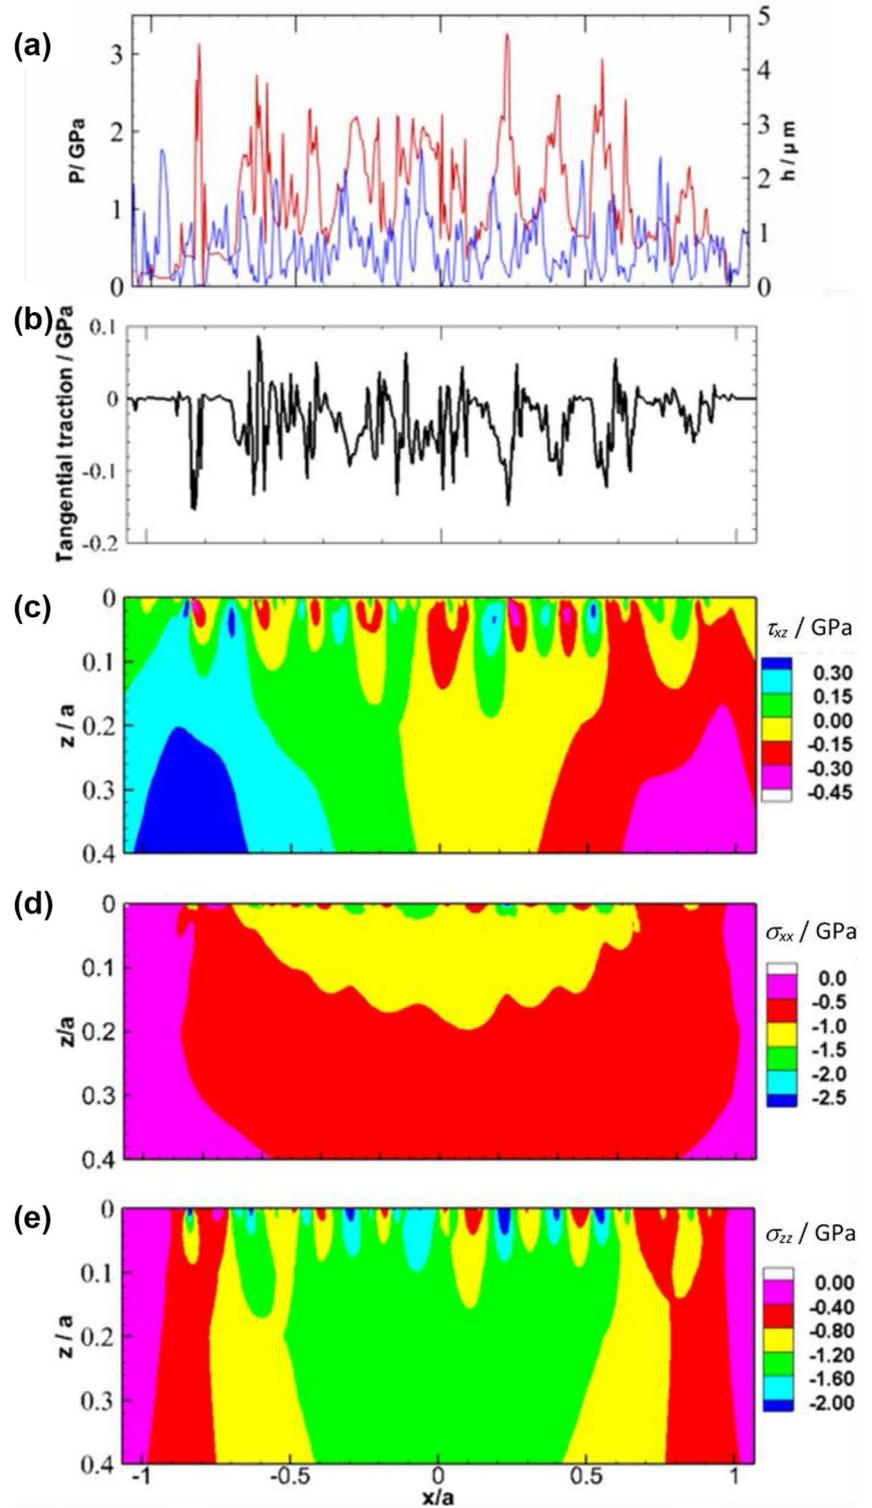
**Fig. 10** Model predictions at an example time step of the transient analysis of the slow surface. **a** contact pressure (red) and film thickness (blue), **b** tangential surface shear stress, and stress fields of **c**  $\tau_{xz}$ , **d**  $\sigma_{xx}$ , and **e**  $\sigma_{zz}$ . (Color figure online)

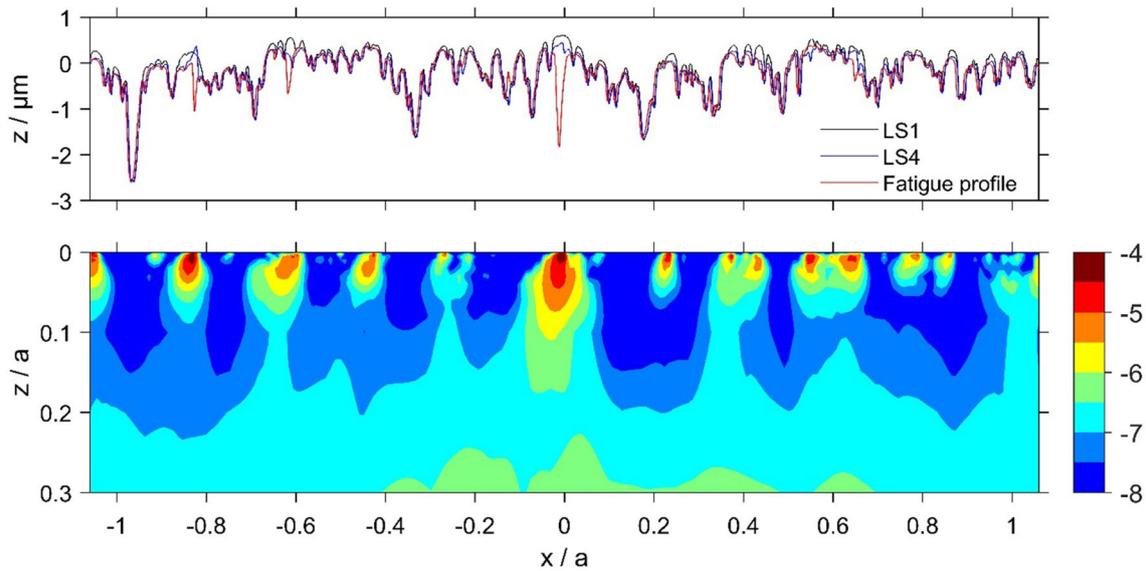
**Fig. 11** Slow disk relocated profiles (upper frame) and contours of  $\log_{10}(D)$  using Fatemi and Socie criterion (lower frame), where accumulated damage,  $D=10^{-n}$ , indicates fatigue in  $10^n$  cycles

Comparison of the Load Stage 1 and Load Stage 4 traces shows minimal further surface modification following the running-in changes which occurred during Load Stage 1. The roughness profiles obtained at each stage were aligned in the profile trace direction to minimise the positional error between deep valley features.

Comparison of the roughness profiles in Figs. 11 and 12 shows that some peaks had been replaced with small valley features by the time that the Load Stage 4 profiles were taken. This is evidence of initiation of micropitting occurring between Load Stages 1 and 4. Examples of this can be seen in Fig. 11 at  $x/a$  values of  $-0.8, -0.6, 0, 0.44$  and  $0.64$ , and in Fig. 12 at  $x/a = -0.28, -0.24, -0.08, 0.79$  and  $1.04$ . Comparison with the Fatigued Profiles shows that further micropits have been formed or enlarged in the further running after the Load Stage 4 measurements were taken. Figure 13 shows four enlarged sections of the profiles where micropits have developed and these can be seen to initiate between Load Stages 1 and 4, clearly demonstrating regions of high damage immediately sub-surface associated with micropit initiation.

These detailed observations are in good agreement with the contour damage results presented in Figs. 11 and 12. It is clear that the asperities sustain calculated damage levels that are significantly higher than those experienced by the surrounding material. In these figures, the contour levels are chosen to vary logarithmically in value as the difference in  $D$  between the areas having the most and least calculated fatigue damage is up to five orders of magnitude. The vertical ( $z$ ) scale of the damage contour is shown as a fraction of the corresponding Hertzian contact semi-dimension,  $a$ . It can be seen from these figures that the accumulated damage calculated is concentrated near the surface of the prominent asperities features within the approximate range  $0.0 < z/a < 0.07$  and this damage occurs after a relatively modest number of load cycles. The results of the damage accumulation model indicate a life between 10,000 and 32,000 cycles for the brown contour areas in Figs. 11 and 12, and between 32,000 and 100,000 cycles for the red contour area. The model results are, therefore, of the same order as the observations, indicating damage initiation occurring early during the micropitting test between Load Stages 1 and 4. This is encouraging given that the model is for two representative run-in surface profiles that in all probability did not run against each other in the actual micropitting test.

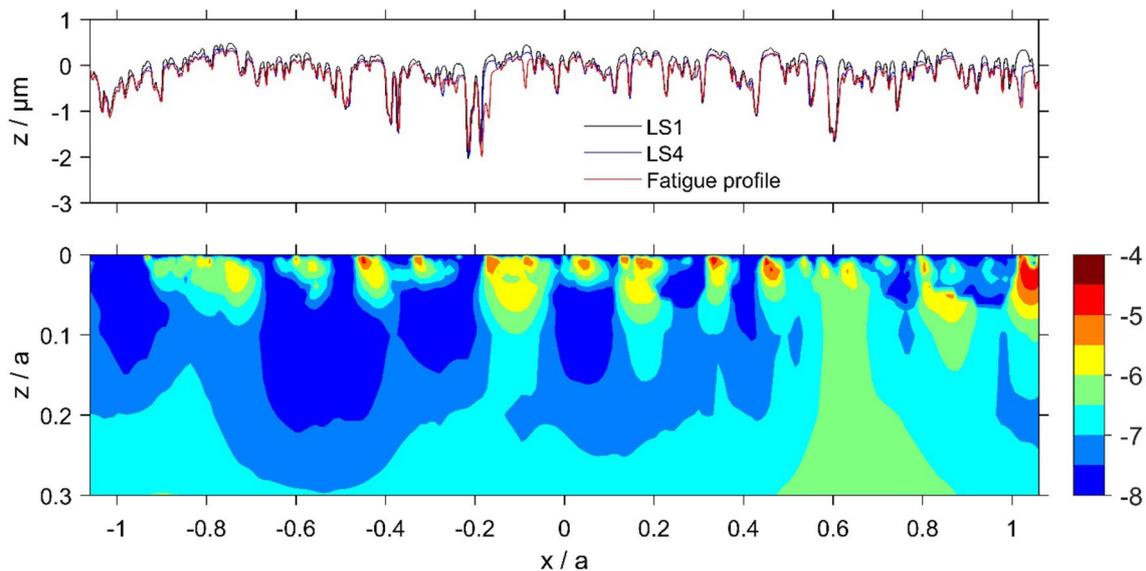
**Fig. 12** Fast disk relocated profiles (upper frame) and contours of  $\log_{10}(D)$  using Fatemi and Socie criterion (lower frame), where accumulated damage,  $D=10^{-n}$ , indicates fatigue in  $10^n$  cycles

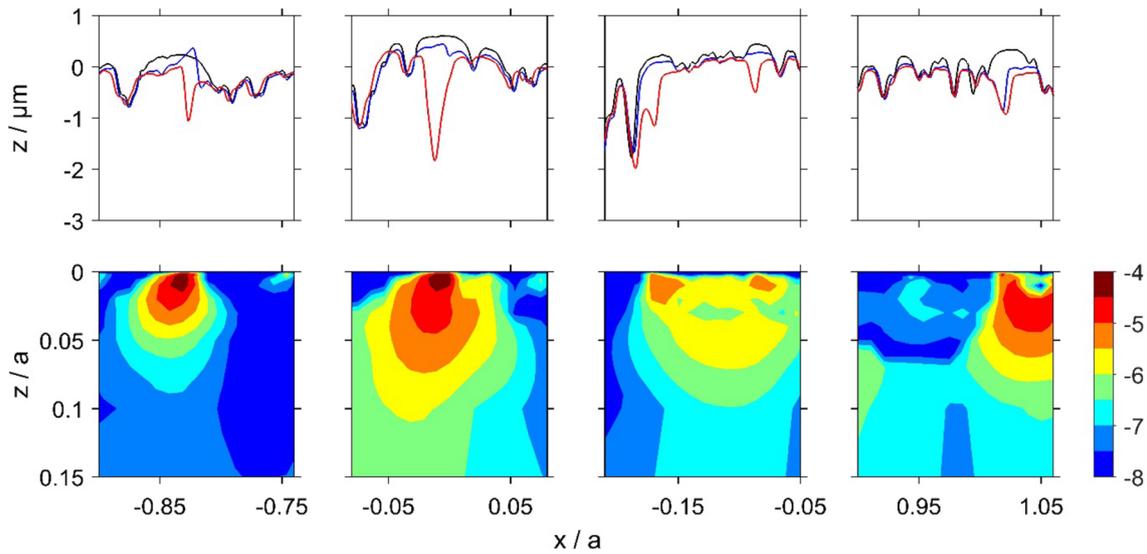
**Fig. 13** Relocated profiles showing micropit initiation (upper frame) and corresponding near-surface contours of  $\log_{10}(D)$  using Fatemi and Socie criterion (lower frame). The first two examples (from the left) are from Fig. 11 and the others from Fig. 12

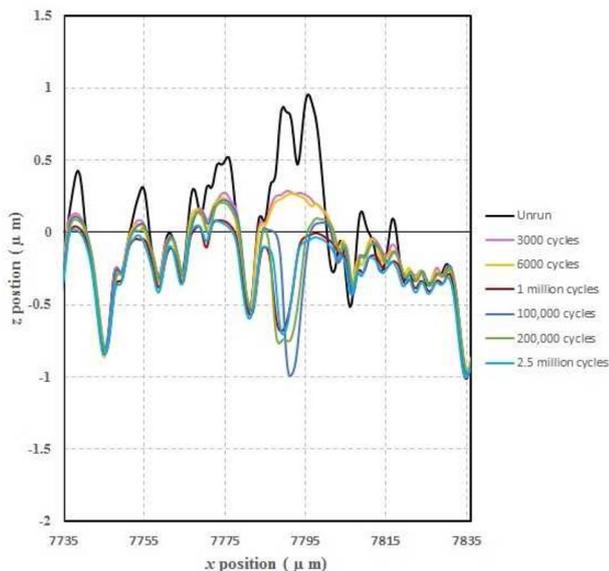
**Fig. 14** Relocated fast disk profiles showing formation of a micropit

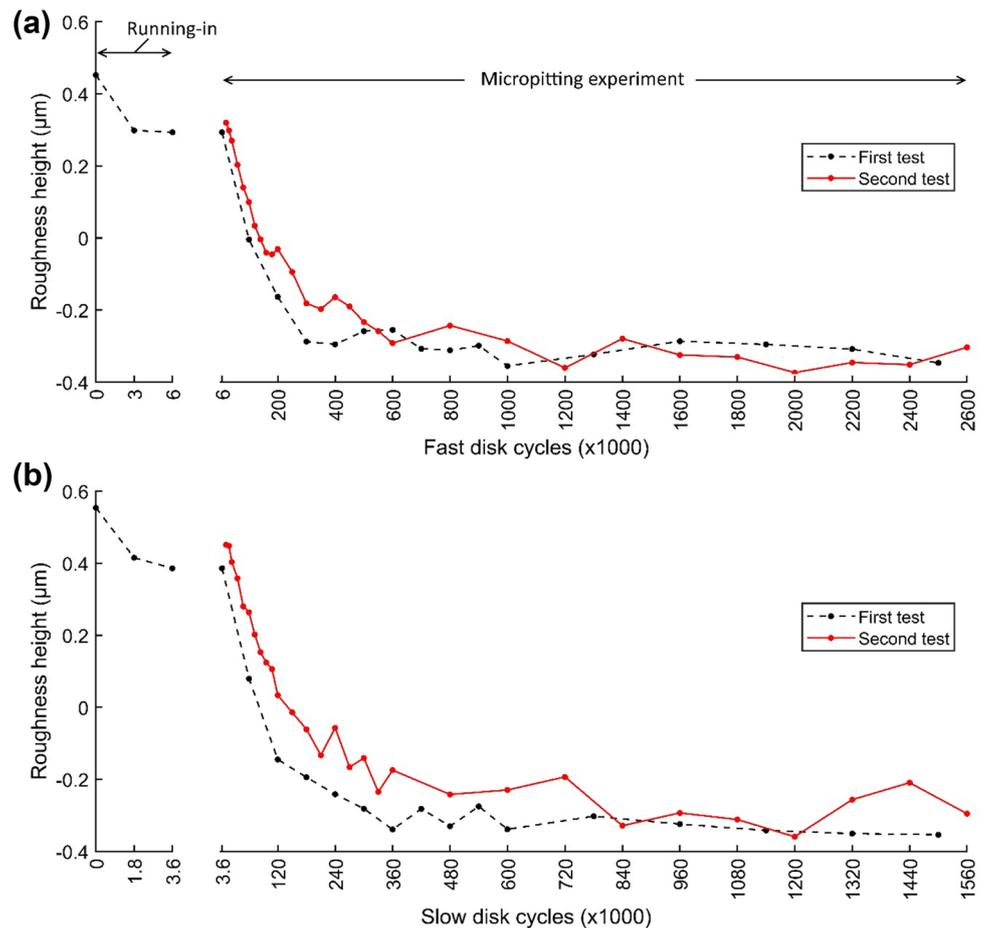
**Fig. 15** Evolution of mean roughness height for pitted regions of the profiles measured during the micropitting experiments. **a** and **b** refer to the fast and slow disks, respectively

measurements and can be seen in Fig. 15a, b for the fast and slow disks, respectively. Figure 15 also includes data from a second micropitting test undertaken to assess repeatability using a new pair of disks. This test was identical to the first test in terms of operating conditions and disk roughness. It did not include detailed running-in measurements, but profile measurements were taken at shorter intervals over the first 200,000 fast disk cycles (10 measurements), and thence at 50,000 fast disk cycle intervals until 600,000 cycles, at

This demonstrates that asperities reduce in height slightly during the running-in stage, but that the significant changes in height as micropits form occurs during the first two post running-in load stages for the original experiment. This is in the period from around 6000 cycles to approximately 200,000 cycles for both disks. The overall trend of these results is for the pitted regions to become deeper as the tests
